PILOTNÝ PROJEKT ODSTRÁNENIA PORÚCH

Posúdenie výskytu a návrh odstránenia systémovej poruchy obvodového plášťa a nosných stien radového bytového domu PV - 2 na Mudrochovej ulici č. 17 - 19 v Šuranoch bolo vypracované v rámci vedecko-technického projektu VTP 2811001800, etapy 02 „Obnova bytových domov konštrukčného systému PV - 2“. V spolupráci s Občianskym bytovým družstvom Šurany bol predmetný bytový dom vybraný na realizáciu pilotného projektu. Cieľom realizácie pilotného projektu bolo potvrdenie príčiny vzniku poruchy a stanovenie nákladov na jej odstránenie.

The assessment of the occurrence and subsequent proposal for the removal of a system fault of the outer wall and load bearing walls of row dwelling house PV - 2 at Mudrochová no. 17 - 19 in Šurany was elaborated within Research-technical project 2811001800, Phase 02 "Upgrading of dwelling houses of the PV - 2 Design System." In cooperation with the Civil Housing Co-operative of Šurany, the subject house was selected for the implementation of a pilot project. It was aimed at confirming the cause of the fault and establishing the costs of its removal.

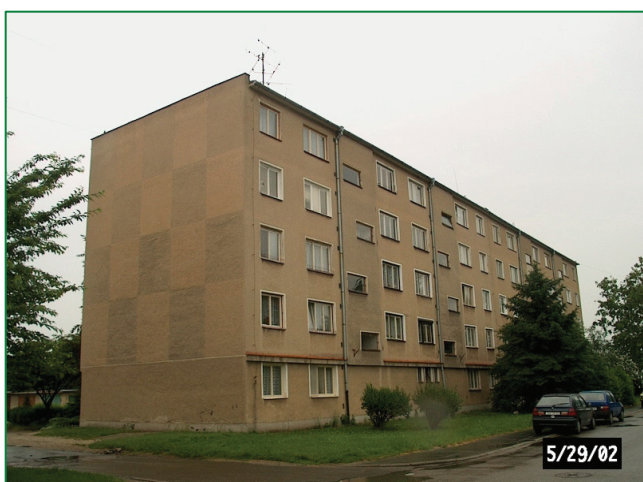
Pohľad na zadnú fasádu bytového domu – pôvodný stav
View of the rear façade of the dwelling house – original condition

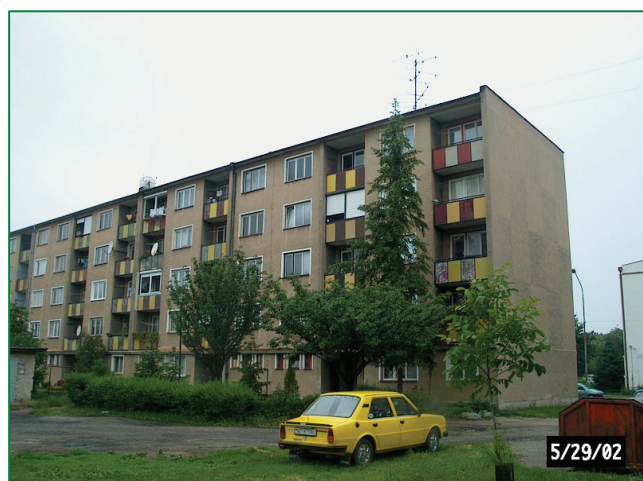
Pohľad na čelnú fasádu bytového domu – pôvodný stav
View of the front façade of the dwelling house – original condition

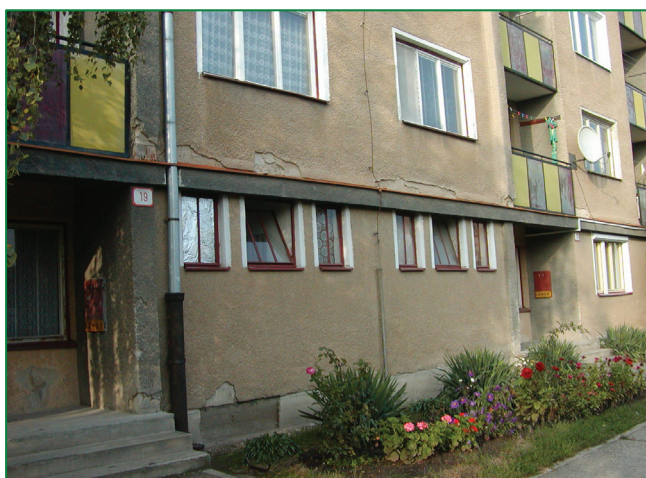
Pohľad na čelnú fasádu – vstupy do domu – pôvodný stav
View of the front façade – entrances of the house – original condition.

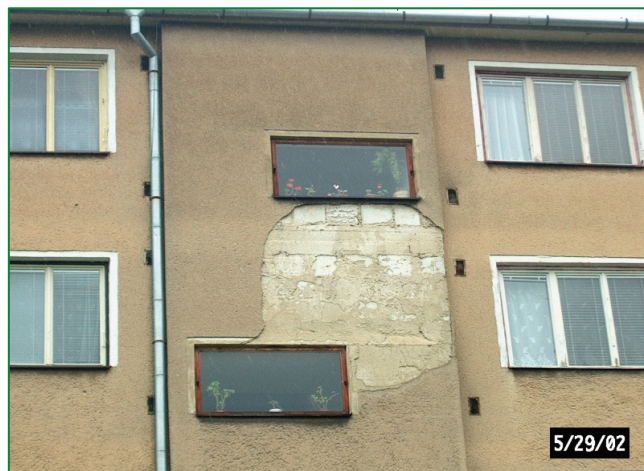
Prieskum potvrdil, že obvodový plášť je porušený, porucha je charakteru systémovej poruchy. Vo vonkajších omietkach sú trhliny. Časť omietok bola uvoľnená a ďalšia časť omietok odpadla. Na vonkajšom obvodovom plášti nebola v priebehu užívania vykonaná žiadna údržba s výnimkou náterov šambrán okolo okien a na jednom mieste bola doplnená odpadnutá omietka.

The survey confirmed the failure of the outer wall, the break being of a system nature. There were cracks in the outer rendering. Part of the rendering was loosened and another part of the rendering had fallen off. No maintenance had been performed on the outer wall during its use with the exception of architraves around the windows and, at one location, supplementation of the fallen rendering.

Pohľad na zadnú fasádu – odpadávajúca omietka na schodisku
View of the rear façade – fallen rendering at the staircase

Jestvujúca brizolitová omietka na vonkajšom povrchu muriva sa odstránila, prípadné väčšie nerovnosti podkladu ako 10 mm sa vyrovnali opravovacou maltou. Zateplenie sa realizovalo podľa technologického postupu platného pre použitý kontaktný zatepľovací systém.

The existing brisolite rendering on the outer surface of the wall was removed, unevenness of more than 10 mm at the base was compensated with correction mortar. The insulation was implemented pursuant to the technological procedure valid for the applied contact insulation system.

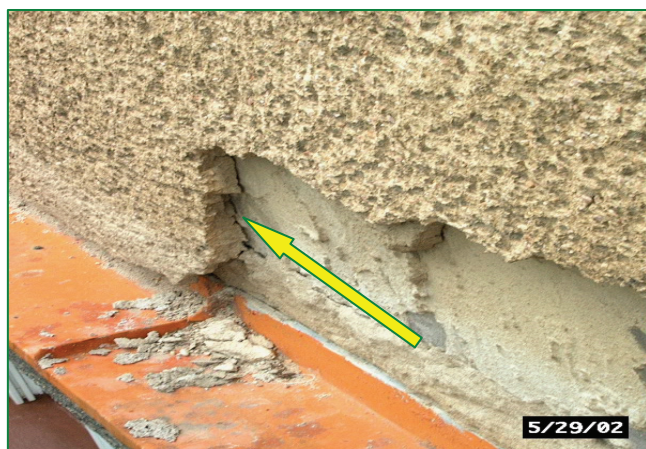
Odpadnutá a oddelená omietka hrúbky 40 mm pri rímse
Fallen off and separated rendering with thickness of 40 mm at the moulding

Prehliadka domu potvrdila, že obvodový plášť 1. nadzemného podlažia i ďalších nadzemných podlaží (2. - 5. NP) je vymurovaný z pórobetónových tvárnic. Prieskumom vonkajších omietok na 1. NP sa potvrdilo, že brizolitová omietka je na väčšine plochy uvoľnená od podkladu. Na niektorých miestach vyšších podlaží bola brizolitová omietka odpadnutá a viditeľné bolo jej uvoľnenie na ďalších plochách od podkladu. Na povrchu sa zistili trhliny a hrúbka omietky v rozpätí 20 - 50 mm. Spôsob uvoľnenenia vonkajších omietok a obnažené murivo potvrdzuje, že pred omietaním stien z pórobetónových tvárnic nebola stena dostatočne navlhčená a nebol nanesený podkladný nástrek z cementovej malty.

The inspection of the building confirmed that the outer wall of the 1st and higher storeys (2nd - 5th) was lined with porous concrete bricks. The survey of the outer rendering at the 1st storey confirmed that the brisolite rendering was, in most areas, loosened from the foundation. At some locations of the higher storeys, the brisolite rendering had fallen off and its loosening from the base was also visible in other areas. Cracks and the thickness of the rendering were in a range of 20 - 50 mm and were identified on the surface. The way in which the outer rendering had loosened, and the bared masonry, confirmed that before rendering the walls of porous concrete bricks, the wall was not sufficiently moistened, nor the base sprayed with cemented mortar. The plinth part with an altitude of 400 mm was rendered. The base layer with a thickness of approx. 15 mm was treated with bush-hammer. The base layer had a thickness of 15- 20 mm. The plinth concrete had crumbled and fallen off. The rendering of the plinth was, around the entire perimeter of the building, separating from the plinth concrete. The rendering had fallen off in some spots.

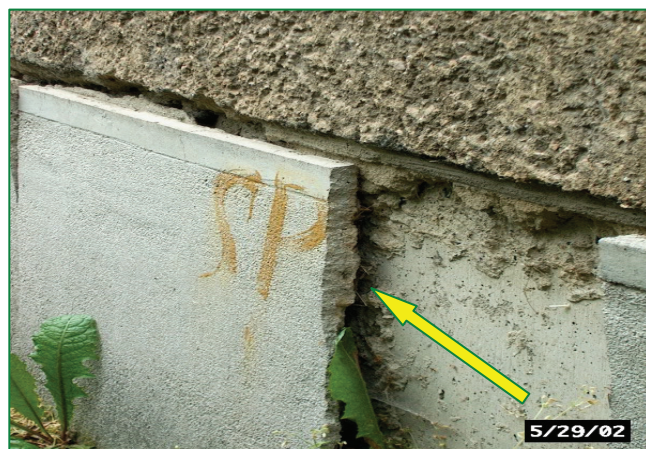
Odpadnutá a oddelená povrchová úprava sokla
Fallen and separated finish of the plinth

Soklová časť výšky 400 mm bola omietnutá. Pohľadová vrstva približne hrúbky 15 mm sa upravila pemrlovaním. Podkladná vrstva má hrúbku 15 - 20 mm. Betón sokla sa miestami drobil a vypadal. Omietka sokla sa po celom obvode domu oddeľovala od soklového betónu. Na niektorých miestach omietka odpadla.

Na sokli sa kompletne odstránila omietka. Poškodený betón sokla sa očistil a opravil. Na zatuhnutý povrch sa naniesla nová omietka podľa technologického postupu pre nanášaný druh omietky.

The rendering was completely removed from the plinth. The damaged concrete of the plinth was cleaned and repaired. A new rendering was applied on the solidified surface pursuant to the technological procedure for the applied type of rendering.

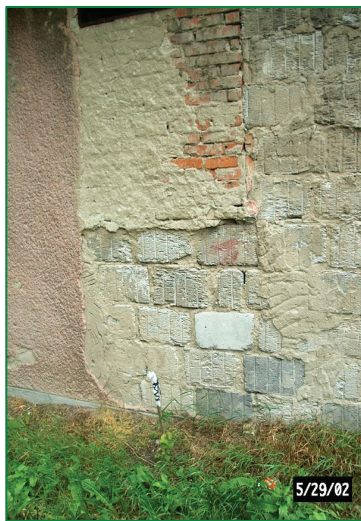
Štítová stena. Dom má 2 typy štítových stien: obvodové a vnútorné steny pri dilatáciách. Vonkajšia obvodová stena 1. nadzemného podlažia bola navrhnutá z tehelného muriva hrúbky 375 mm. V 2. a ďalších podlažiach je stena z pórobetónových tvárnic hrúbky 240 mm.

Štítová stena pri dilatácii v 1. NP je vymurovaná z tehál hrúbky 250 mm. Stena je v ďalších podlažiach z pórobetónových tvárnic hrúbky 240 mm. Vonkajšie omietky obvodových štítových stien boli uvoľnené od podkladu, ale neodpadávali. Vnútorné omietky na štítových stenách boli v rovnakom stave ako omietky na všetkých nosných stenách.

Rôzne druhy murovacích materiálov
v štítovej stene
Different kind of masonry materials in the
gable wall

Gabled wall. The house has two types of gabled walls: outer and inner walls at the dilations. The outer wall of the 1st level storey was designed from brick masonry with a thickness off 375 mm. In the 2nd and other storeys, the wall was also constructed of porous concrete bricks with a thickness of 240 mm.

The gabled wall at a dilatation in the 1st storey was constructed of bricks with a thickness of 240 mm. The wall is, in the other storeys, constructed the same kind of bricks. The outer rendering of the outer gabling walls was loosened from the base but had not fall off. The inner rendering on the gabling walls was in the same shape as the rendering on all the bearing walls.

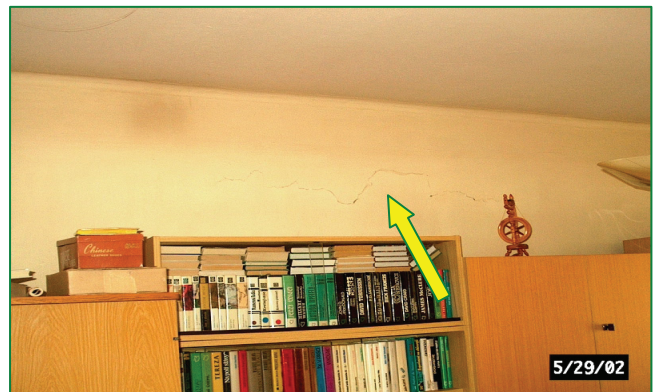
Nosné steny. Vnútorné nosné steny boli v 1. NP navrhnuté z tehál na šírku muriva 250 mm, vo vyšších podlažiach z pórobetónových tvárnic. Steny typického podlažia sú vymurované z pórobetónových tvárnic hrúbky 240 mm. Vizuálna diagnostikácia stien v bytoch potvrdila, že omietky na prevažnej ploche sú uvoľnené. Časť uvoľnených omietok obyvatelia odstránili a steny znovu omietli. Takto opravené omietky sa už po niekoľkých rokoch znovu uvoľňujú.

Trhliny a oddelenie vnútornej omietky od podkladu
Cracks and separation of the inner rendering from the base

Bearing walls. The inner bearing walls of the 1st storey were designed of bricks with the width of the masonry being 250 mm, while in the higher storeys they were of porous concrete bricks. Walls of a typical storey were constructed of porous concrete bricks with a thickness of 240 mm. Visual diagnostics of the walls of the apartments confirmed that rendering in most areas had loosened. Part of the loosened rendering had been removed by the inhabitants, who then re-rendered the walls. Such repaired rendering had been loosening again after a few years.

Najvhodnejším spôsobom odstránenia systémovej poruchy vonkajších stien je zateplenie obvodového plášťa a na vnútorných stenách odstránenie porušenej omietky a naniesenie novej omietky s dodržaním technologických požiadaviek (navlhčenia podkladu a dodržanie hrúbok), prípadne obloženie sádkartónovými doskami.

The most suitable method of removal of the system fault was to insulate the outer wall and, on the inner walls, remove the damaged rendering and apply new rendering complying with technological requirements (moistening the base and compliance with thickness), or line it with plasterboard.

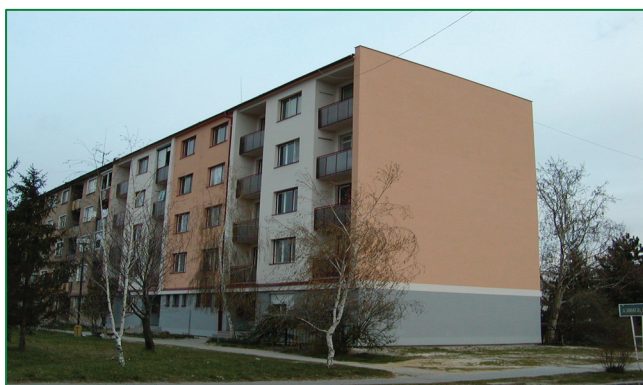
Pohľad na čelnú fasádu bytového domu po zateplení
View of the front façade of the dwelling house following the additional insulating

Nakoľko požiarová výška budovy je nižšia ako 22,5 m priečelia a štíty vrátane lodžií, ríms, okenných ostení a nadpraží sa zateplili kontaktným zatepľovacím systémom s tepelnoizolačnou vrstvou z penového polystyrénu (EPS). Hrúbka tepelnej izolácie sa stanovila v projektovej dokumentácii s prihliadnutím na splnenie požiadavky energetického kritéria podľa STN 73 0540-2: 2002.

Because the fire height of the building is less than 22.5 m, the facade and gables, including the loggias, inner beads, and door heads, were insulated with contact system (ETICS) and insulation layer made of polystyrene foam (EPS). The thickness of the thermal insulation was stipulated in the design documentation reflecting compliance with energy criterion pursuant to STN 73 0540-2: 2002.

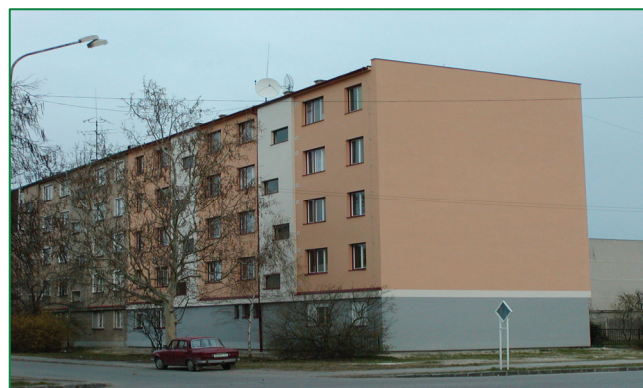
Pohľad na zadnú fasádu bytového domu po zateplení
View of the rear façade of the dwelling house following the additional insulating
