PILOTNÝ PROJEKT - NÁRODNÁ TRIEDA Č. 41-45, KOŠICE

V rámci vedeckotechnického projektu VTP 6 - 400 "Obnova budov pozemných stavieb s dôrazom na bytový fond" bol realizovaný **pilotný projekt Národná trieda č. 41-45, Košice** zameraný na obnovu bytového domu vrátane zníženia spotreby tepla na vykurovanie a výstavbu nových bytov v strešnej nadstavbe.

Within the scope of science-technical project VTP 6 - 400 "Upgrading of buildings with emphasis to housing stock" has been realized *the pilot project Národná trieda No. 41-45, Košice* intent on the dwelling house upgrading, including the reduction of heat consumption for heating and construction of new dwellings in the roof superstructure.

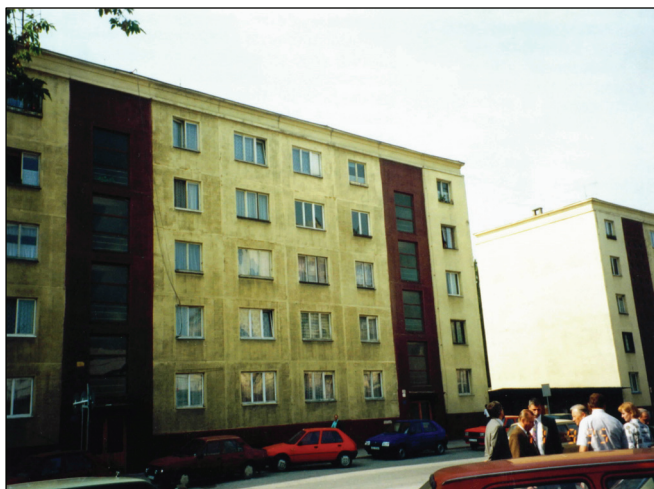
▲ Pôvodný stav bytového domu
Original Condition of the Dwelling House

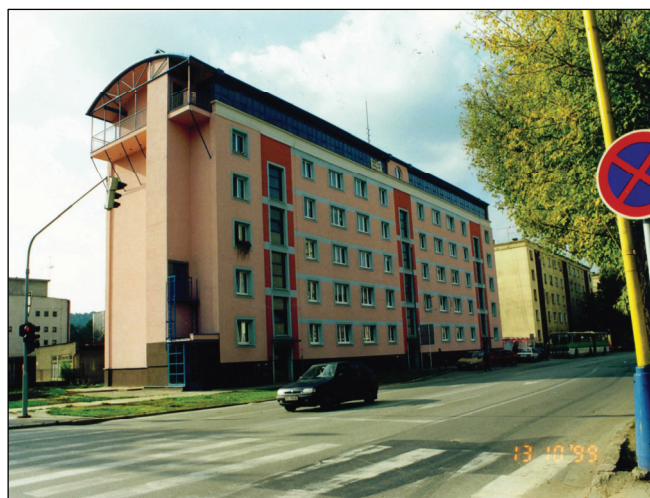
▲ Nový stav bytového domu
New Condition of the Dwelling House

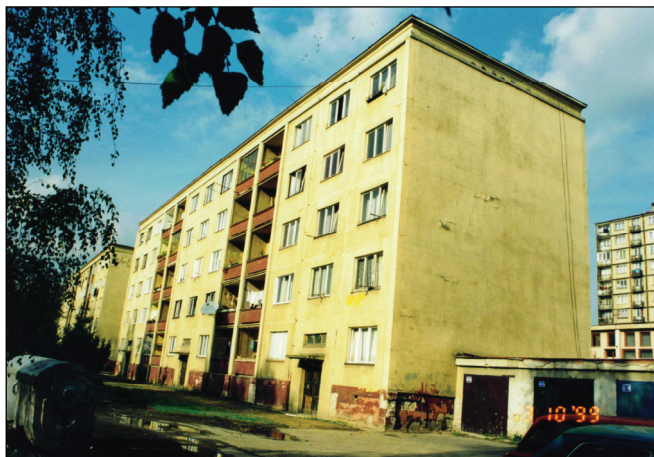
▲ Pôvodný stav bytového domu - pre porovnanie vedľajší dom

Original Condition of the Dwelling House - next one comparing the neighbour house

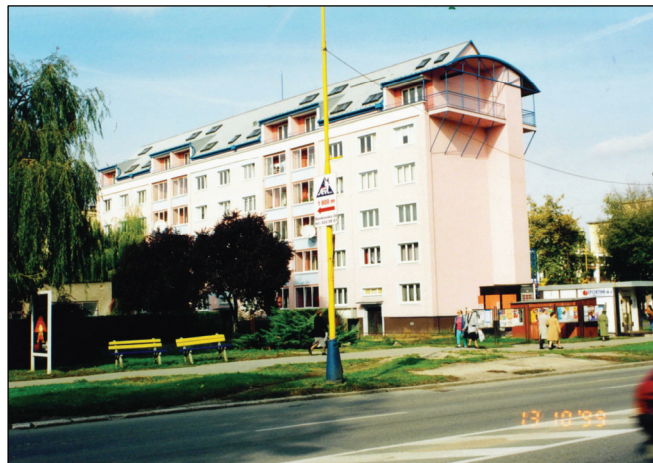
▲ Nový stav bytového domu so zasklenými lodžiami

New condition of the dwelling House with glazed loggias

- zasklenie lodžii - oproti projektu realizátor zmenil jednoduché zasklenie na izolačné dvojokno v plastových rámoch.

- glazing of loggias - the supplier of realization works changed, in comparison with design, a single glazing for an insulating double-glass in plastic frames.

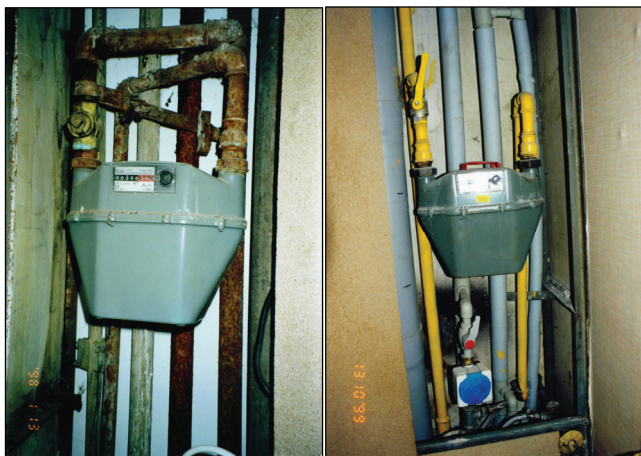
▲ Pôvodné inštalácie rozvodov a po obnove
Original installation distribution lines and after their upgrading

- replacement of installation distribution lines for gas - original distribution lines made of black steel with the threaded joints (though they didn't get over the end of their service life, but in regard of the flooding caused by users several times during the dwelling house existence, they were completely corroded in the passages through the ceiling plate) were replaced by new ones;

- výmena inštaláčnych rozvodov v bytových jadrách (výmena stúpacích potrubí studenej vody, teplej úžitkovej vody a cirkulácie za potrubia z polypropylénových rúr HOSTALEN bola vykonaná z prefabrikovaných dielov, spájaných polyfúznym zvarovaním a tlakovo odskúšaných);
- výmena plynoinštaláčnych rozvodov - pôvodné rozvody z čiernej ocele so skrutkovými spojmi (síce nedosiahli koniec svojej životnosti, ale vzhľadom na niekoľkonásobné vytopenie užívateľmi počas existencie bytového domu, boli úplne skorodované v prechodoch cez stropnú dosku) boli vymenené za nové;

replacement of installation distribution lines in the sanitary blocks (replacement of the upward pipelines of cold water, hot utility water and circulation by the pipelines made of HOSTALEN polypropylene tubes was carried out by means of prefabricated parts, joined by the polyfusion welding and by pressure tested);

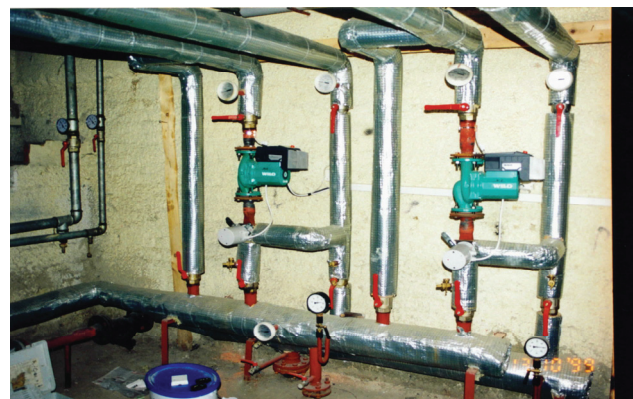
▲ Strojovňa výmenikovej stanice
Machinery-room of the heat exchanger station

- replacement of heating system, by a divided horizontal system of distribution lines - the zone control. As the object is thermally attached to the block's boiler-room with an equithermal control of hot water, the system has been dimensioned and realized on reduced parameters by which is provided an hydraulic stability of the system (prevention from non-heating and overheating of lower/upper floors). Two mixing fittings for the zone control (north, south) MIX AP, DN 40 with electric drive are installed. As the heating system is solved by the zone control, the thermostatic controlling of radiator fittings has not been used on the heaters. Measurement of the heat energy consumption for this object is performed by the object heat gauge located in the heat machinery-room. The object's thermal losses calculation was made in accordance with STN 06 0210 up to exterior temperature -15°C .

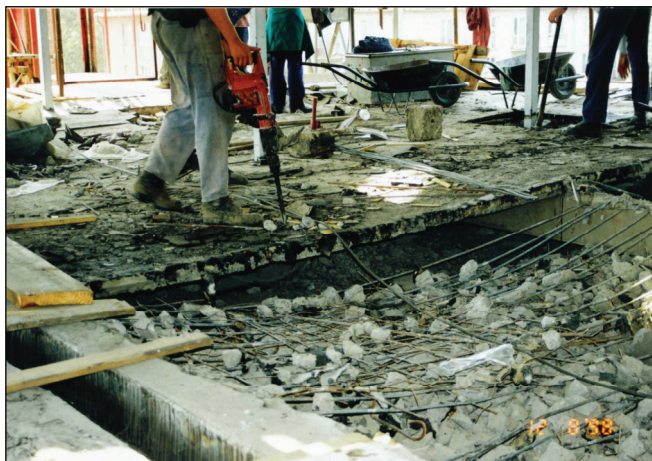
▲ Rozoberanie pôvodnej konštrukcie dvojplášťovej strechy
Dismantling of original structure of the double-jacketed roof

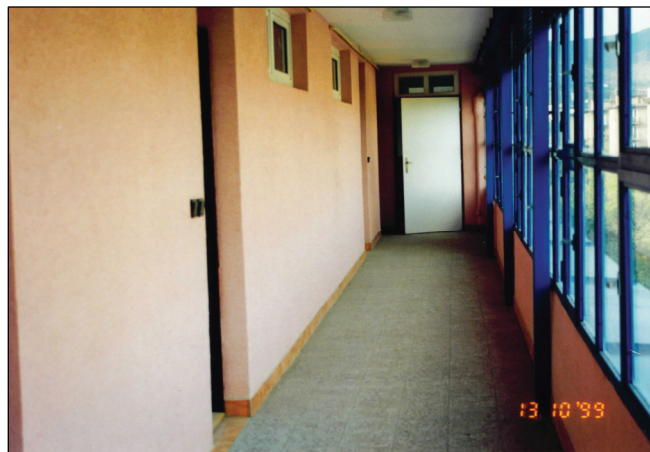
▲ Pohľad na pavlač - prístupy do nových bytov

View of the built-on gallery part - entrances into new apartments
