## PILOTNÝ PROJEKT ODSTRÁNENIA SYSTÉMOVEJ PORUCHY LODŽII ZT

Posúdenie výskytu a návrh odstránenia systémovej poruchy predsadených lodžií konštrukčného systému ZT bolo vypracované v rámci Vedecko-technického projektu (VTP) 2811001800, etapy 02.1 „Pilotný projekt obnovy bytovej výstavby“. V spolupráci so spoločenstvom vlastníkov a správcom PROGRES, s.r.o. sa na overenie vybral bytový dom na Novohorskej ulici č. 12-20 v Bratislave. Cieľom realizácie pilotného projektu bolo potvrdenie príčiny vzniku poruchy a stanovenie nákladov na jej odstránenie.

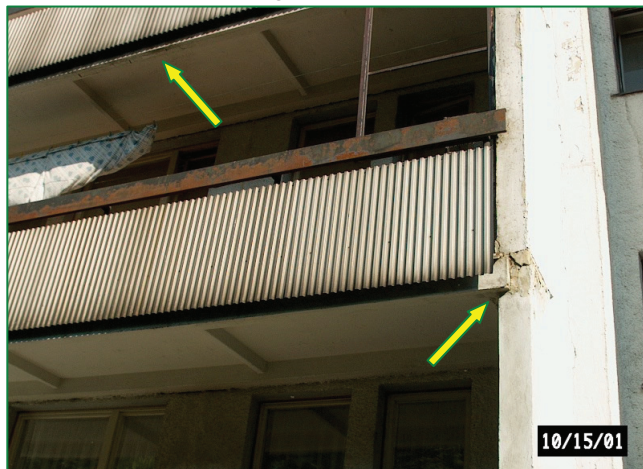
Pohľad na predsadenú lodžiu – pôvodný stav  
View of protruding loggia - original condition

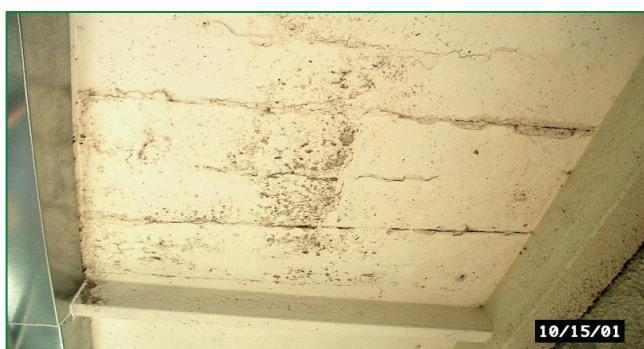
- A. Technický stav zábradlia lôžii bol vyhovujúci, korózia sa vyskytovala len ojedinele a v počiatočnom štádiu.
- B. Po celom vonkajšom povrchu obvodovej steny oboch priečelí (pred celou stenou mimo schodísk sú predstavené lôžie) steká atmosférická voda, ktorá v mnohých prípadoch (v rozsahu približne 45%) zateká aj do bytov. Na západnom priečelí bolo zatekanie intenzívnejšie (smer prevládajúcich vetrov).
- C. V stropných paneloch lôžii sa zistili trhliny a korózia výstuže (v rozsahu približne 80%).

Trhliny a korózia výstuže v stropnej lôžiovej doske  
Cracks and corrosion of reinforcement in a ceiling loggia board

- A. The technical shape of the loggia railings was suitable, the corrosion occurred only sporadically in an initial stage.
- B. Along the external surface of the outer wall of both façades (the loggias protrude from the entire wall except where the staircases are located) atmospheric water flows that in many cases leaks into the apartments (in a range of approximately 45%). On the western façade the leakage had been more intensive (predominant direction of wind).
- C. Cracks and corrosion of reinforcement were identified in the ceiling panels of the loggias (approxim. 80%).

Oprava zdegradovaného betónu sa vykonala reprofilačným systémom Schomburg ASOCRET – P/FM30 pri náhrade prierezu od 5 do 40 mm. Pri väčšej náhrade prierezu sa použil ASOCRET – P/GM100.

Repair of the degraded concrete was performed with Schomburg ASOCRET – P/FM30 re-profiling system, replacing the section from 5 to 40 mm. ASOCRET – P/GM100 was used to replace larger diameters.

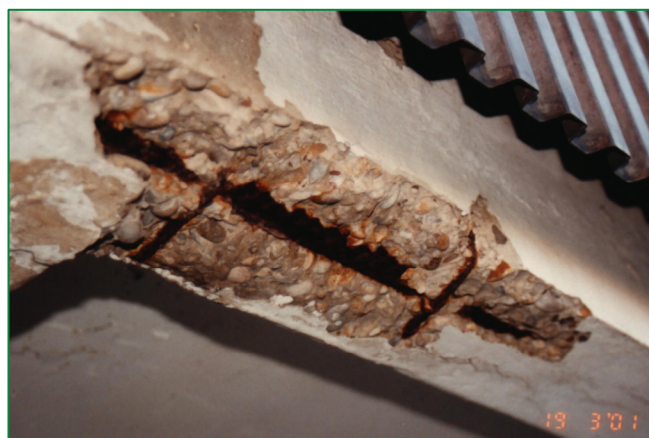
- D. V miestach stykov stropných panelov a stien lôžii boli zistené trhliny a odpadnuté kusy zdegradovaného betónu (v rozsahu asi 60%).
- E. V podlahových vrstvách nebola zhotovená hydroizolácia.
- F. Lôžia Novohorská č. 14, byt č. 11 (v prízemí východného priečelia) je uzavretá parapetným vymurovaným pásom a oknami. Priehyb stropnej dosky je zvýšený oproti ostatným približne na dvojnásobok.

Zdegradovaný betón a skorodovaná výstuž  
Degraded concrete and corroded reinforcement

- D. Cracks and fallen pieces of degraded concrete were identified at the joints of ceiling panels and loggia walls (in a range of approximately 60%).
- E. Hydro-insulation had not been laid down in the floor layers.
- F. The loggia at Novohorská no. 14, flat no. 11 (on the ground floor of the eastern façade) is closed with a parapet walled band and windows. The deflection of the ceiling board was doubly increased compared to others.

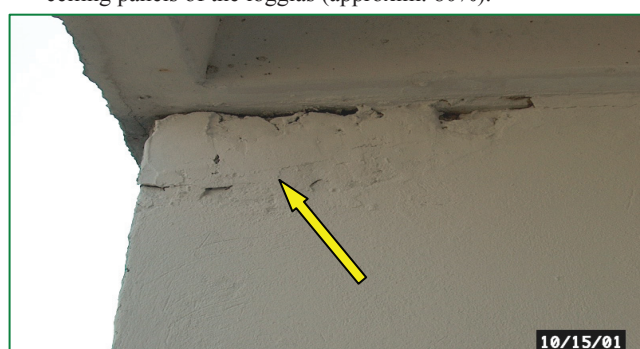
Poškodenie nosnej steny v uložení lôžiovej dosky  
Damage of the bearing wall in the mounting of a loggia board

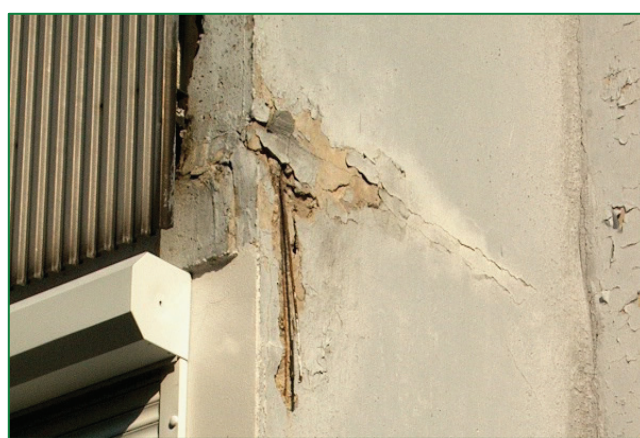
Zdegradovaná zálievka styku lôžiovej nosnej steny  
Degraded filler of the joint of a loggia bearing wall

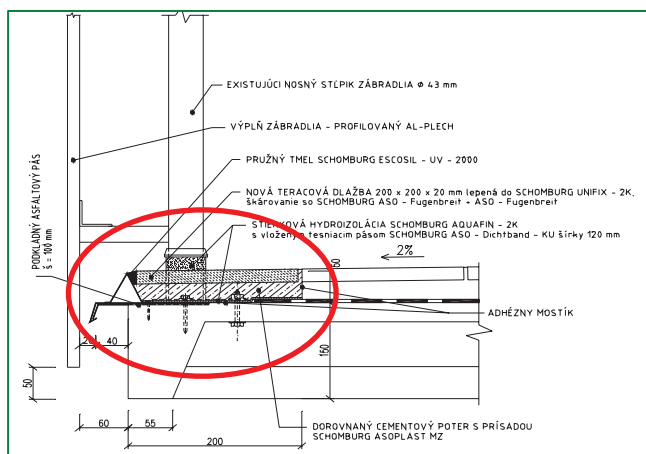
Detail koncovej úpravy lodžiovej dosky a kotvenia zábradlia  
Detail of finishing of loggia board and anchoring of railing

Skorodované kotvenie zábradlia sa odstránilo a nahradilo novým kotviacim prvkom s povrchovou úpravou pozinkovaním. Výplň zábradlia bola ponechaná pôvodná z profilovaného hliníkového plechu.

Corroded railing anchoring was removed and replaced with a new anchoring element with zinc coating finishing. The railing filling was maintained with the profiled aluminium sheet.

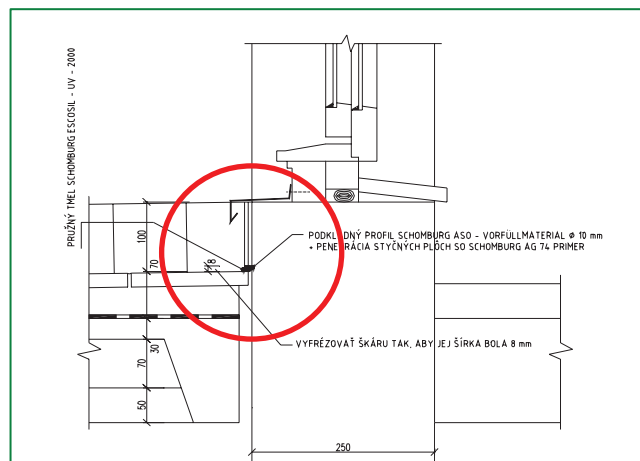
Detail úpravy keramického soklíka a dlažby  
Detail of finish on ceramic plinth and flooring

Medzi keramickým soklíkom a keramickou dlažbou sa vyfrézovala škára pri obvodovom plášti tak, aby vznikla škára šírky 8 mm, ktorá sa vyplnila podkladovým profilom Schomburg ASO – VORFÜLLMATERIAL Ø 10 mm. Styčné plochy obkladu a dlažba sa napenetrovali s použitím Schomburg AG 74 PRIMER a nakoniec bola škára pretmelená pružným tmelom Schomburg ESCOSIL – UV – 200.

Between the ceramic plinth and ceramic flooring a gap was milled at the outer wall to a gap width of 8 mm, filled with bottom profile Schomburg ASO – VORFÜLLMATERIAL Ø 10 mm. The contact areas of lining and flooring were penetrated using Schomburg AG 74 PRIMER and the gap was finally sealed with Schomburg ESCOSIL – UV – 200 flexible binder.

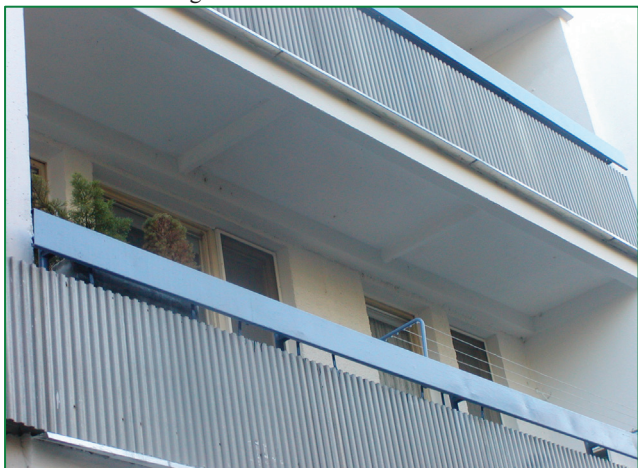
Pohľad na obnovenú lodžiu  
View of the upgraded loggia

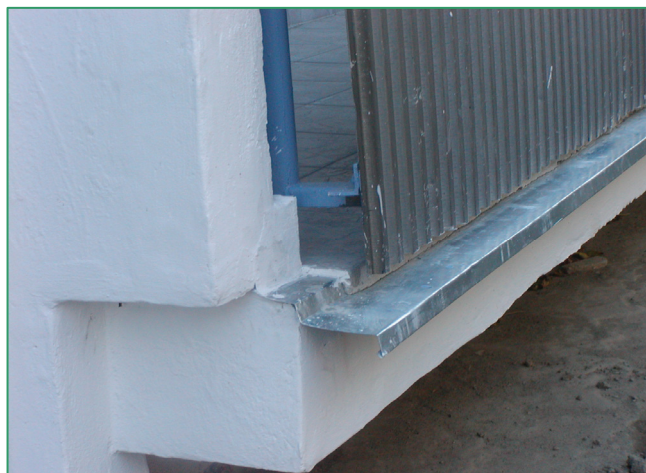
Detail lodžiovej dosky pri odkvape po obnove  
Detail of loggia board at the cornice following renovation
