PILOTNÝ PROJEKT - UL. ROSNÁ Č. 3, KOŠICE

V rámci vedeckotechnického projektu VTP 6 - 400 "Obnova budov pozemných stavieb s dôrazom na bytový fond" sa riešil **pilotný projekt** Košice, Rosná ul. č. 3 zameraný na odstránenie systémovej poruchy (neskoršie zavedenej ako systémová porucha) a zníženie spotreby tepla pri prevádzke budovy.

In frame of the Research and Technology Project 6 - 400 "Rehabilitation of Ground Surface Buildings with Emphasis Put on the Housing Stock" we have developed the solution of the **Pilote Project** Košice, Rosná Str. No.3, aimed at removal of failures in the building systematic defects and on reduction of heat consumption by using of buildings.

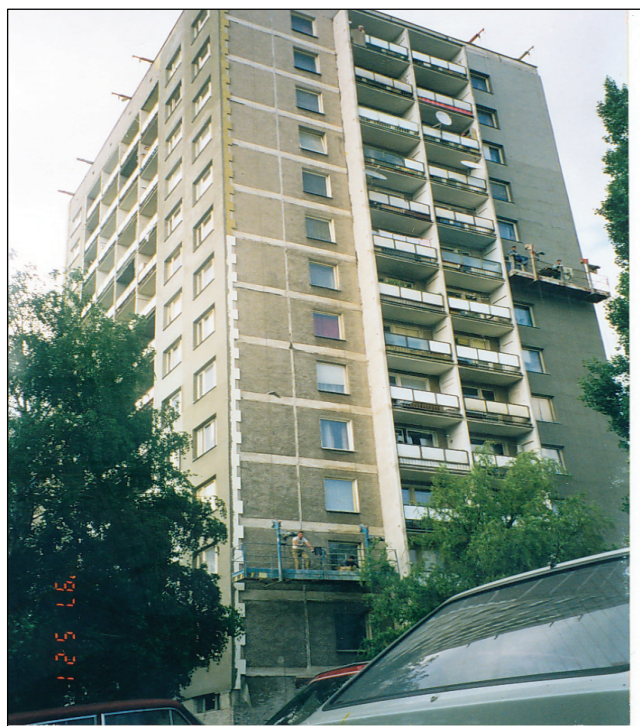
**Pôvodný stav bytového domu**  
**Original Condition of Residential House**

- Nosný systém je kombinovaný; nosné steny sú v oboch na seba kolmých smeroch.
- Obvodový plášť v priečeli je riešený ako jednovrstvový z troskopemzobetónu TPB tr. 01 (TPB 80), s projektovanou objemovou hmotnosťou  $1450 \text{ kg/m}^3$ , v prvom podlaží hr. 290 mm, v ostatných podlažiach hr. 320 mm. Výpočtová hodnota tepelného odporu je  $R = 0,426 \text{ m}^2\cdot\text{K/W}$  ( $U = 1,68 \text{ W/(m}^2\cdot\text{K)}$ ).

V štítovej stene sú k nosnej železobetónovej stene hr. 140 mm ukotvené obkladové panely z troskopemzobetónu TPB tr. 0 (TPB 105), s projektovanou objemovou hmotnosťou  $1650 \text{ kg/m}^3$  a hr. 210 mm v prvom podlaží a v

- The load-bearing system is of combined type, with the perpendicular load-bearing walls.
- The building jacket on the facade has been designed as single-layer wall from the slag-pemza concrete TPB Class 01 (TPB 80) of density  $1450 \text{ kg/m}^3$ , with the wall thickness 290 mm at the 1<sup>st</sup> storey and wall thickness 320 mm on higher storeys. The thermal resistance is  $R = 0,426 \text{ m}^2\cdot\text{K/W}$  ( $U = 1,68 \text{ W/(m}^2\cdot\text{K)}$ ).

At the gable the load-bearing iron-concrete wall 140 mm thick, holds the anchors of the lining panels from the slag-pemza concrete TPB Class 0 (TPB 105), of density  $1650 \text{ kg/m}^3$  and 210 mm thick on the 1<sup>st</sup> storey and 240 mm thick on the higher storeys. The thermal resistance  $R = 0,551 \text{ m}^2\cdot\text{K/W}$  ( $U = 1,39 \text{ W/(m}^2\cdot\text{K)}$ ).

tepelného odporu je  $R=0,551 \text{ m}^2\cdot\text{K}/\text{W}$  ( $U=1,39 \text{ W}/(\text{m}^2\cdot\text{K})$ ).

- Na nosných stenách sú uložené stropné panely hr. 120 mm. Okenné konštrukcie sú drevené, zdvojené v bytových priestoroch a v schodiskovom priestore sú typu jednoduchého zasklenia v oceľovom ráme. Strecha je jednoplášťová s výpočtovou hodnotou tepelného odporu  $R = 1,011 \text{ m}^2\cdot\text{K}/\text{W}$  ( $U = 0,85 \text{ W}/(\text{m}^2\cdot\text{K})$ ).

120 mm thick. The building had wooden window frames, with double glazing in the housing premises and steel window frames with single glazing in the staircase space. The roofing structure has single jacket with thermal resistance  $R = 1,011 \text{ m}^2\cdot\text{K}/\text{W}$  ( $U = 0,85 \text{ W}/(\text{m}^2\cdot\text{K})$ ).

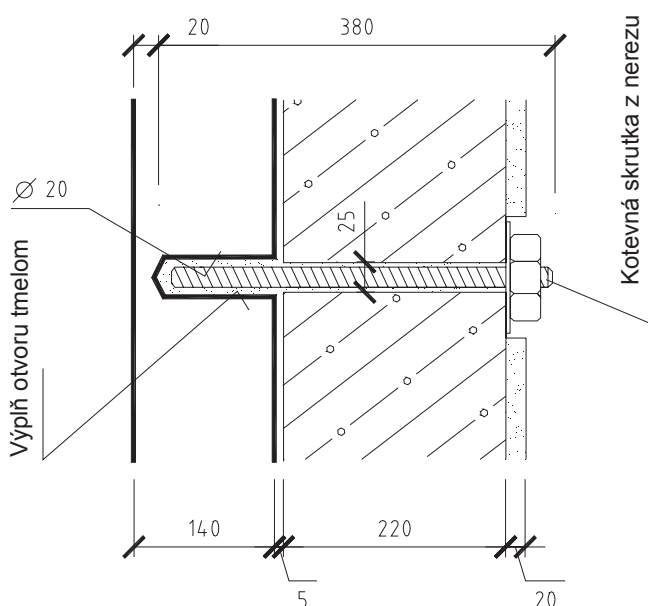
#### Schéma ukotvenia panelu

#### Porucha :

- dochádzalo k oddeľovaniu obkladového panela z troskopemzobetónu od nosnej štitovej železobetónovej steny.

#### Defect :

- there came to separation of lining of slag-pemza concrete panels from the load-bearing gable

**Systémová porucha** bola odstránená dodatočným ukotvením štitových obkladových panelov. Každý panel bol ukotvený 4 kotvami. Rozmiestnenie kotiev bolo navrhnuté s ohľadom na rozvody elektroinštalácie. Ukotvenie bolo navrhnuté pomocou lepených kotiev (závitová tyč  $\varnothing 16 \text{ mm}$  pozinkovaná alebo nerezová) do nosných stenových panelov vo vodorovnej polohe. Cez obkladový panel sa do hĺbky 100 mm v nosnom paneli

**The systematic failure** has been removed through supplemental mounting of additional front-side lining panels. Each panel has been mounted by means of 4 anchors. The layout of these anchors has been designed

vyvrtal otvor  $\varnothing$  22 mm. Prekontrolovala sa hĺbka vrtu a narezala sa príslušná dĺžka závitovej tyče ( dĺžky 355 - 370 mm ). Po dôkladnom vyčistení sa otvor vyplnil tmelom HILTI HIT - HY 150 a krúživým pohybom bola zasunutá závitová tyč. Vytlačený tmel sa odstránil. Po zatvrdnutí a osadení podložky R18 sa utiahla matica M16. Počas realizácie ukotvenia sa nevyskytli podstatné problémy. Zhotovené kotvy pri skúškach vykazovali značnú rezervu a sú vhodné pre aplikáciu pri odstraňovaní statických porúch, kde vzniká potreba zachytiť ťahové a šmykové sily.

with respect to the existing electrical installation networks. The anchoring system has been designed with steel anchors glued by means of adhesive ( threaded rod  $\varnothing$  16 mm galvanized or stainless steel) into the load-bearing wall panels in horizontal position. The borehole of  $\varnothing$  22 mm diameter and 100 mm depth has been drilled into the load-bearing panel. The depth of the borehole has been measured and the corresponding length of threaded rod has been cut (total length of 355 - 370 mm ). After this borehole has been thoroughly cleaned, it has been filled with the sealing substance (tmel) HILTI HIT - HY 150 and the anchoring threaded rod has been inserted by moving it in a circular direction. Then the extruded sealing substance has been removed. After the substance had been hardened, the gasket R18 and the nut M16 were put on the threaded rod and the nut has been tightened. No essential problems have occurred during the implementation of the anchoring system. The tests performed on the manufactured anchors have proved that there is sufficient reserve in the mechanical strength and that the anchors are suited for application by removal of failures in building statical physics, when it is necessary to hold the tensile and torsion forces.
