PILOTNÝ PROJEKT OBNOVY CELOPANELOVEJ BUDOVY ZT

Pre pilotný projekt obnovy štítových stien bytových domov ZT s keramzitbetónovými obkladovými dielcami bol na základe diagnostikácie vybraná budova v Bratislave Karlovej Vsi, na Kuklovskej ulici č.5, súpisné číslo IV. 4 94. Vlastníkom bytového domu je Bratislava – m.č. Karlova Ves, správcom K.R.S., s.r.o. Matejkova 20, 840 04 Bratislava. Dom má 52 bytov. Pilotný projekt bol realizovaný od septembra 2001 do decembra 2001, v rámci VTP 2811001800.

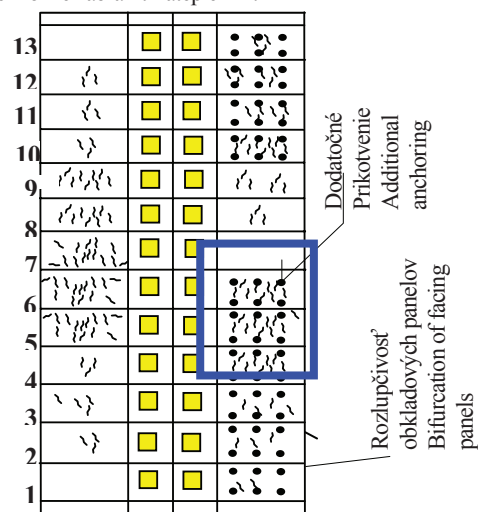
Poruchy sa vyskytujú vždy na klimaticky namáhanej štítovej stene. V prípade pilotného projektu sa jedná o severozápadnú orientáciu. Zistené poruchy na severozápadnom štíte:

- na 23 z 28 (82%) štítových paneloch sú viditeľné trhliny prevažne zvislého smeru,
- najdlhšie a najširšie trhliny sú v strede šírky panelov,
- niektoré dielce sú z prednej lícovej plochy vybušené miestami (vizuálny odhad) až o 0,1m,
- niektoré obkladové panely boli v r. 1994 dodatočne ukotvené,
- na ukotvených paneloch sa objavujú nové trhliny,
- na bočnej hrane obkladových panelov je viditeľné rozdujovanie.

Schéma pôvodného stavu severozápadného štítu
Scheme of the north-west gable wall in original shape

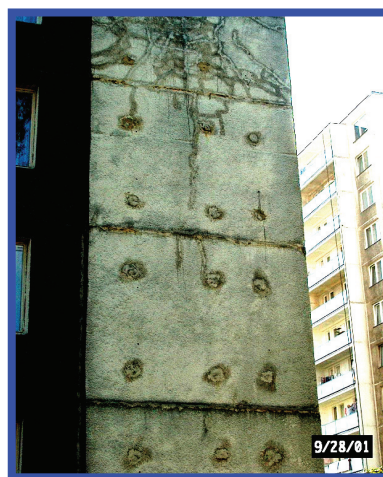
Pohľad na pôvodný stav časti severozápadného štítu
View on the north-west gable wall in original shape

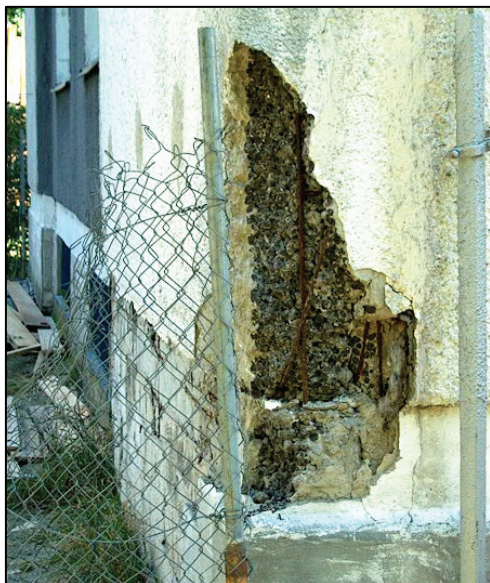
Pohľad na bočnú plochu obkladového panelu po samovoľnom odpadnutí oddelenej hmoty keramzitbetónu
View on side parts of facing panel after individual fall of "keramzit-concrete" mass

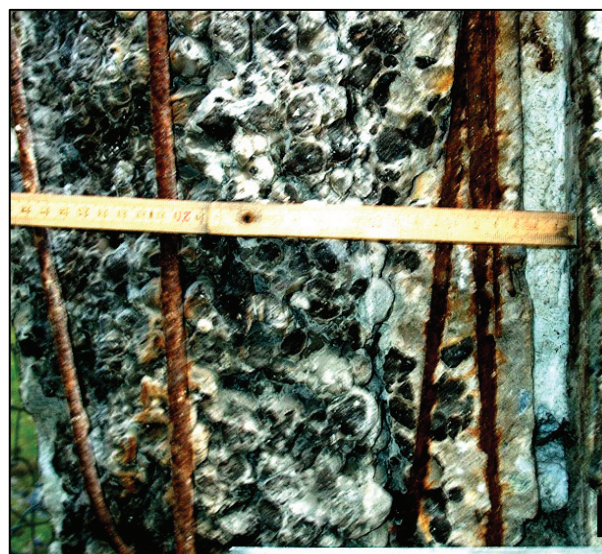
Korózia výstuže obkladového panelu po samovoľnom odpadnutí oddelenej hmoty keramzitbetónu
Reinforce corrosion of facing panel after individual fall of "keramzit-concrete" mass

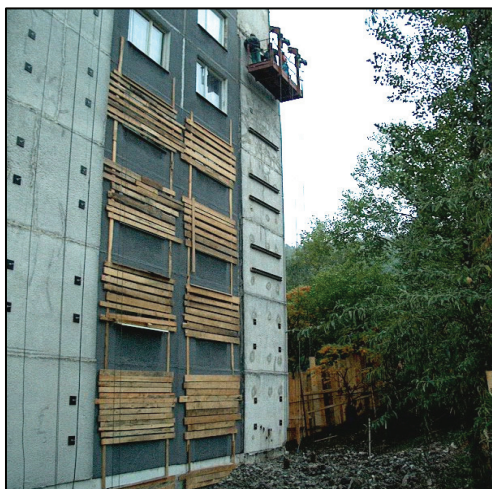
Klimaticky namáhaný náveterný štít počas odoberania obkladových panelov
Climatic stressed gable wall during the taking off the facing panels

S prihliadnutím na zistené mechanické vlastnosti keramzitbetónu obkladových dielcov a ich fyzický stav bol zvolený pre pilotný projekt postup postupného odstránenia obkladových panelov a ich nahradenie kontaktným zatepľovacím systémom. Týmto postupom sa overil aj skutočný stav geometrického usporiadania, stavu ukotvenia a vlastností keramzitbetónu. Súčasťou postupu bola realizácia bezpečnostných opatrení (ohradenie územia pevným plotom výšky 3 m, montážne prikotvenie obkladových panelov, zadebnenie okien nižších podlaží).

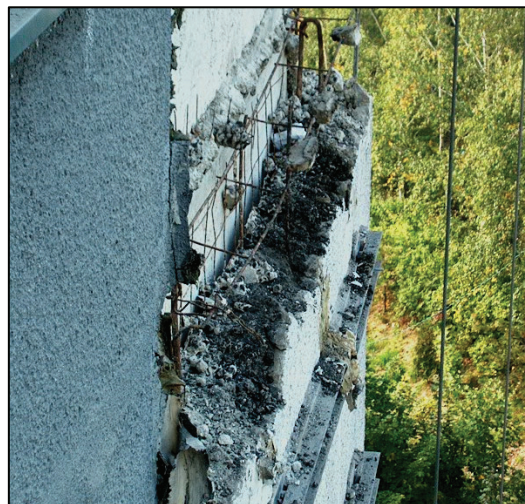
Obnažená výstuž a ukotvenie obkladových panelov
Naked reinforce and anchoring of the facing panels

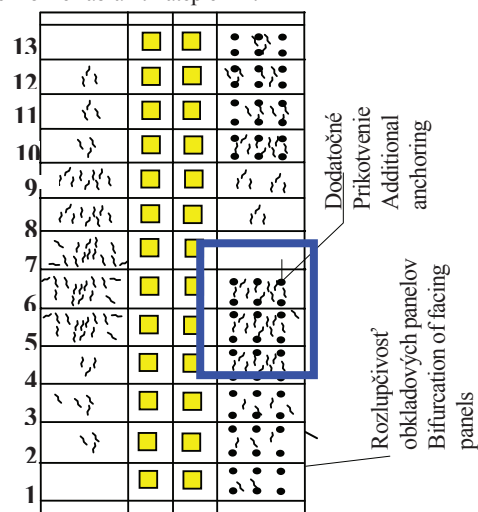
Poruchy sa vyskytujú vždy na klimaticky namáhanej štítovej stene. V prípade pilotného projektu sa jedná o severozápadnú orientáciu. Zistené poruchy na severozápadnom štíte:

- na 23 z 28 (82%) štítových paneloch sú viditeľné trhliny prevažne zvislého smeru,
- najdlhšie a najširšie trhliny sú v strede šírky panelov,
- niektoré dielce sú z prednej lícovej plochy vybušené miestami (vizuálny odhad) až o 0,1m,
- niektoré obkladové panely boli v r. 1994 dodatočne ukotvené,
- na ukotvených paneloch sa objavujú nové trhliny,
- na bočnej hrane obkladových panelov je viditeľné rozdujovanie.

Schéma pôvodného stavu severozápadného štítu
Scheme of the north-west gable wall in original shape

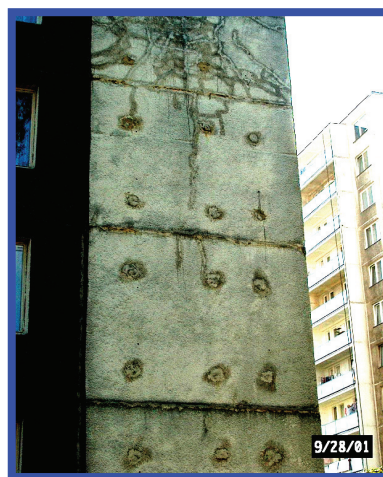
Pohľad na pôvodný stav časti severozápadného štítu
View on the north-west gable wall in original shape
