FINAL REPORT

on investigation of air accident
of aircraft type **MPX – 741 - Zenair**
registration **OM-AXM**

Date: 22. 05. 2011

Place: Bidovce

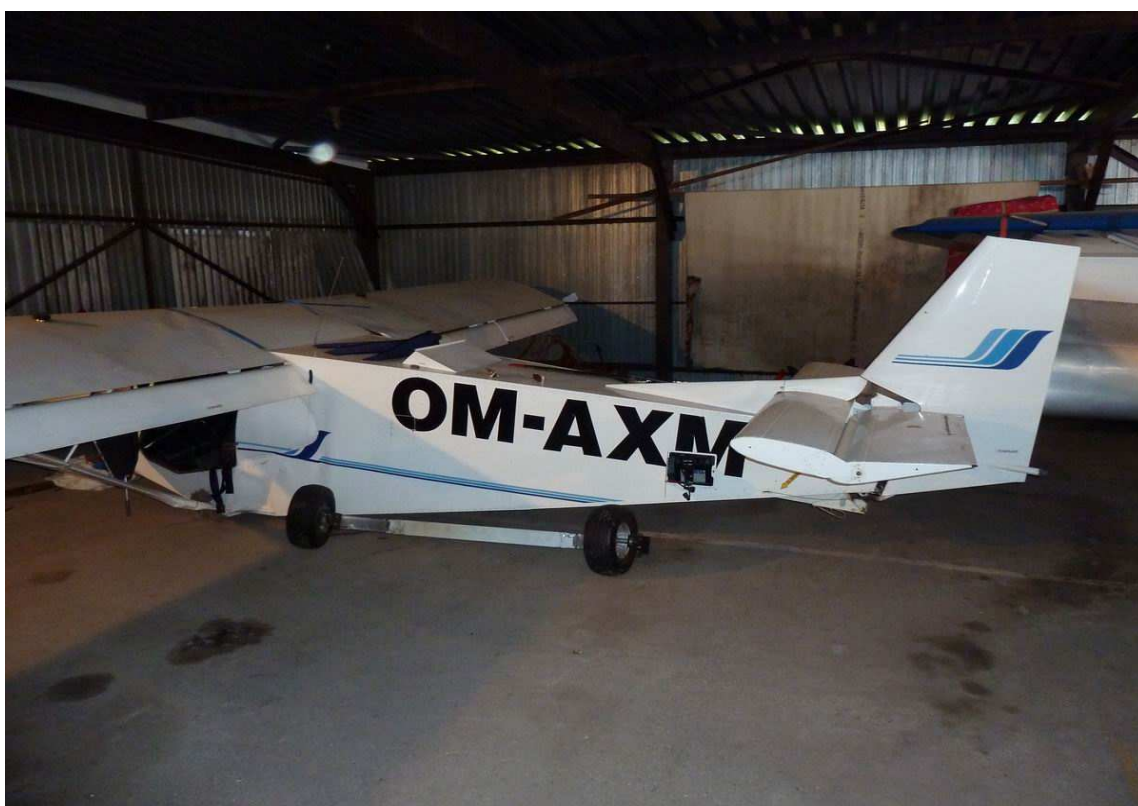
1.3 Damage to aircraft

The aircraft was substantially damaged in the air accident.

When making the landing manoeuvre, the pilot was influenced by uncomfortable impact of sunshine in the cockpit, due to which he incorrectly distributed his attention between the monitored board instruments and the surrounding external environment and did not pay adequate attention to one of the most important instruments – air speed indicator. This lack of attention resulted in the decrease of speed below the minimum speed required for flight in landing configuration, followed by a low-speed fall, due to which the aircraft hit hard to the unpaved runway section, the landing gear was massively damaged and the underbody was sliding on the grass surface until the aircraft stopped.

- the operator SNA will analyze the air accident with the flight personnel, putting stress on the elimination of potential influence of the sun and the method of distribution of attention during landing manoeuvre.
