**FINAL REPORT**

on investigation of air accident

of aircraft type **AL-Fox**

registration **OM-M300**

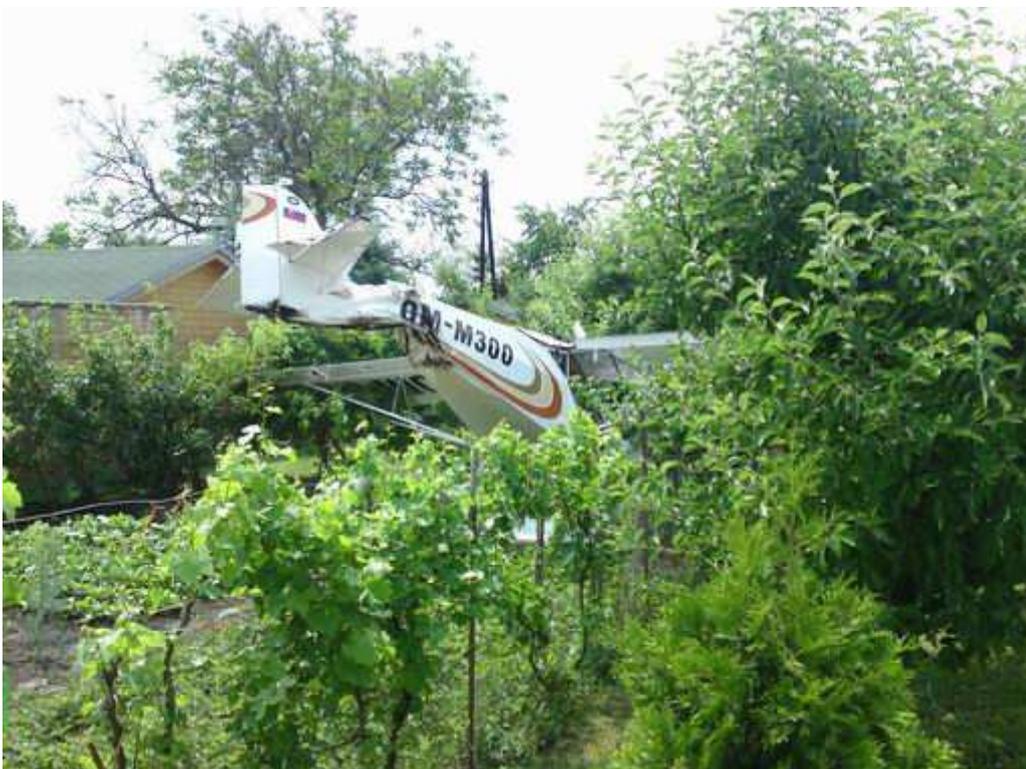
The flying sports vehicle was destroyed.

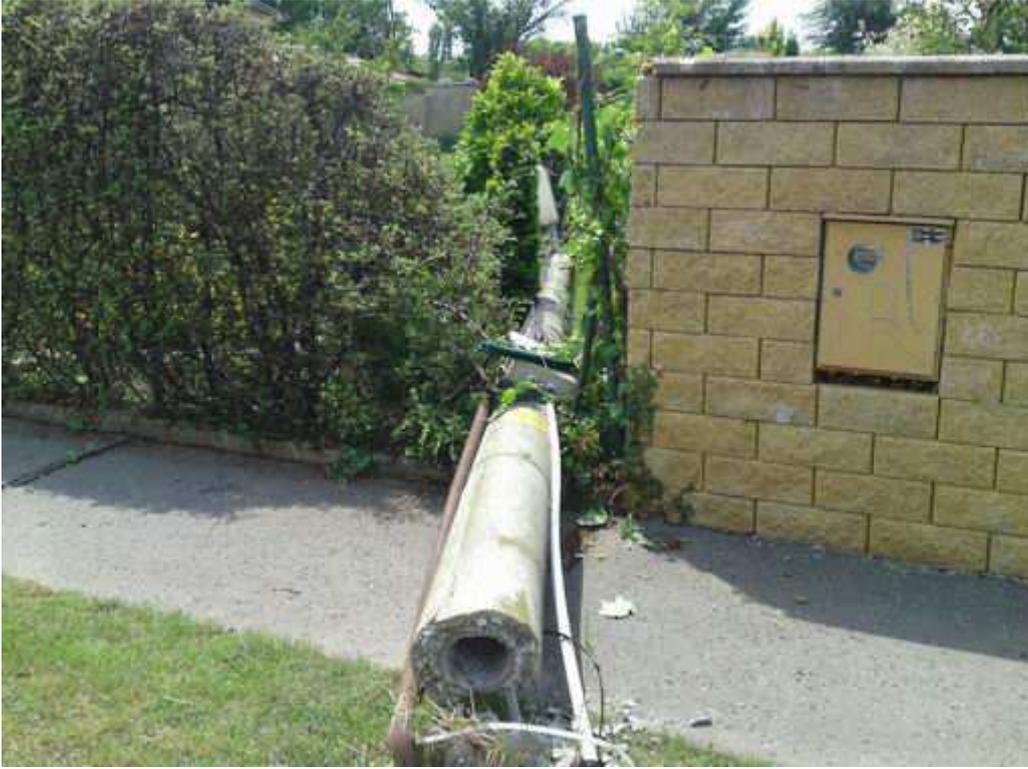
- demolished local electric power lines
- damaged TV antenna
- broken concrete pole of local power line

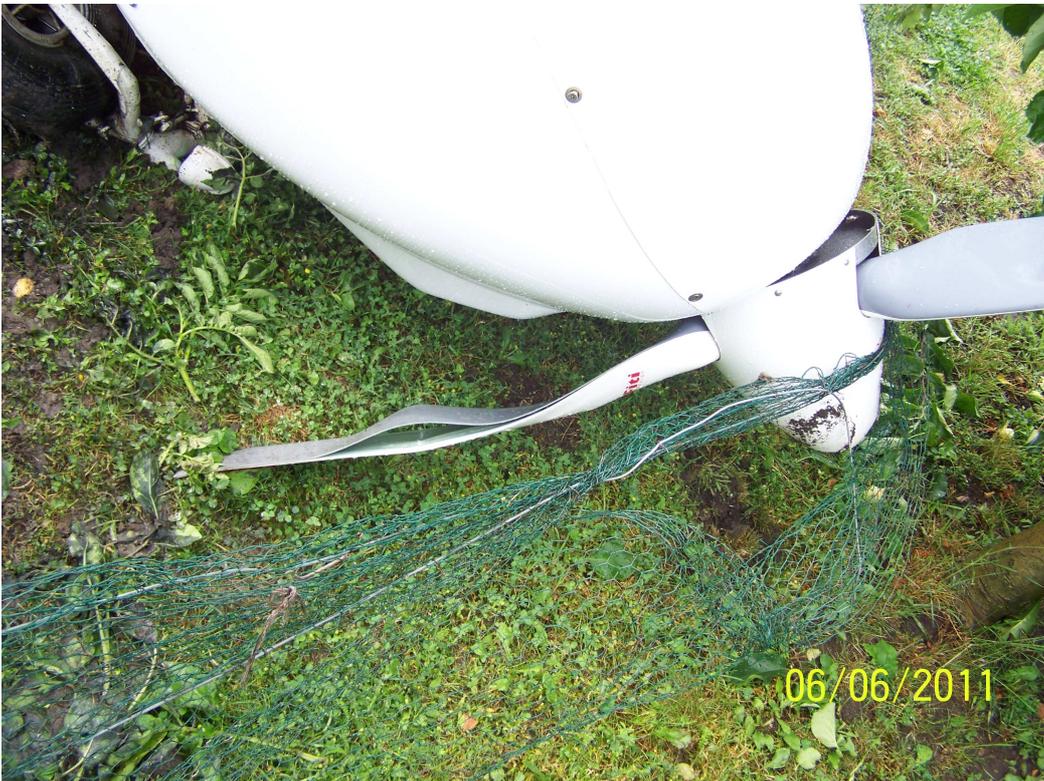
- damaged garden enclosure

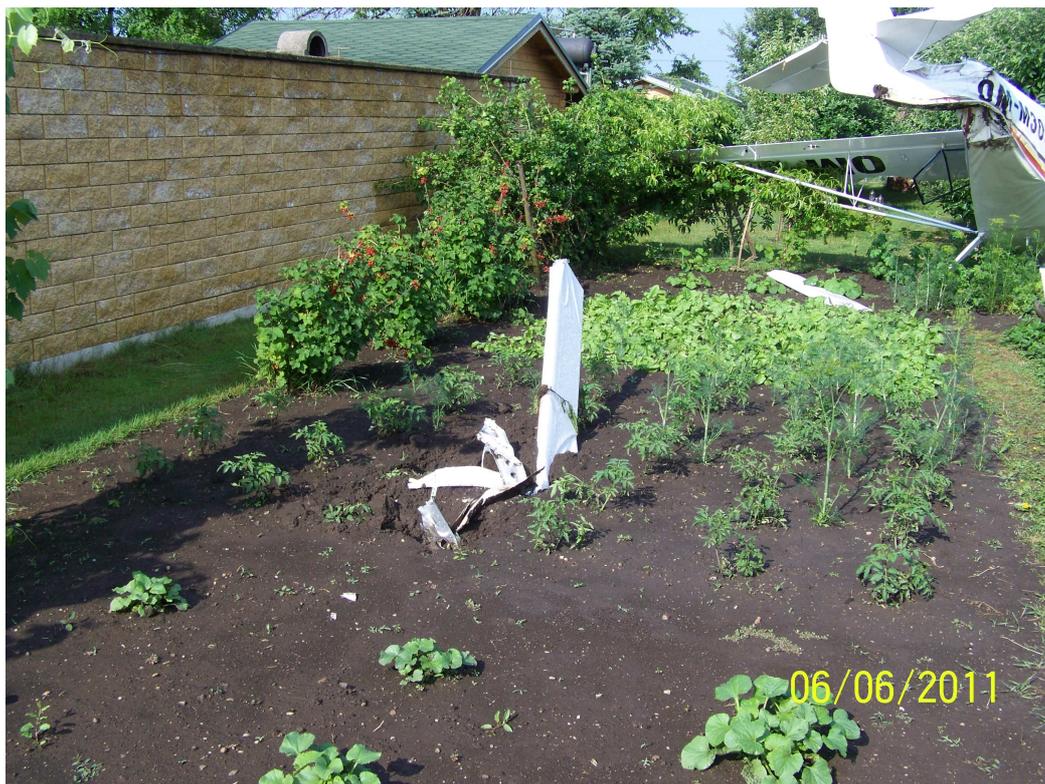
- damaged crops grown in the garden

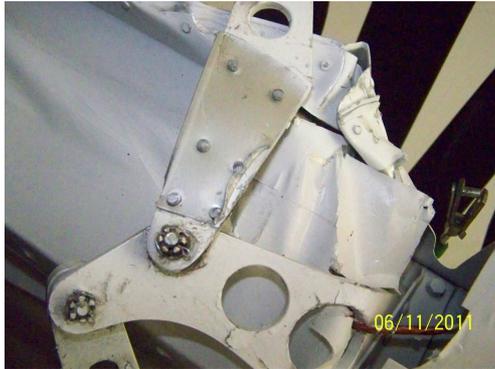
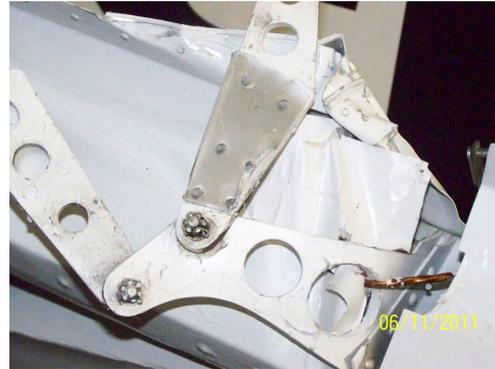
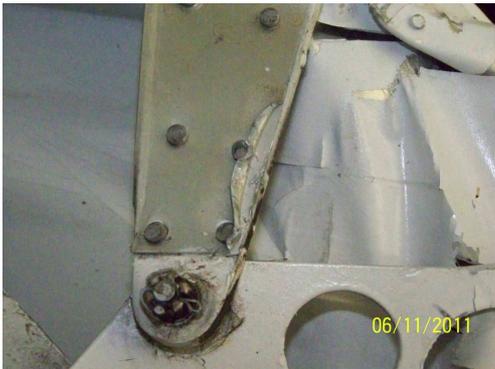
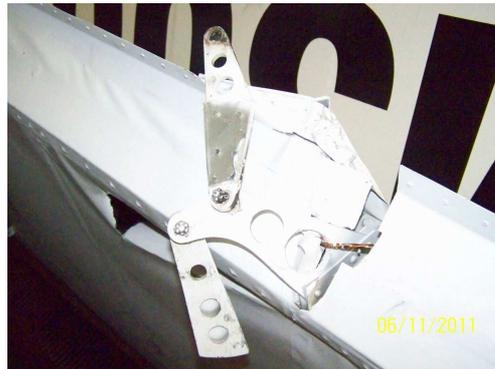
- the detailed technical analysis of wreckage revealed a long-term contact of the right aileron with the right-hand landing flap. This contact was overlooked during maintenance and technical inspections and no correction was made.

- the concurrence of these circumstances caused the contact of the aileron with the right wing flap after extension of wing flaps and their congruous position in downward deviation (port-wing-down) without possibility of correction by means of other controls.

This situation occurred due to the contact of the extending wing flap with the aileron and its blocking in the port-wing-down position. Vyšetřovaním bola táto skutočnosť stanovené ako bezprostredná príčina leteckej nehody.

a) to exclude mutual collision of steering tillers and controls by suitable technical implementation (design).

b) to ensure the systematic performance of prescribed periodical maintenance works and inspections of FSV, especially for FSV designed for training of aviation personnel.

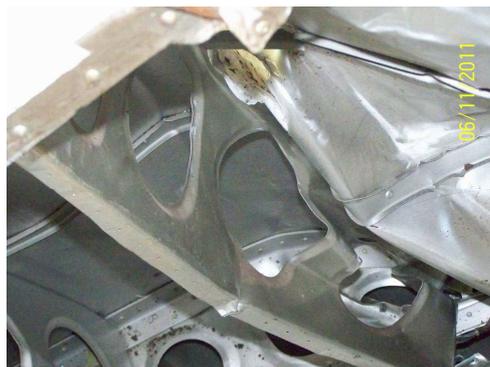
- the section rib carrying the common central console of ailerons and wing flaps is made of duralumin sheet with thickness of 0.5 mm (on both sides), without further reinforcement.
