FINAL REPORT

on investigation of air accident
of helicopter type **Robinson R44 II**
registration **OM - JOJ**

Date: 18.06.2011

Place: Airport Boleráz / LZTR

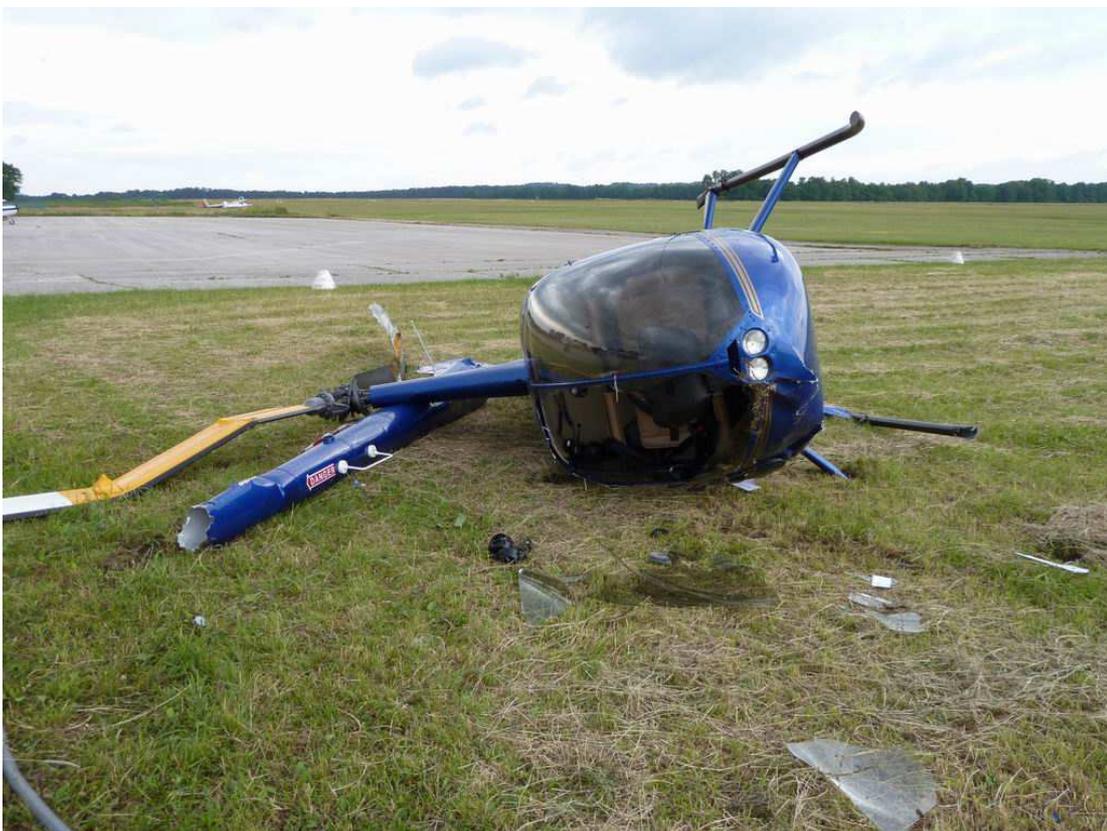
The helicopter was destroyed in the accident.

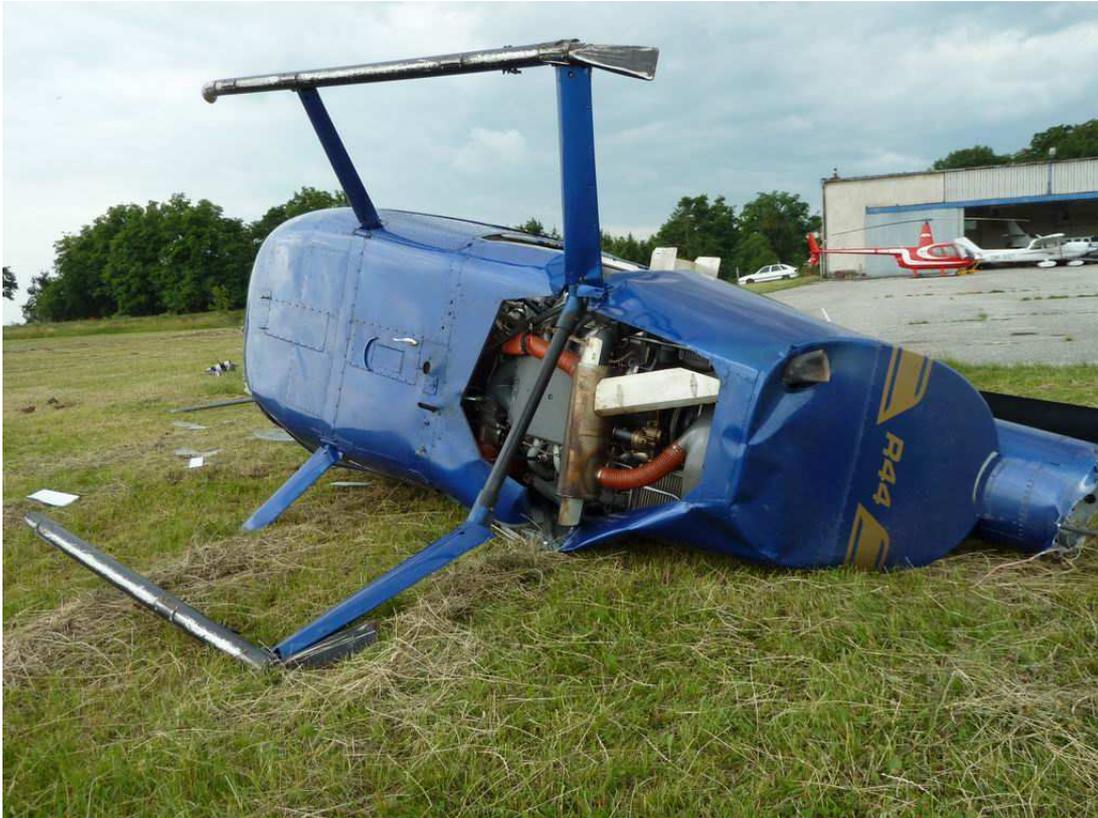
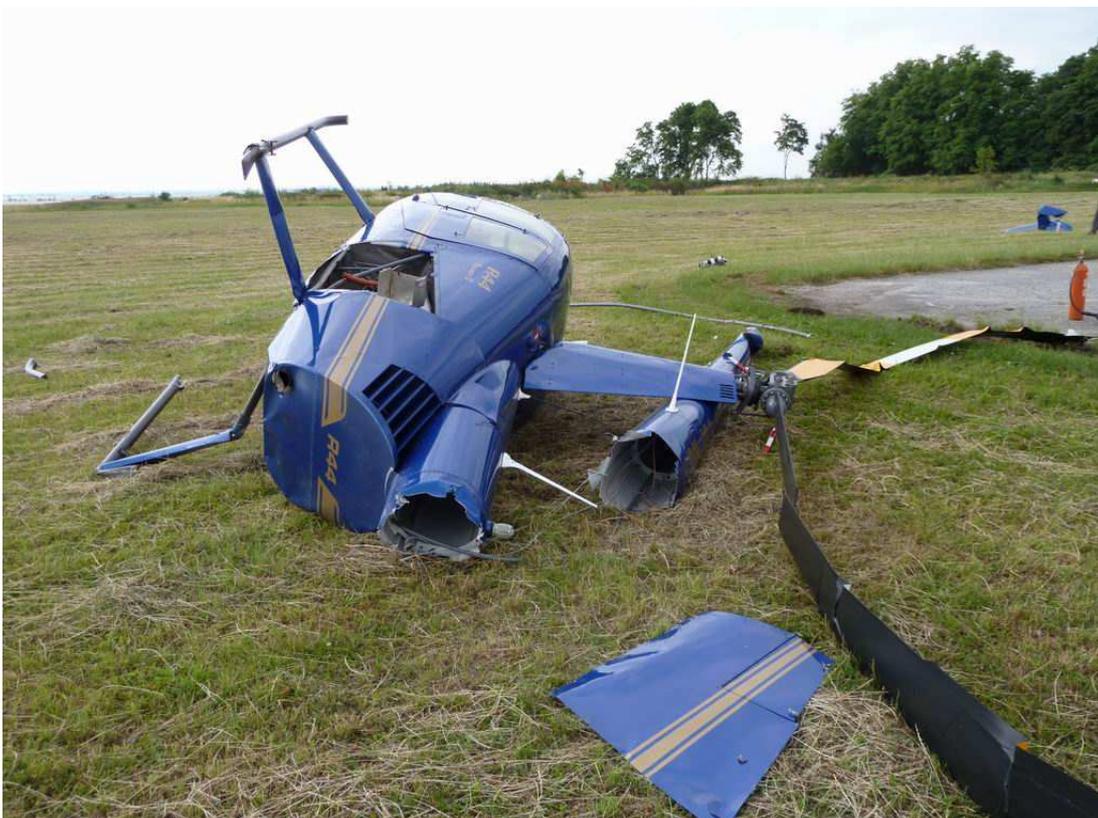
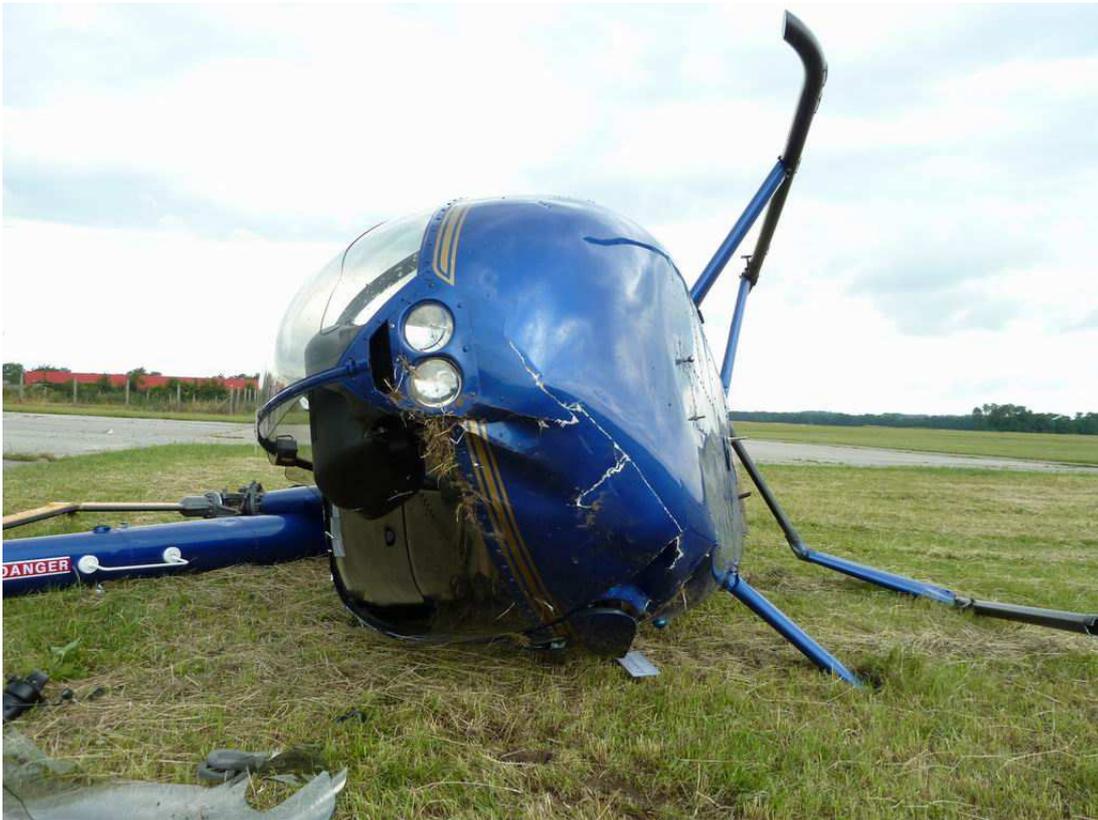
The helicopter fell on its right side in the vicinity of the reinforced asphalt area of the airport. The final position of the helicopter after the accident was documented, including photodocumentation.
