Reg. No.: SKA2011006

FINAL REPORT

of aircraft type **Z 137T**

registration No. **OM - NRK**

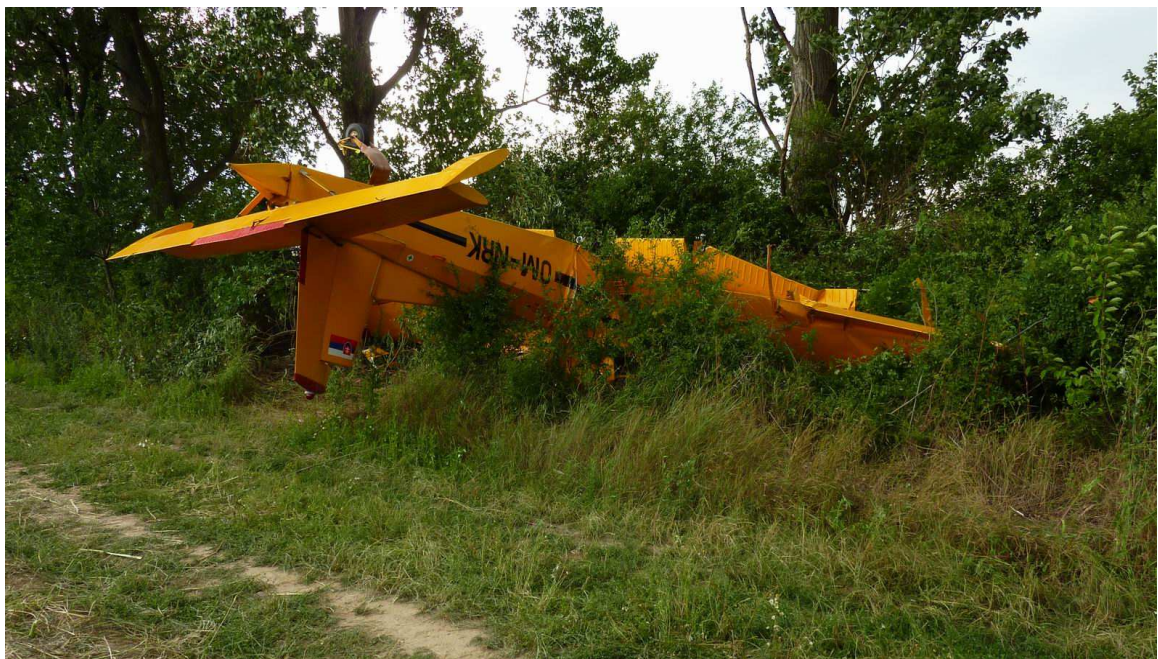
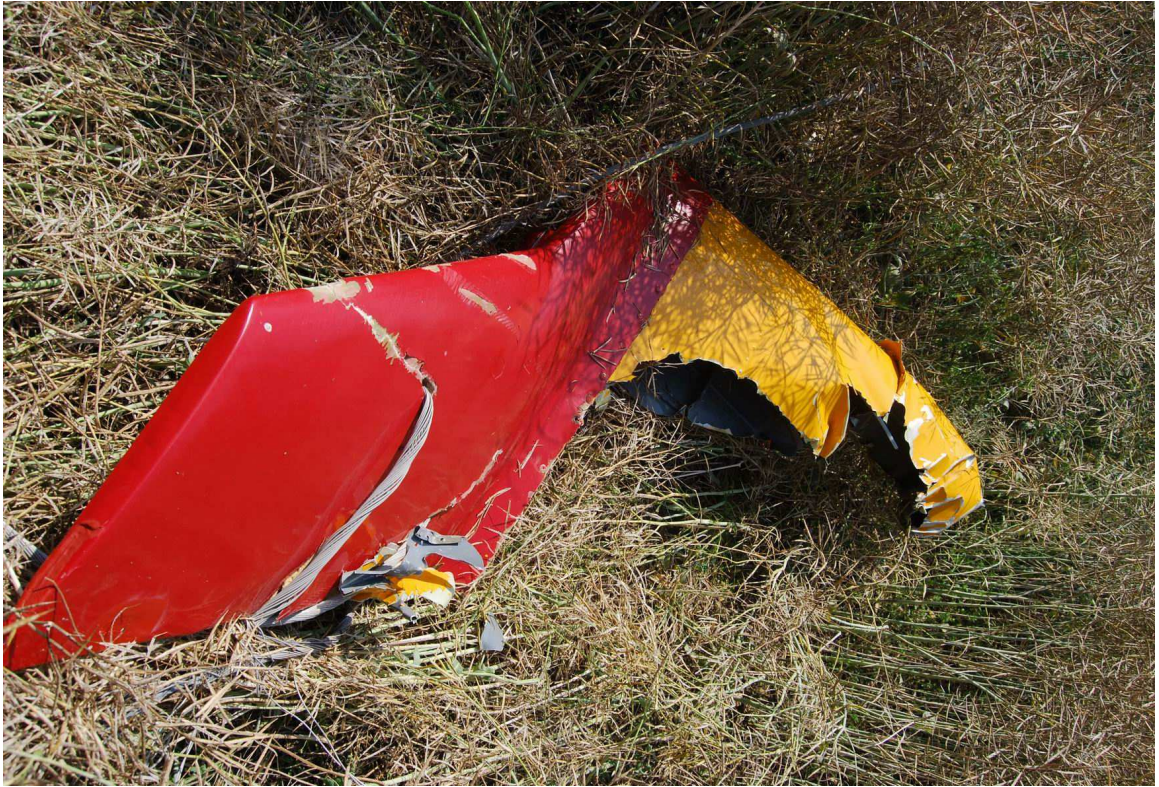
The aircraft was destroyed in the incident.

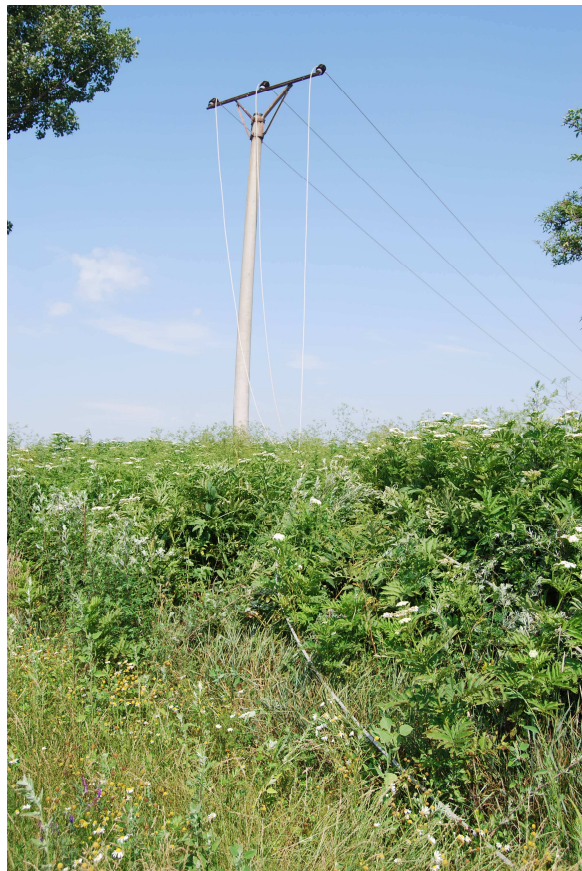
High tension cables were torn during the accident.

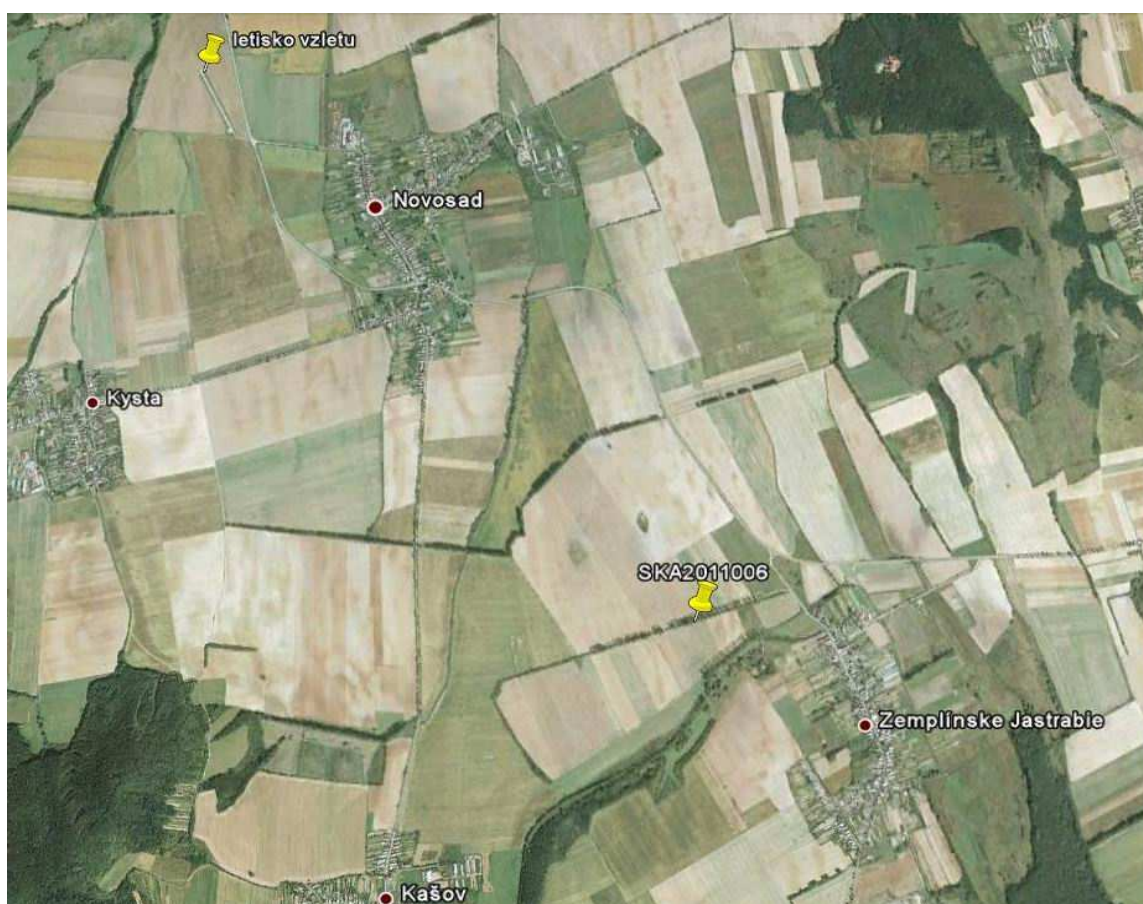
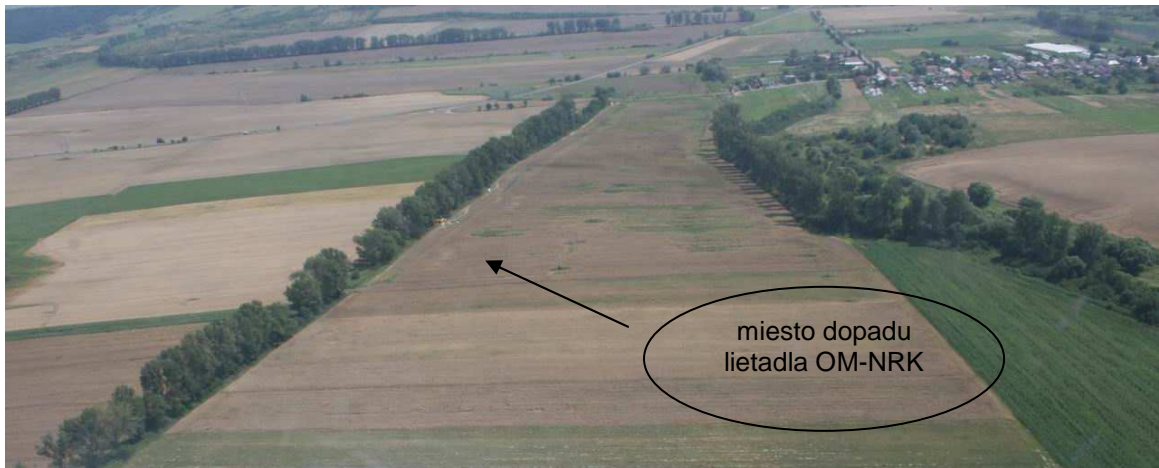
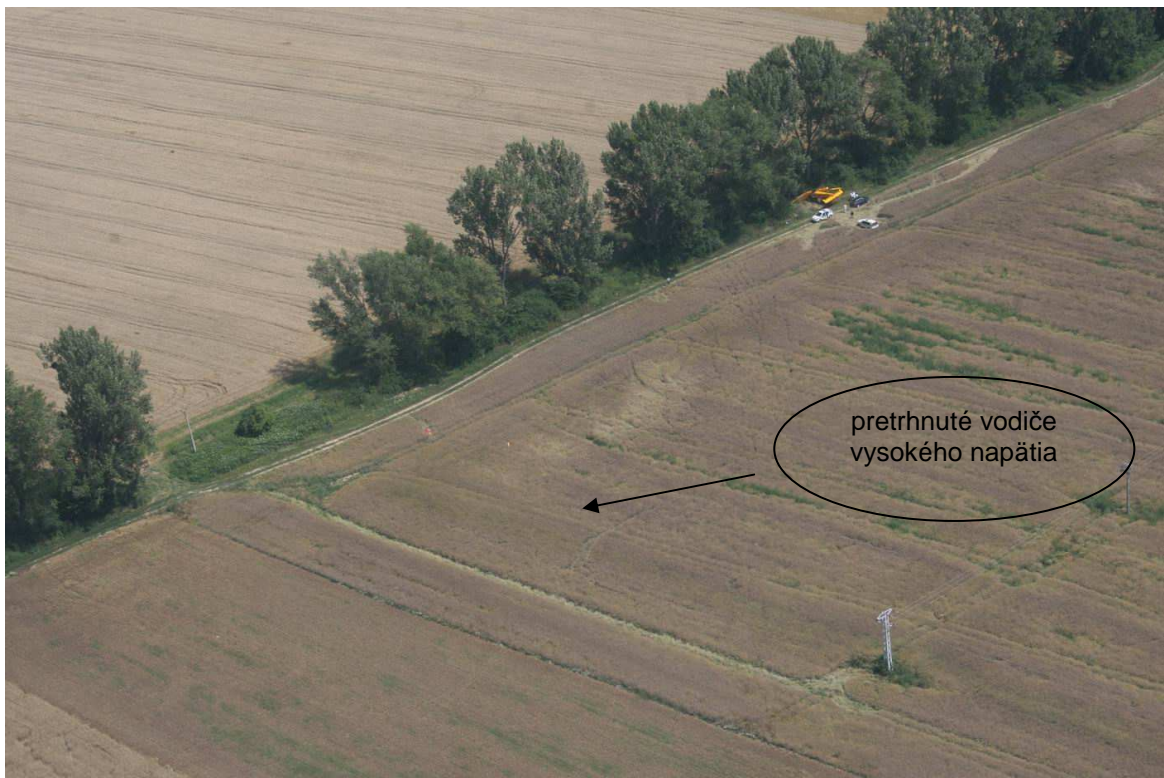
The aircraft remained in one piece after the accident, turned in the position on its back. The winglet of left wing with its terminal piece was found near the broken high tension cables.
