FINAL REPORT

on investigation of air accident
of glider type **L-13 SE VIVAT**
registration No. **OM – 9109**

Date: 10.07.2011

Place: Airport Prešov / LZPW

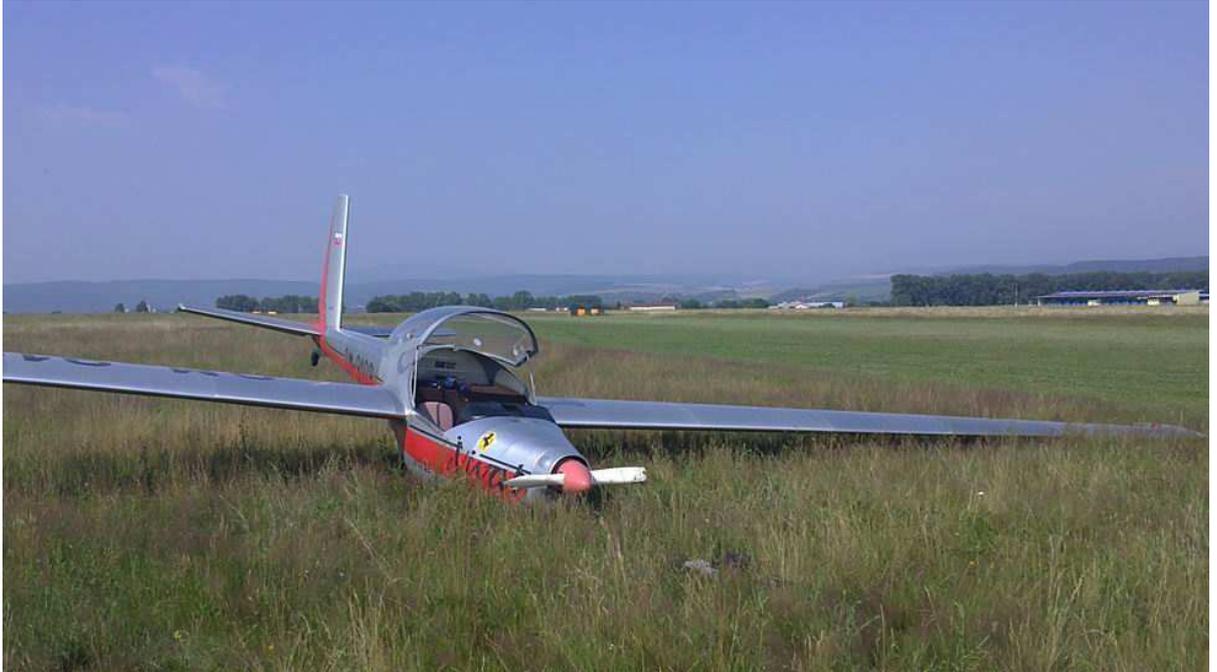
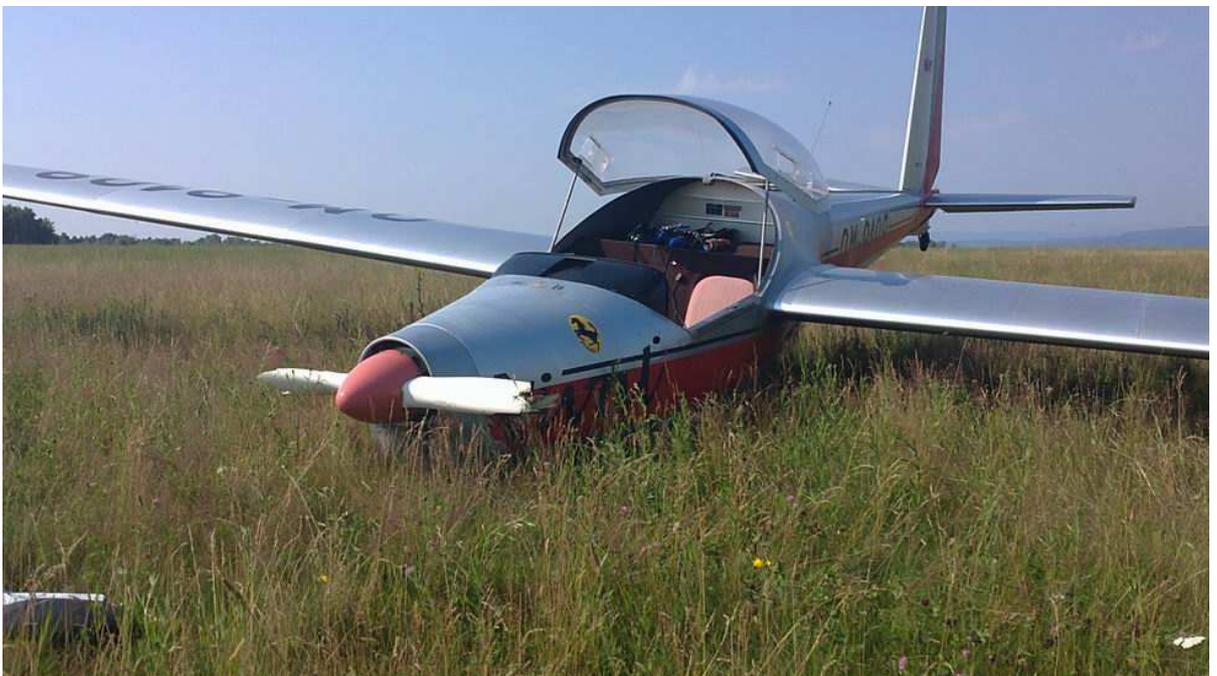
The lower engine hood was damaged and became deformed and the propeller was destroyed during landing.

Damages to the glider allow the repair to be done using standard procedures and by replacement of damaged parts.

- landing of powered glider on unlocked landing gear
- nonobservance of procedures and inconsistent implementation of prescribed operations by the pilot who extended the landing gear without checking its locking.

To implement an analysis of the air accident with flying personnel.
