FINAL REPORT

on investigation of air accident
of aircraft - unpowered paraglider **PLUTO M**

Registration No. **OM-P397**

Date: 16.07.2011

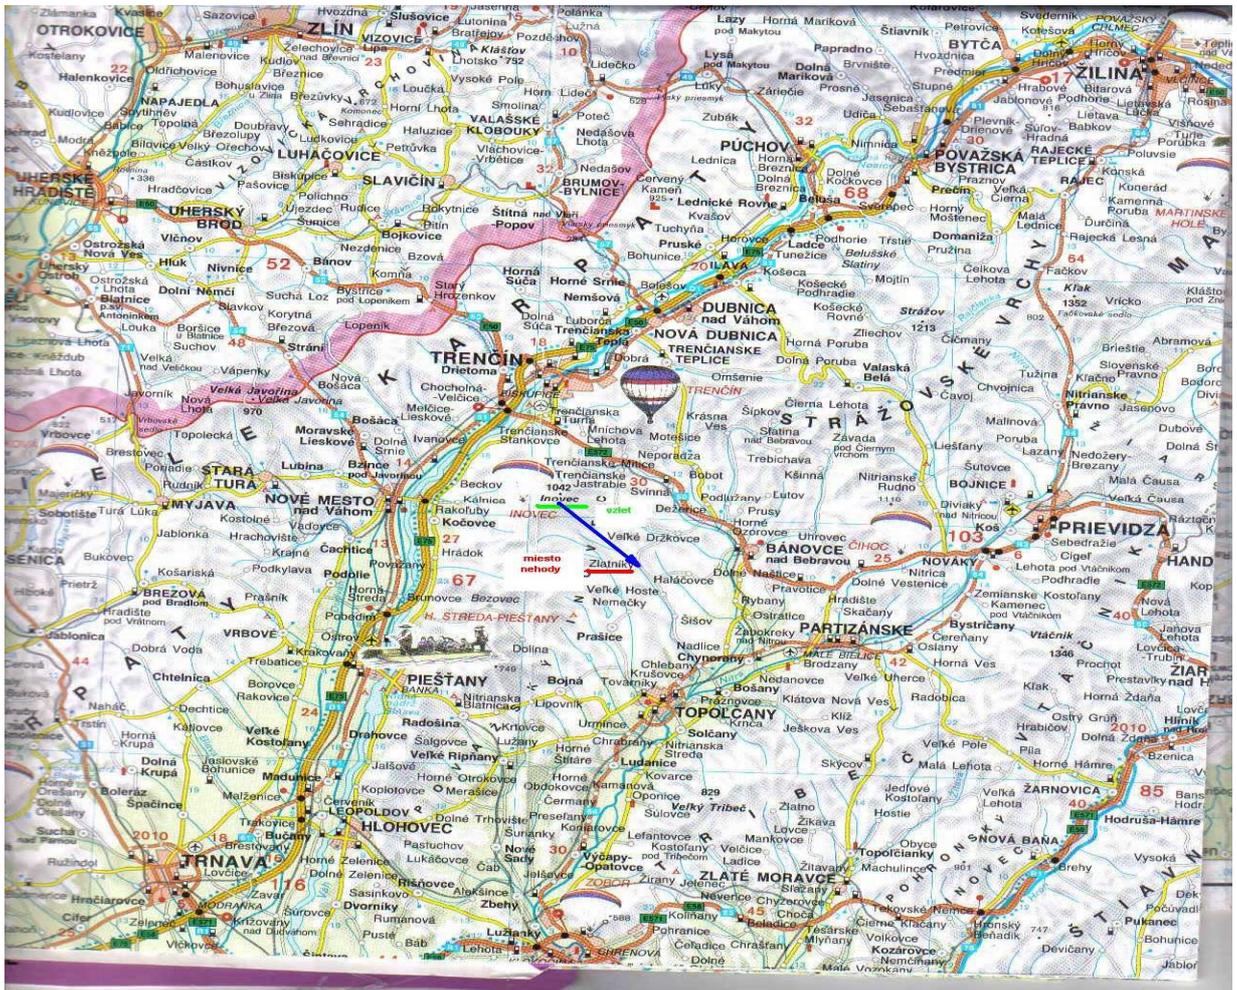
Description of cross country flight of FSV

The pilot of FSV made a recreational and sports flight with take-off from the flight surface INOVEC at 13:56. The whole flight occurred without negative manifestations, under pleasant meteorological conditions without significant air turbulences with use of updraft flows at a course of 135° from the take-off site to the community of Zlatníky. During the cross country flight, in front of the community of Zlatníky, the pilot noticed a weakening of the updraft flows and decided to land. As landing site he chose the football ground in the community of Zlatníky.

During landing approach in a low altitude the airfoil of FSV became deformed and the aircraft fell to the ground. The pilot landed in the area in front of the football ground railing, in the south-east corner from the outer side of the football ground.

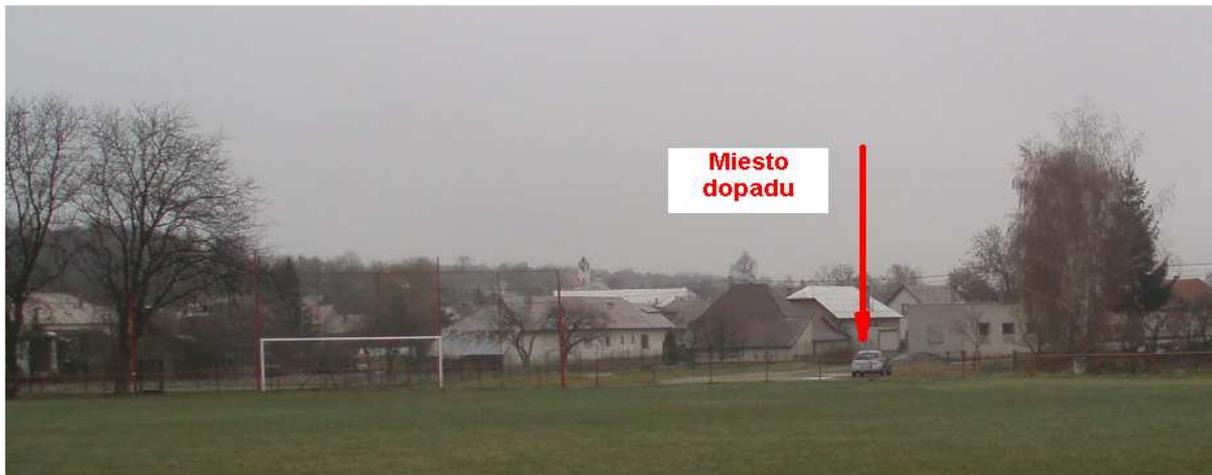
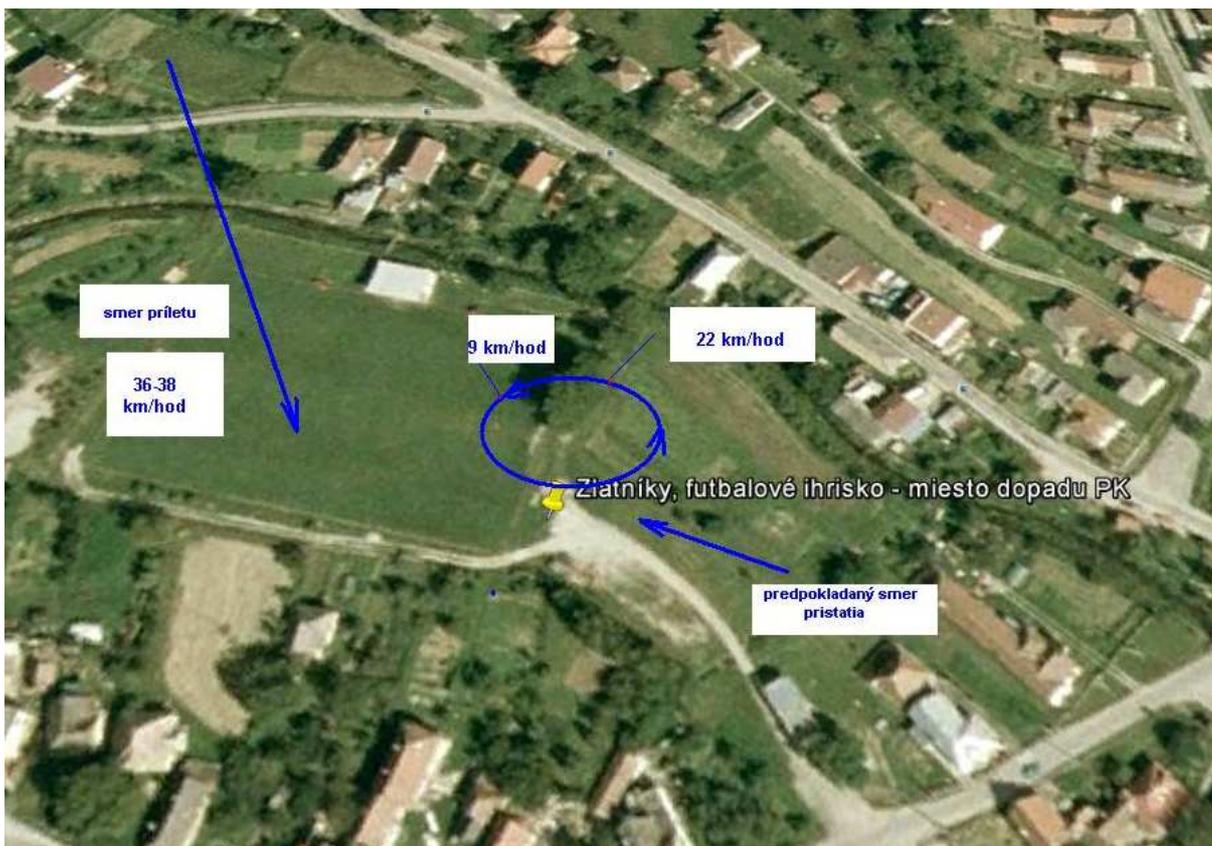
The place of air accident is situated in the south-east corner of the football ground from its outer side in front of its railing.

- unsuitable choice of surface for safety landing,
- deformation of the left side of the airfoil caused by incorrect steering of FSV in a left-hand turn, with subsequent loss of flight speed.

- we recommend the pilots of FSV not to make turns in the phase of landing approach in an altitude below 20 m above the ground level, unless they are forced to do so in order to avoid obstacles or to make slight direction corrections. The landing approach should be made, as far as possible, on the most direct flight route under steady flight regime, with more consistent pre-flight preparation.

- we recommend the pilots of FSV that their choice of landing site outside approved areas (safety landing) should be motivated primarily by their safety and safety of third persons.
