# MINISTRY OF TRANSPORT, CONSTRUCTION AND REGIONAL DEVELOPMENT OF THE SLOVAK REPUBLIC

## FINAL REPORT

on investigation of air accident  
of aircraft type **ASW 20**  
registration **OM - 1111**

Date: 23.07.2011

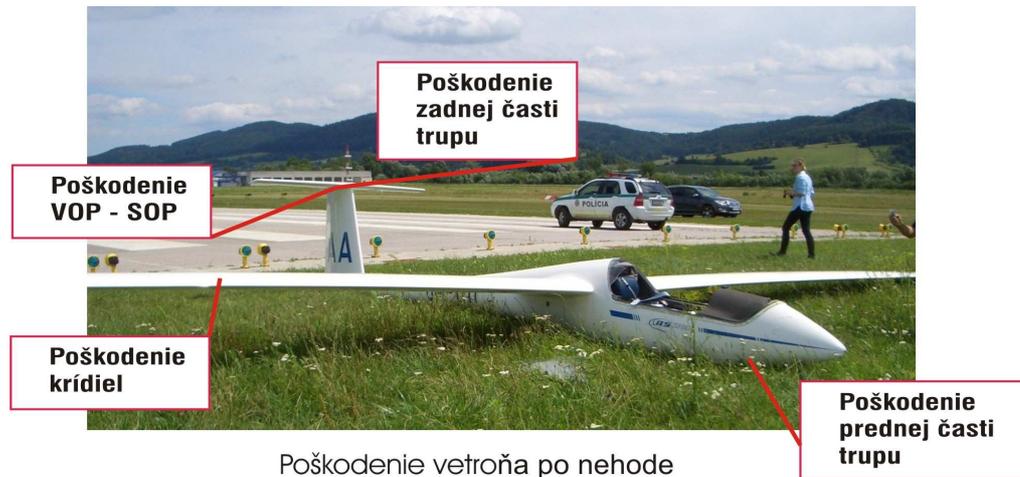
### 1.3 Damage to aircraft

The glider ASW 20 remained in one piece after the air accident. The glider was taken apart on the place of impact and the scope of damage was documented.

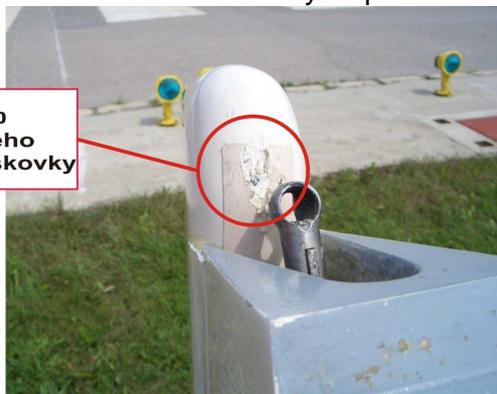
Miesto poškodenia  
smerovky od voľného  
konca tiaha výškovky

From the state of damage to the vertical rudder it results that the damage was caused by movement of the loose end of the elevator rod.

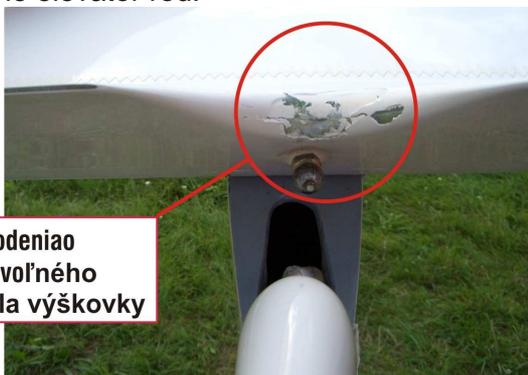
Miesto poškodenia  
výškovky od voľného  
konca tiaha výškovky

The state of damage to the elevator also leads to the conclusion that the damage was caused by the loose end of the elevator rod.

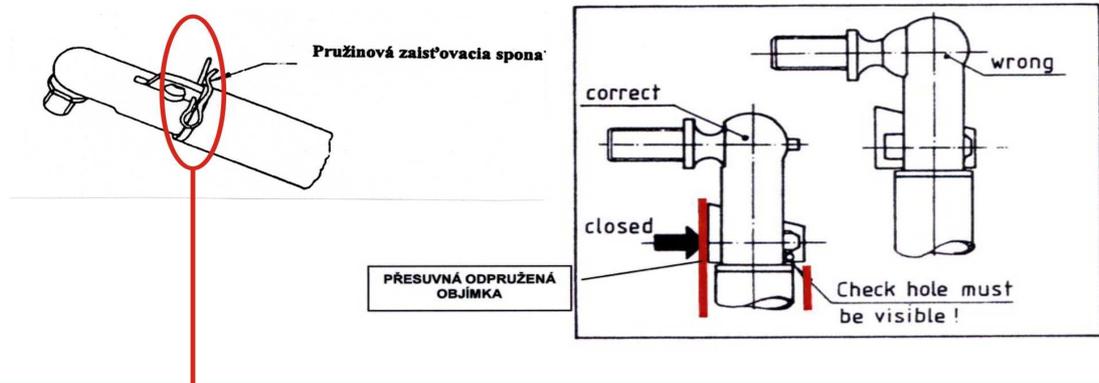
State of capability of elevator rod terminal (L`Hotellier):

- Modification of rod
- According to glider maintenance records the binding decision of LBA 1993-001/3 from 9 April 1998 was implemented and verified on 6 October 2008.
- The said type of terminal and its modification accepted by the binding decision correspond to the implementation of the binding decision.

V súlade s platnou Letovou príručkou - Príručkou pre údržbu daného vetroňa je v príručke stanovené **povinnosť** použitia Pružinovej zaisťovacej spony osadenej do kontrolného otvoru, ktorá v tomto prípade v súlade s príručkou nebola použitá.

The status check detected non-compliance with approved documentation of glider. The flight manual – glider operating manual provides (page 17):

“The experience-based **obligation** to use for securing of the terminal a “spring clamp embedded in the manhole in a “locked terminal“ position.

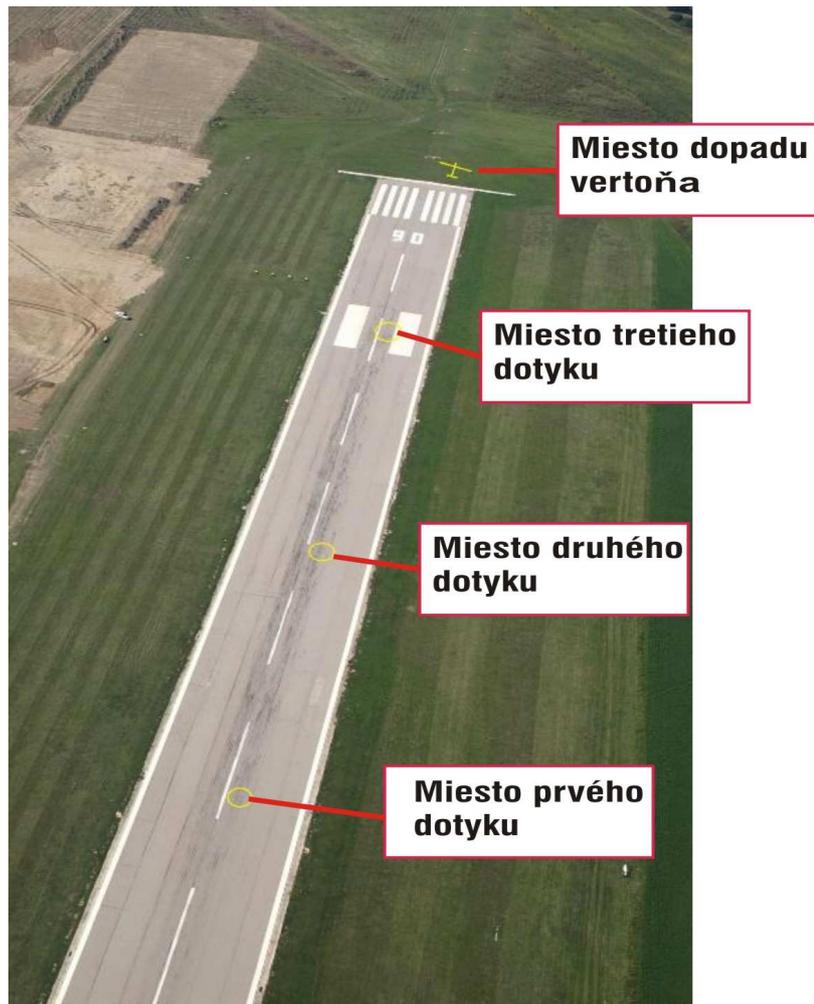
**Celková situácia VPD 24 LZZI**

The impact of the glider to RWY 24 left traces of multiple contacts with RWY on RWY. On the basis of analysis of the accident video recording, witness statements, character of flight and impacts on RWY we can state that the flight characterized by significant amplitudes, change of flight altitude, changes of incidence angle related to increasing flight speed during towing of the glider and the decrease of speed after detachment of towing rope to the stalling speed, was the result of uncontrolled flight with unattached elevator.
