Reg. No.: SKA2011011

FINAL REPORT

on investigation of air accident
of aircraft type **CESSNA 150 L**
registration No. **SP-KDN**

Date: 20.08.2011

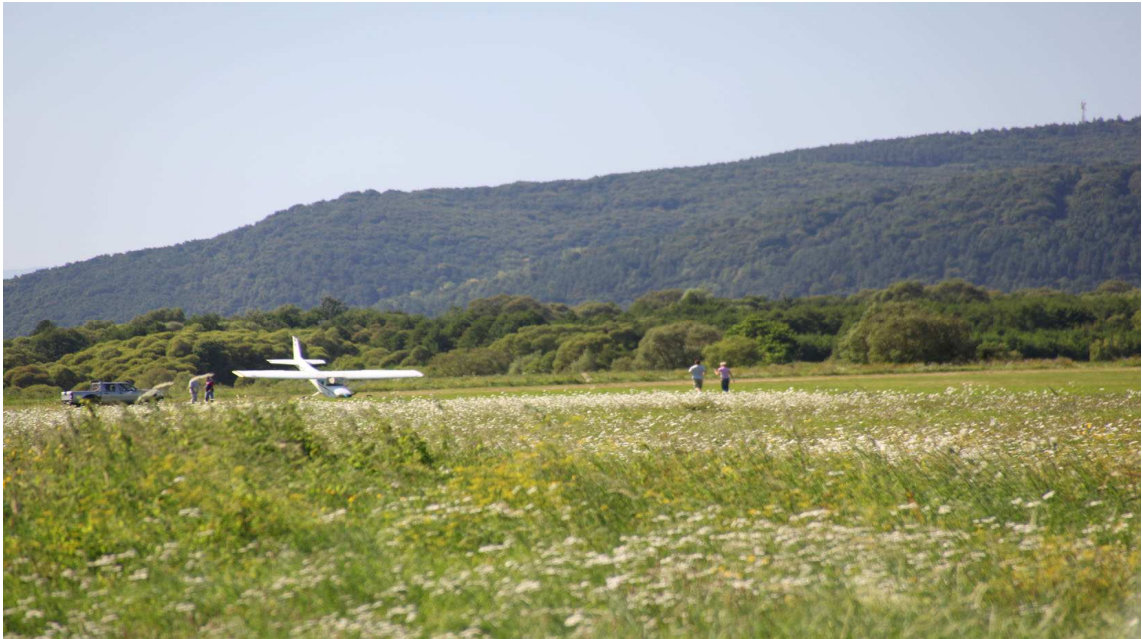
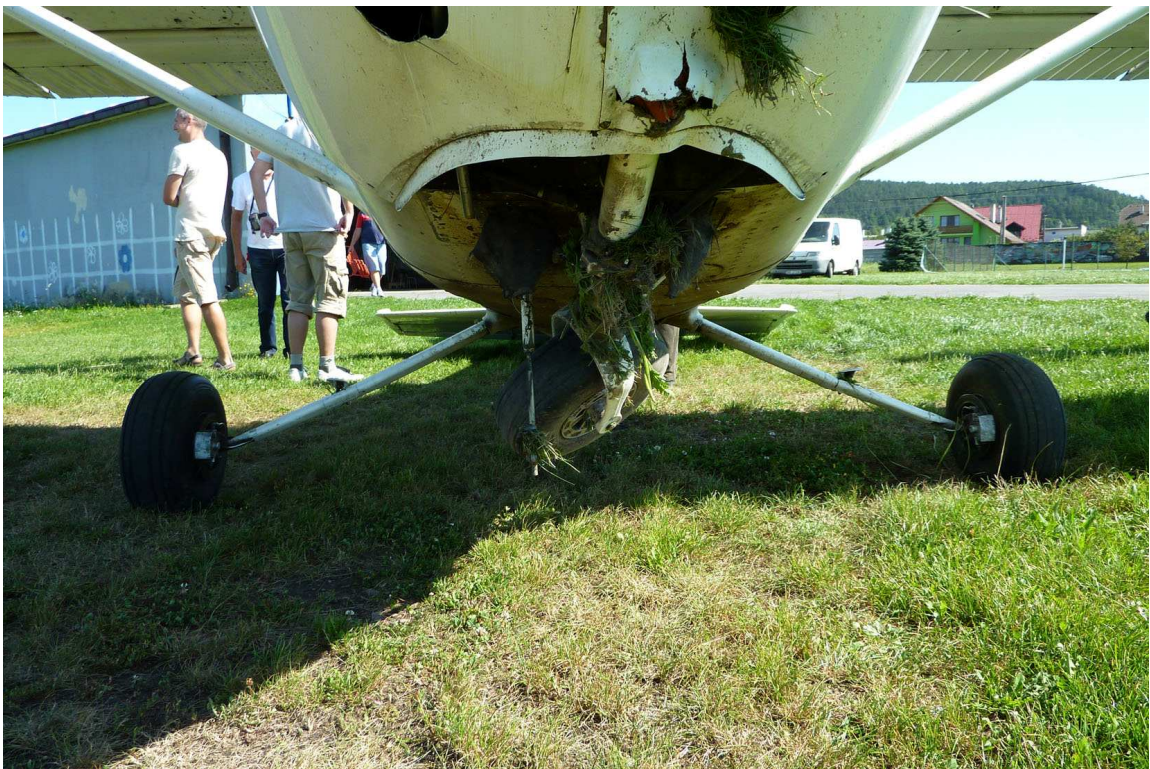
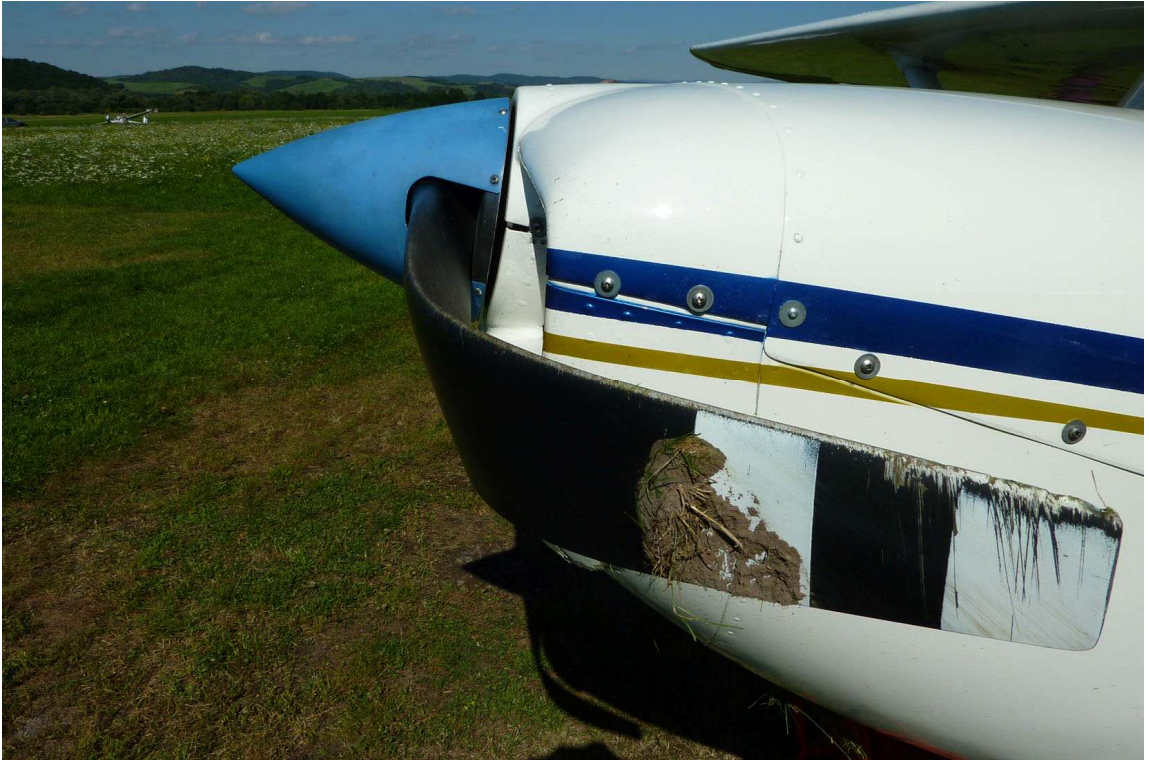
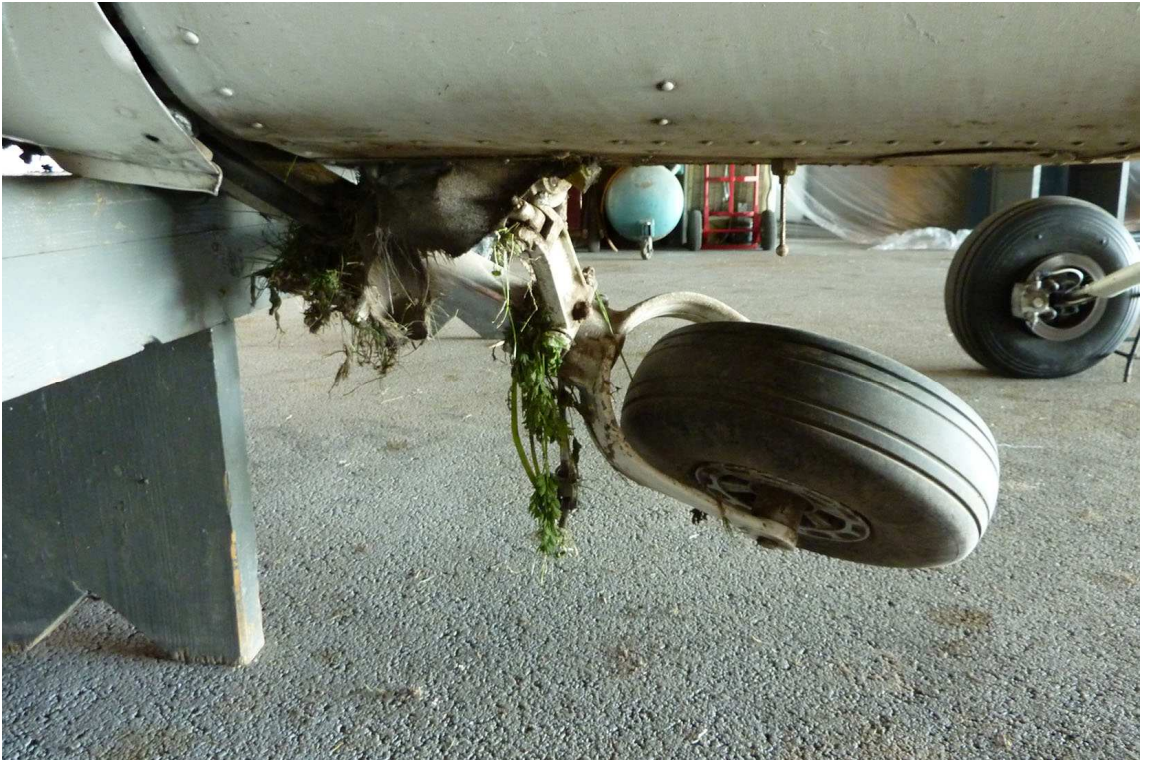
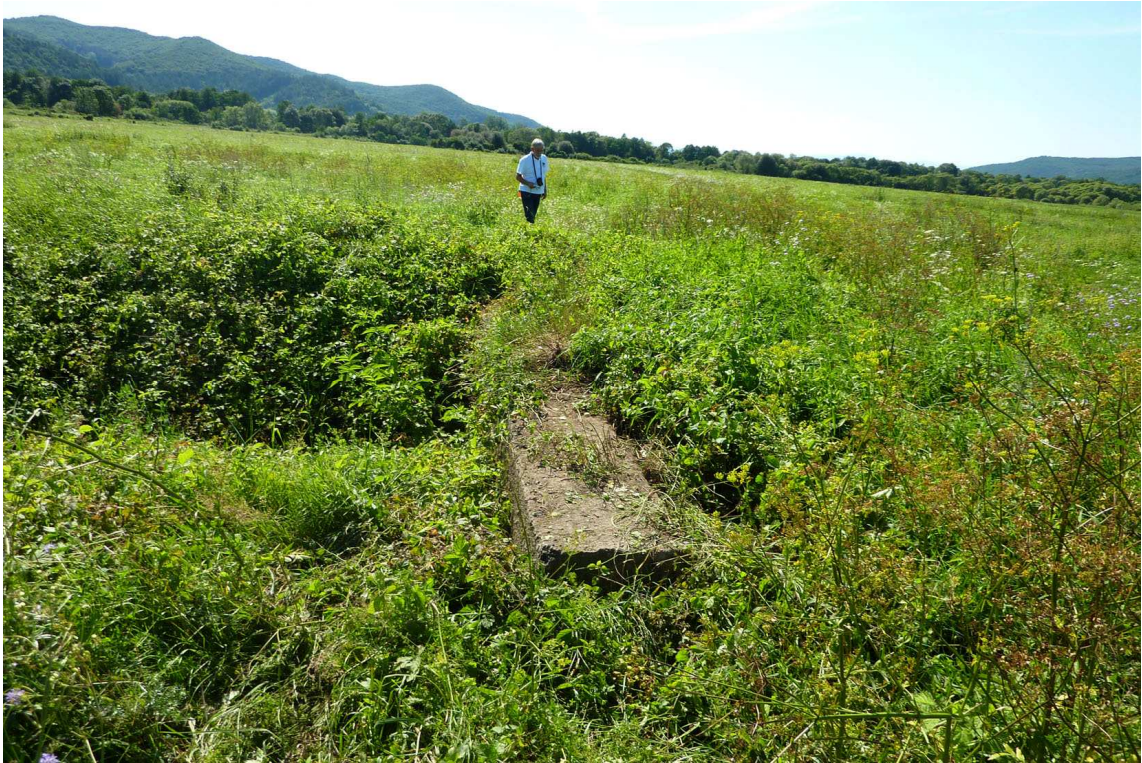
front landing-gear leg, both legs of main landing gear, attachment of main landing gear in aircraft body, lower body section in suspension of the attachment of main landing gear on the right and left sides, deformation of skin in the lower body section near the attachments of main landing gear, left wingtip arc, propeller, forced engine cut-off, engine hood in upper and lower sections, engine air.

The aircraft stopped on RWY leaned on the engine in the landing direction, in one piece.
