# MINISTRY OF TRANSPORT, CONSTRUCTION AND REGIONAL DEVELOPMENT OF THE SLOVAK REPUBLIC

## FINAL REPORT

on investigation of air accident  
of powered hang-glider MW155/TOMI CROSS5  
registration No. **OM – H041**

Date: 20.08.2011

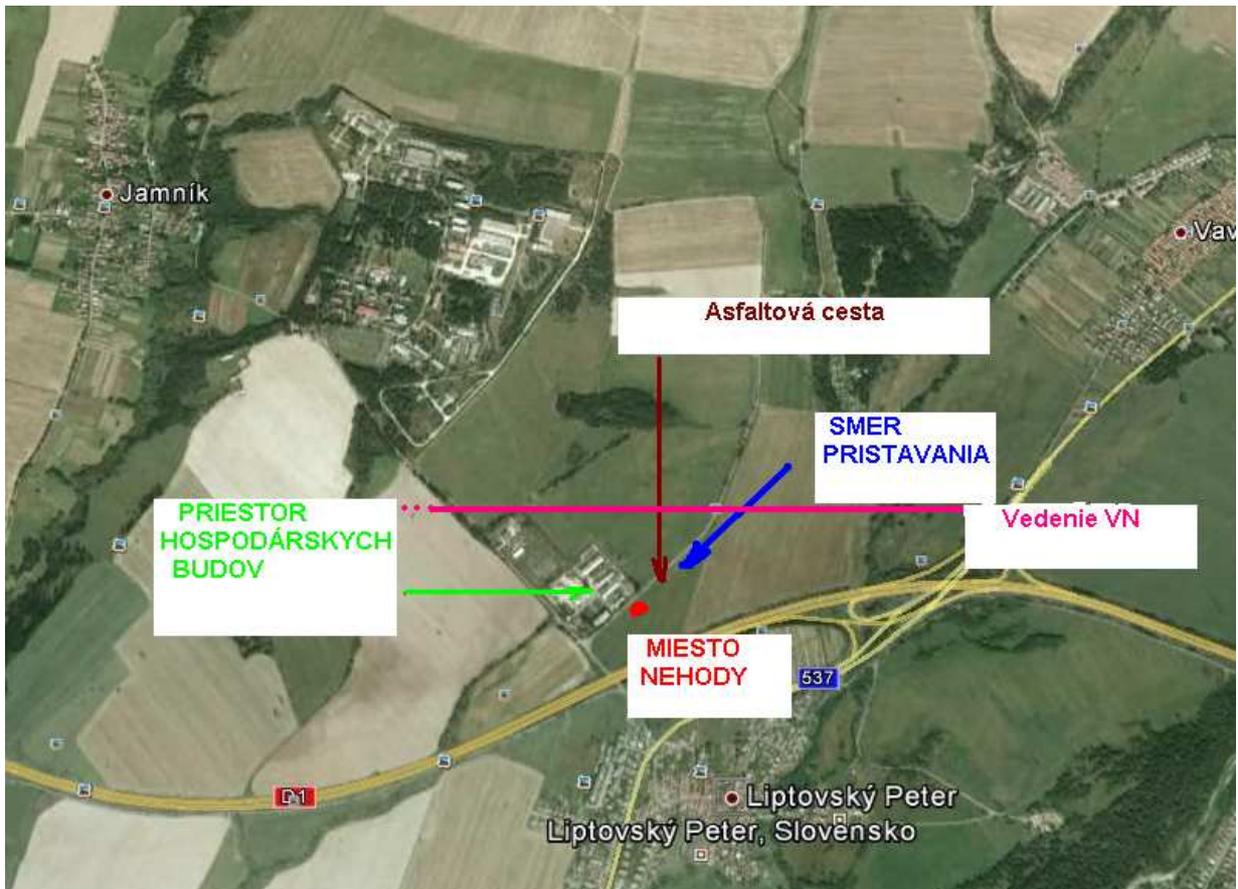
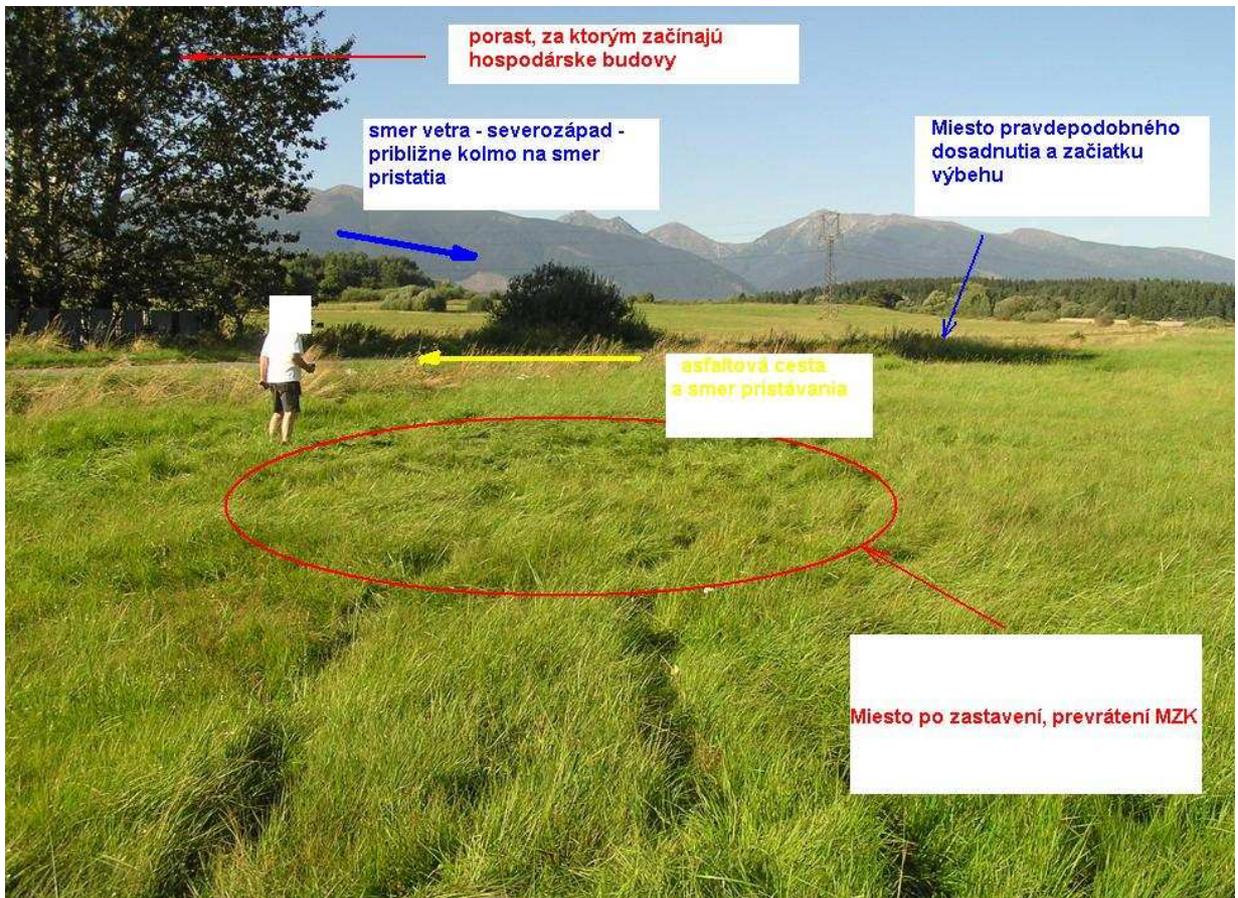
Damage to the wing canvas, wing reinforcement, wing ropes, wing spar, propeller, aerodynamic covers of landing gear, front wheel and landing gear frame.

The place of accident is situated left of the asphalt road (at the sight in direction of 225°).

Before arrival of the race organizer to the place of accident PHG was dismantled by its crew and prepared for transport from the place of accident.

The aircraft operators of LAA SR should fulfil their obligation not to handle the aircraft or its wreckage after air accidents in order to allow the aircraft inspection, preservation of material evidence and documents, unless it is necessary for prevention of other damage;

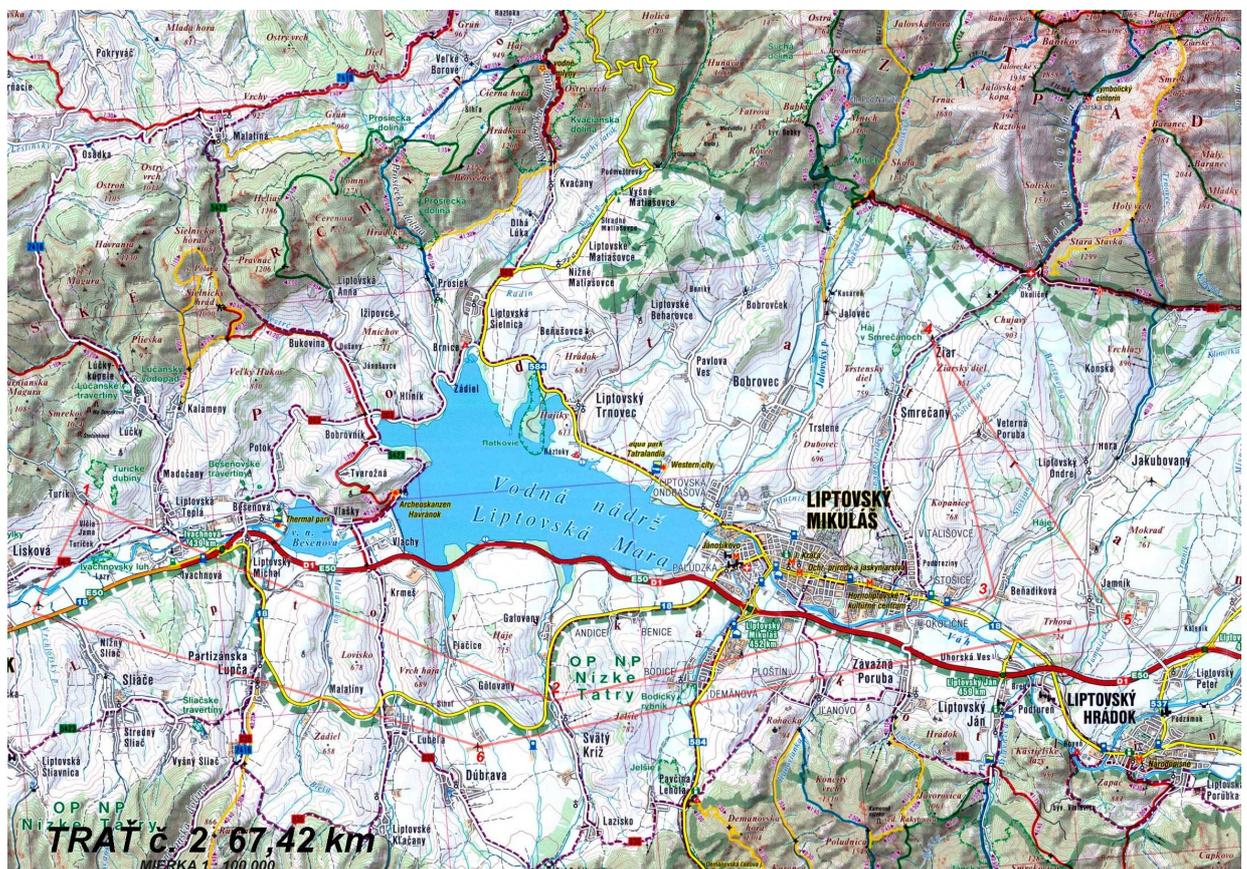
For the respective day the race organizer chose the air navigation race on the following route:

LZRU – Turík – Gôtovany – Beňadiková – Žiar – Jamník – Dúbrava – Partizánska Ľupča – LZRU.

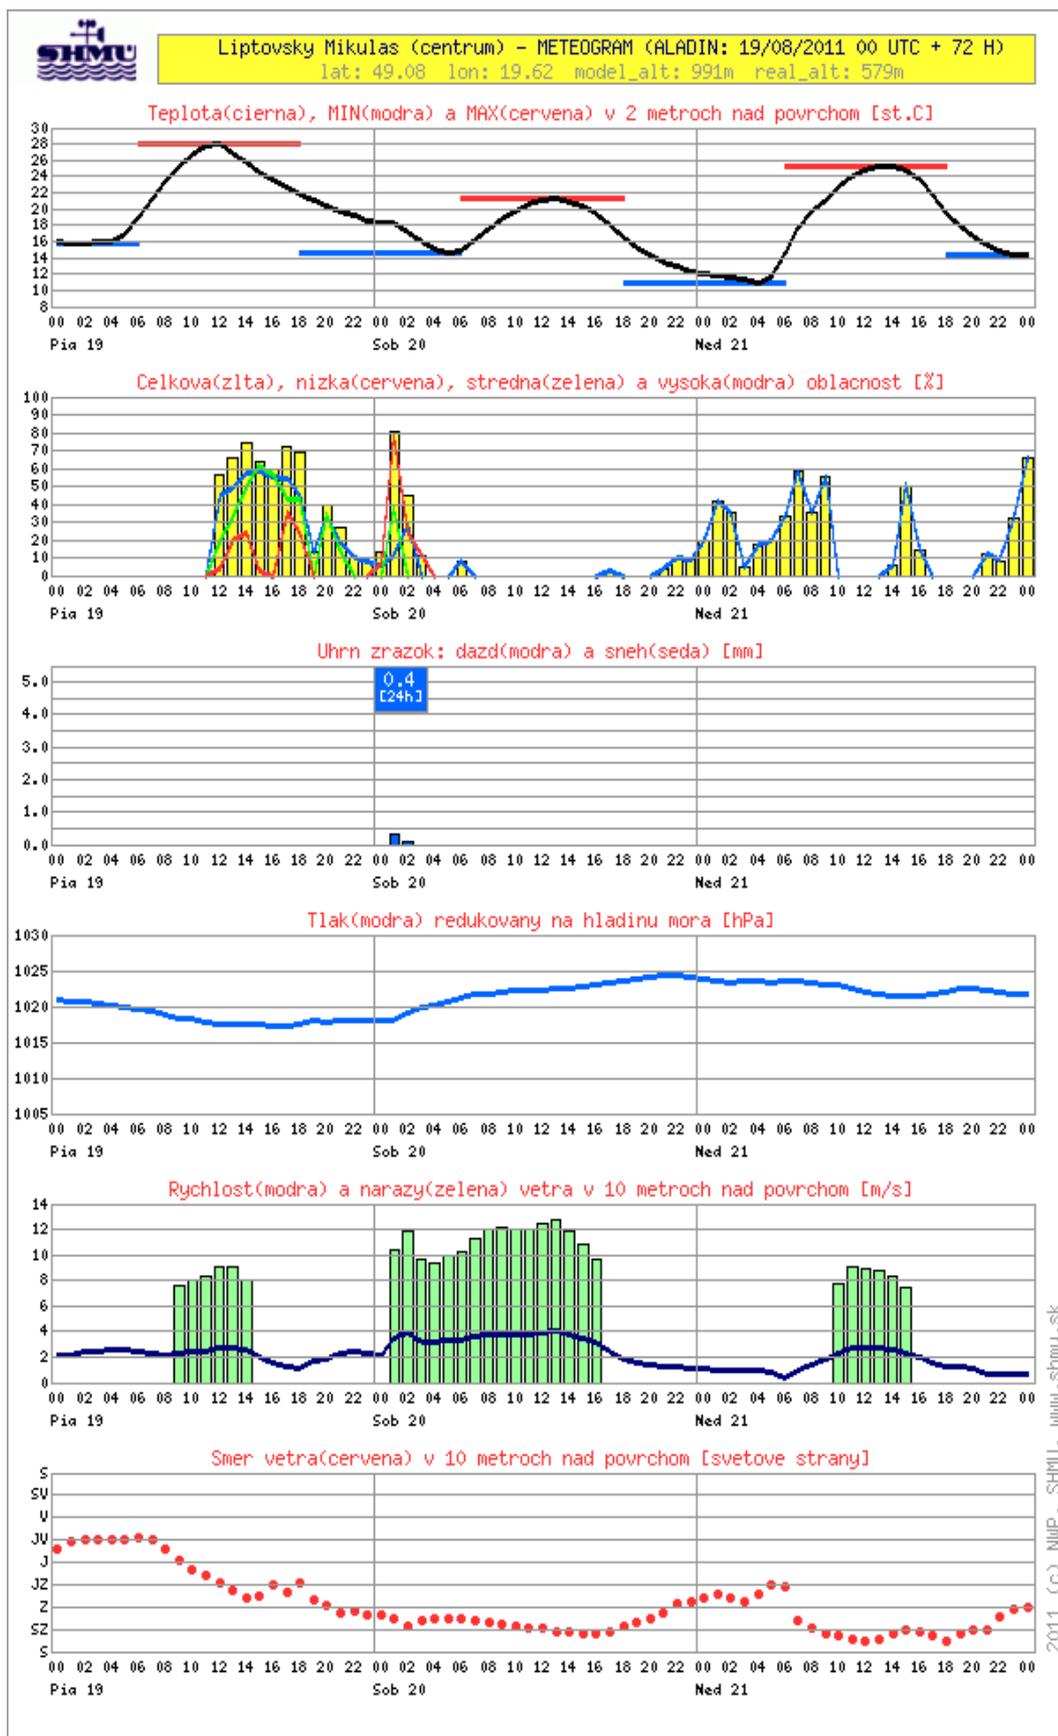
1.18.2 The Slovak Hydrometeorological Institute („SHMÚ“) published the following weather forecast for the location of Liptovský Mikuláš for the race day:

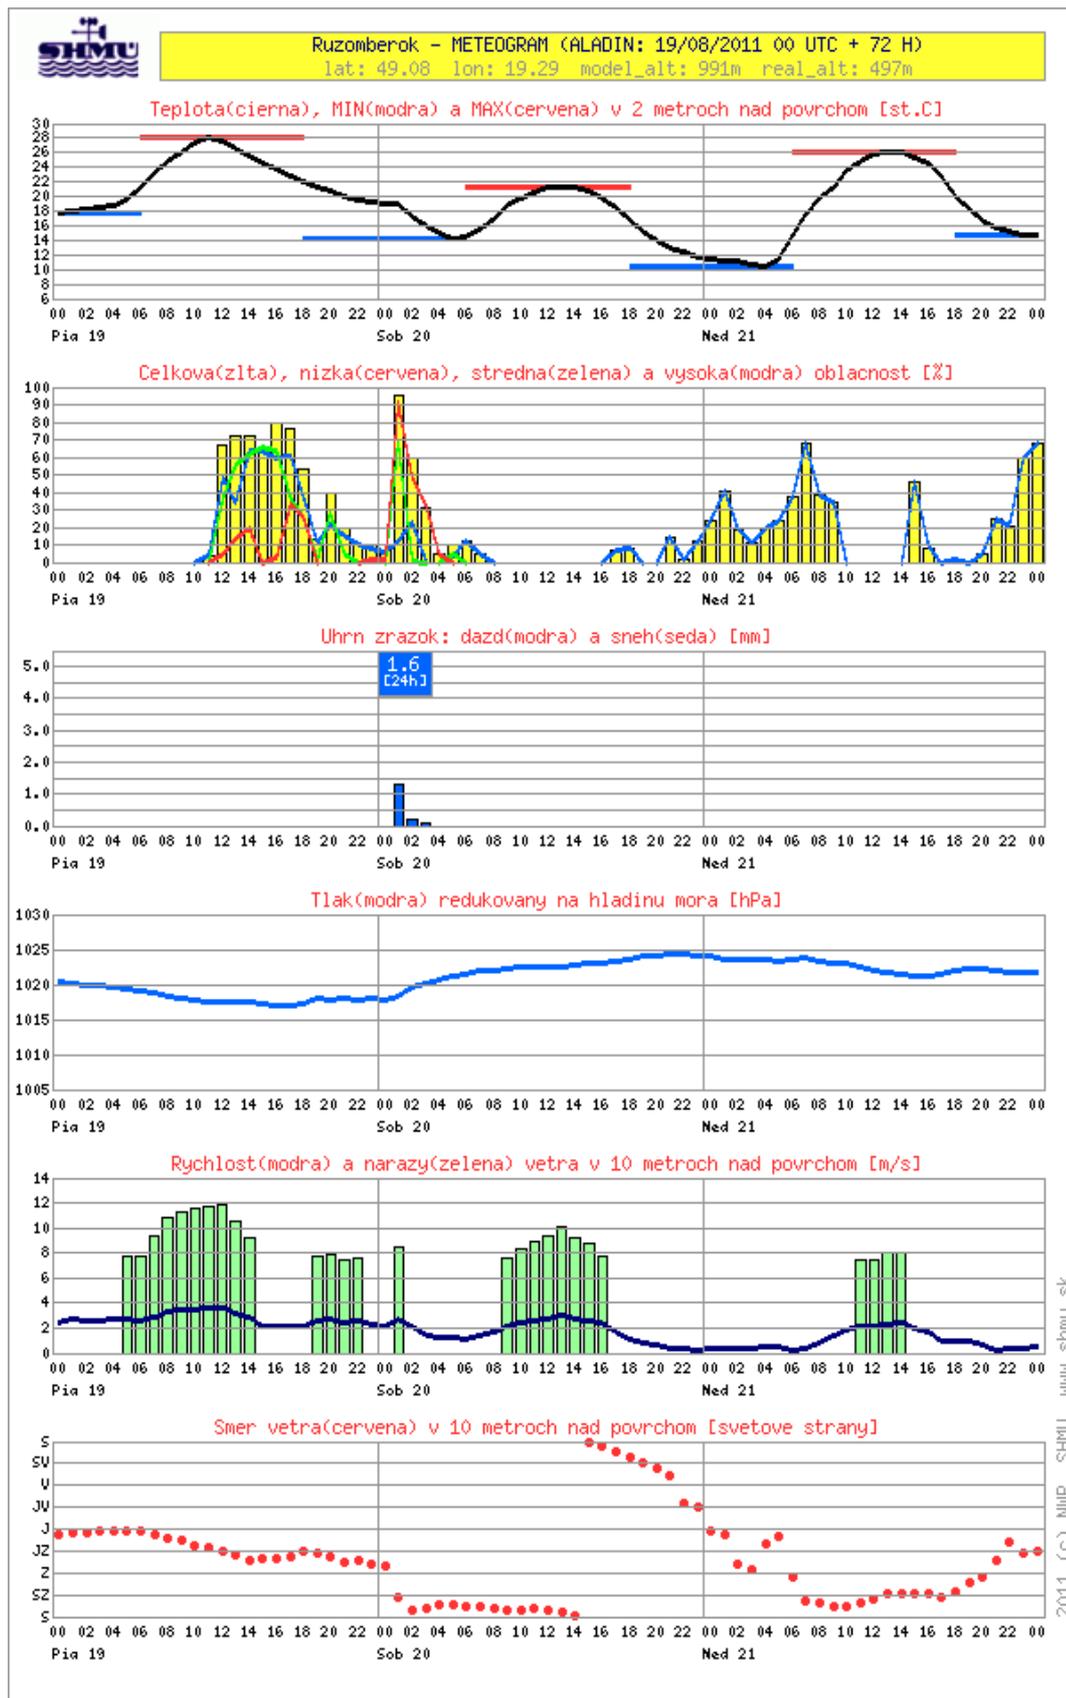
1.18.3 SHMÚ published the following weather forecast for the location of Ružomberok:
