FINAL REPORT

on investigation of air accident

of aircraft type **Z-226 M / VSO - 10**

Registration No. **OM – KMF / OM - 3503**

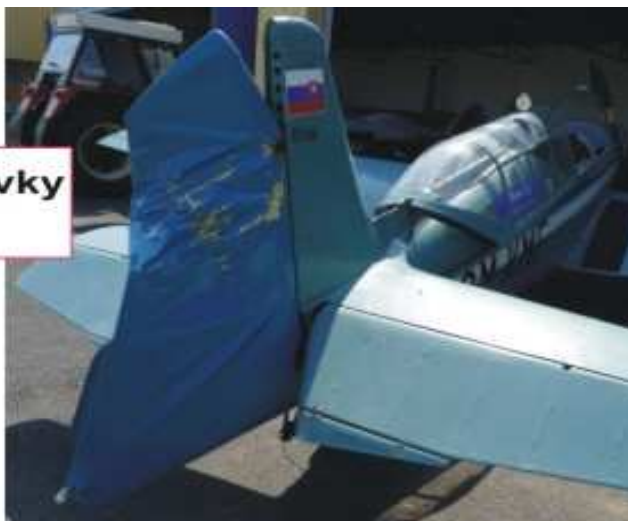
The towing aeroplane was damaged when the towing rope got looped around the horizontal tail plane and the vertical rudder.

**Poškodenie smerovky
pohľad zľava**

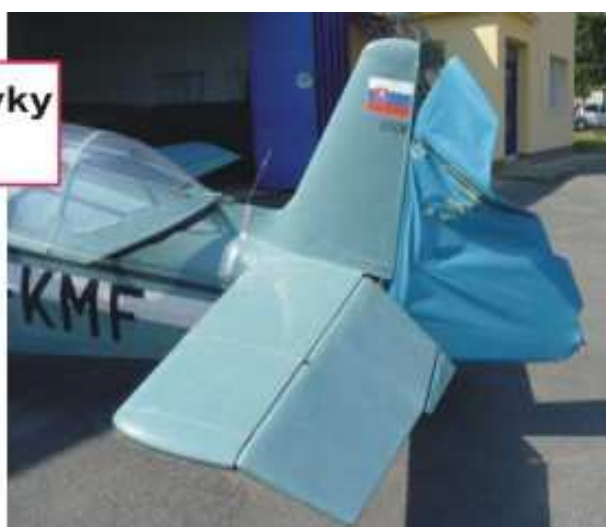
**Poškodenie smerovky
pohľad sprava**

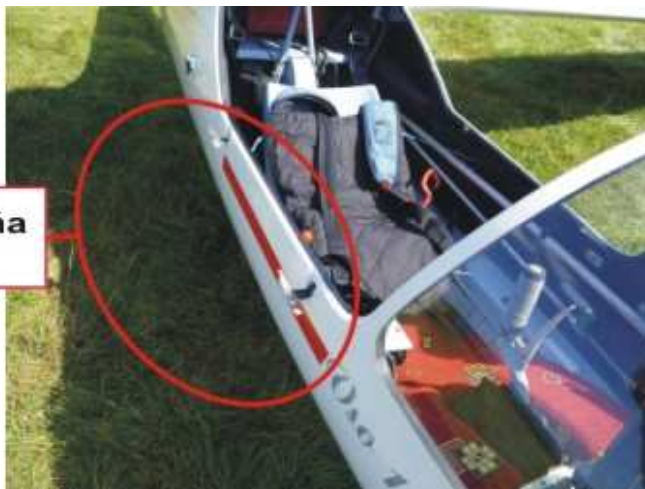
The damage to the glider was caused by the release of the seat back cable lock, followed by the shift of the seat. The pilot by mistake opened the glider's cockpit cover (loss of cockpit that was torn from the hinges).

**Poškodenie vetroňa
vytrhnutie kabíny**

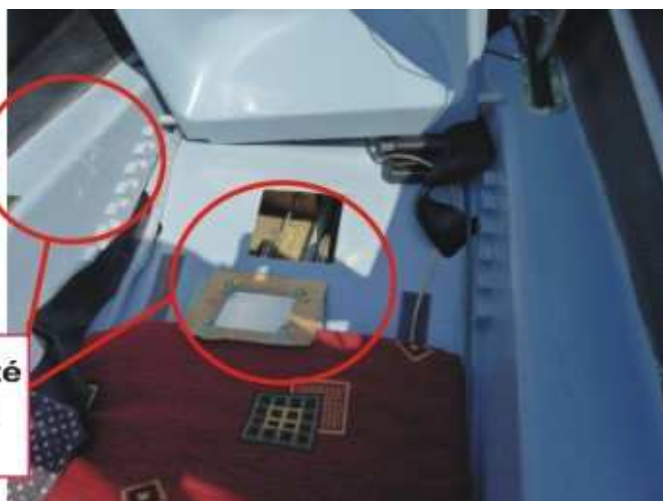
**Poškodenia vzniknuté
uvoľnenou opierkou
sedačky**

The main cause of the accident was the release of the seat back cable lock.
