Reg.No. : SKA2011014

FINAL REPORT

on investigation of air accident
of hand glider **RELIEF 14S**
registration No. **OM-H456**

Date: 11.09.2011

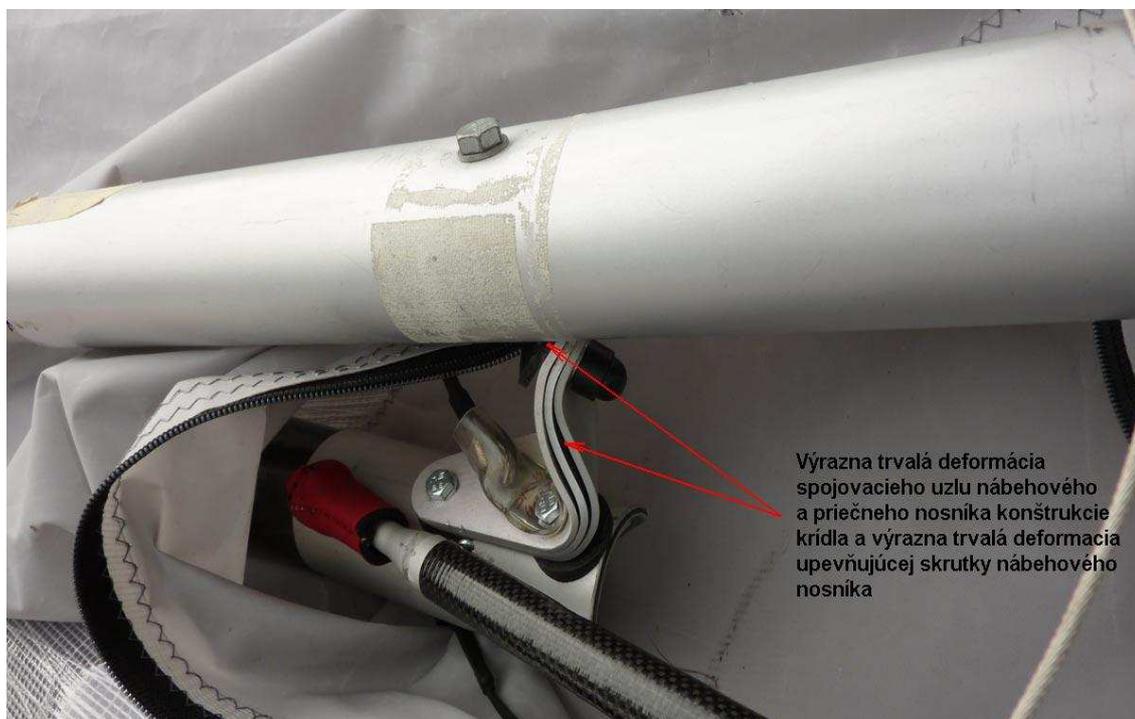
Detected damages:

- destruction of and damage to leading and cross spars, keel spar, left-hand trapeze tube,
- permanent deformation of some connection pieces and spars of HG body,

- permanent deformation of wing canvas reinforcement, damage to the wing canvas on several places, damage to suspension harness of the pilot and permanent deformation of pilot's attachment.

- the character of damage indicates that these damages occurred after the collision of HG with the ground at approximate flight speed of 61 km/h during descent at a speed of 4 m/s.

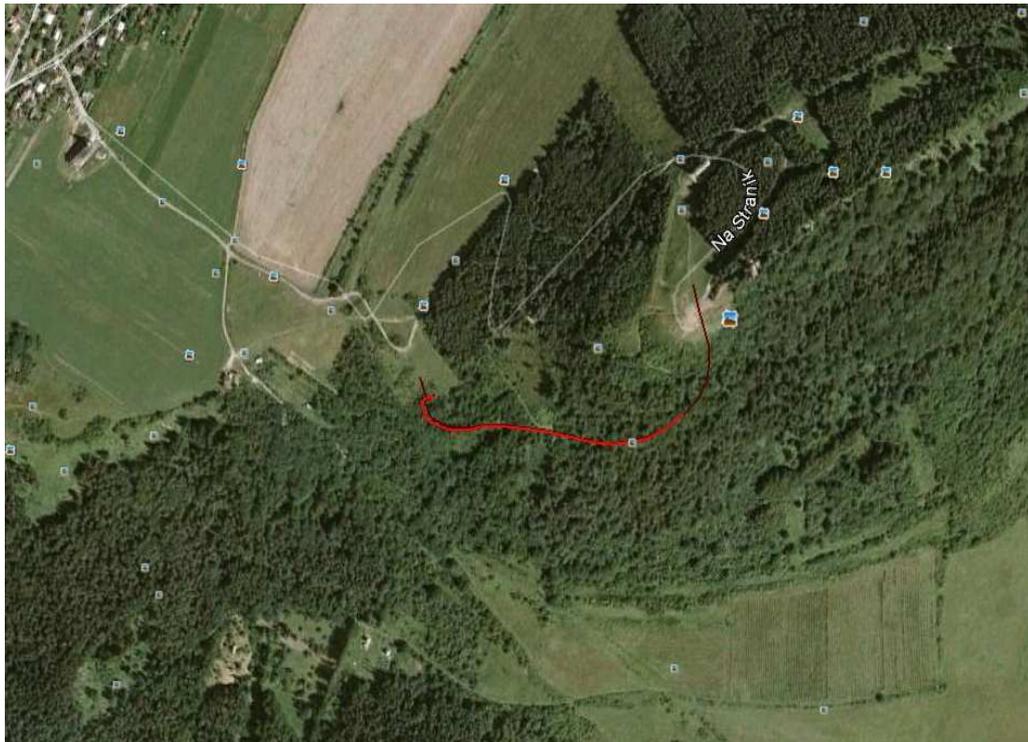
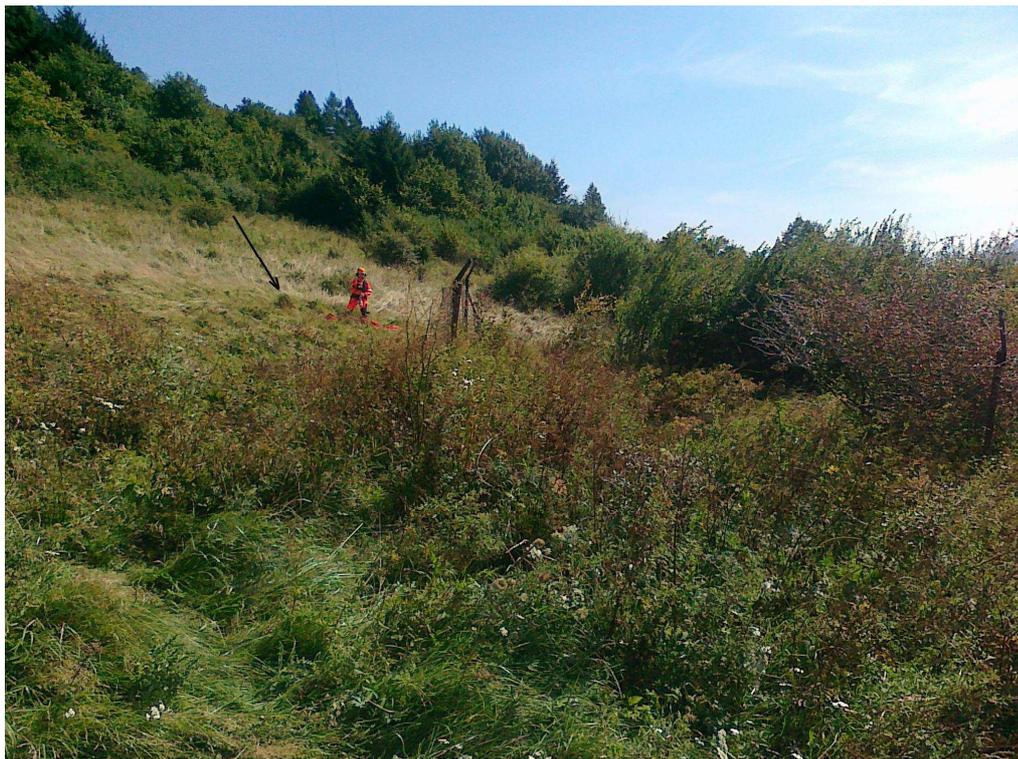
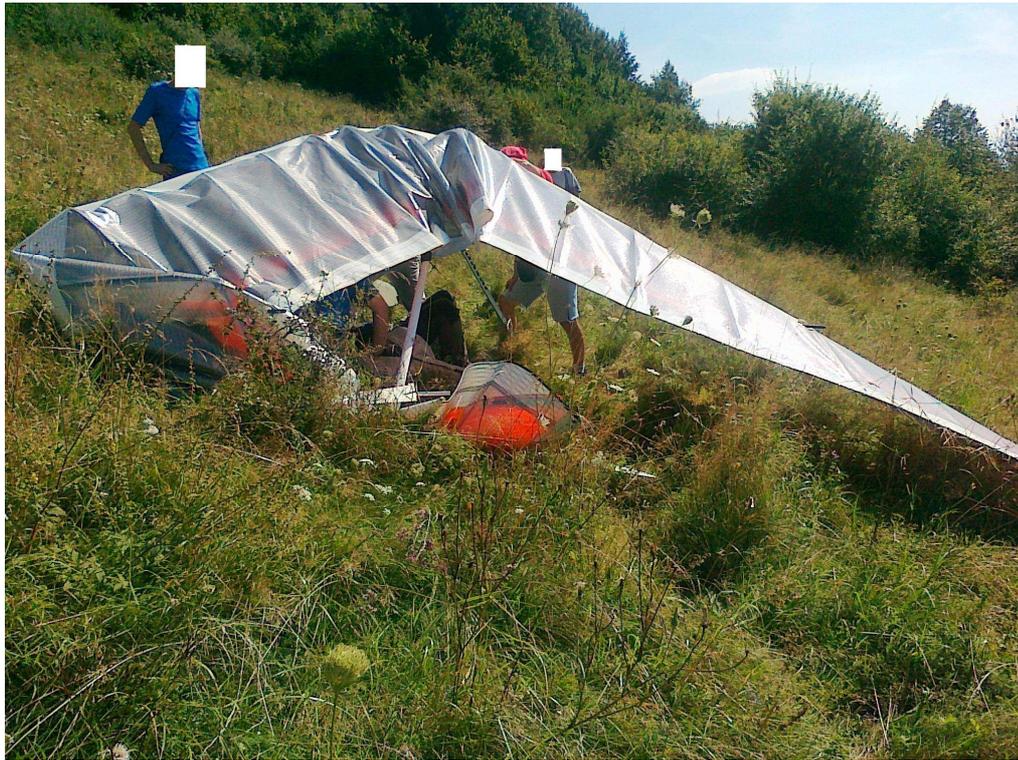
The place of air accident is situated in a proximity of the take-off site – area for take-off and landing of FSV Straník, north-west of the take-off site. The place of impact is a grass sloping area.
