## FINAL REPORT

on investigation of air accident

of powered paraglider  
Registration No. **OM-P802**

aircraft **CTSW**  
Registration No. **OM-M608**

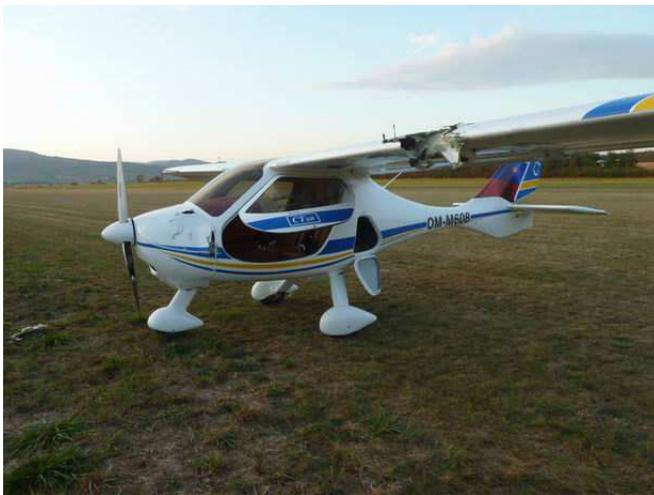
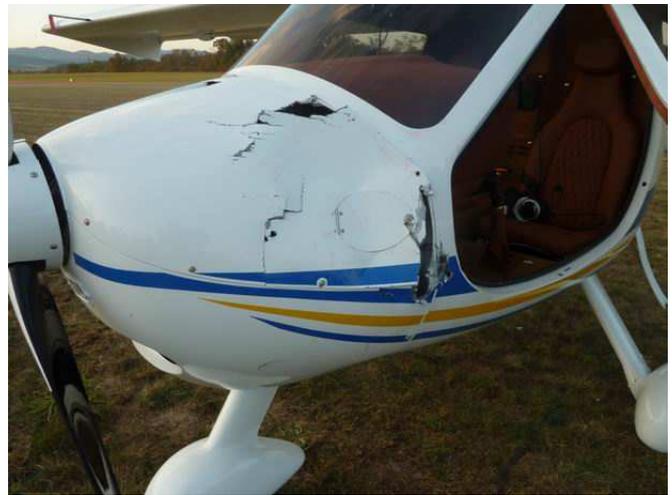
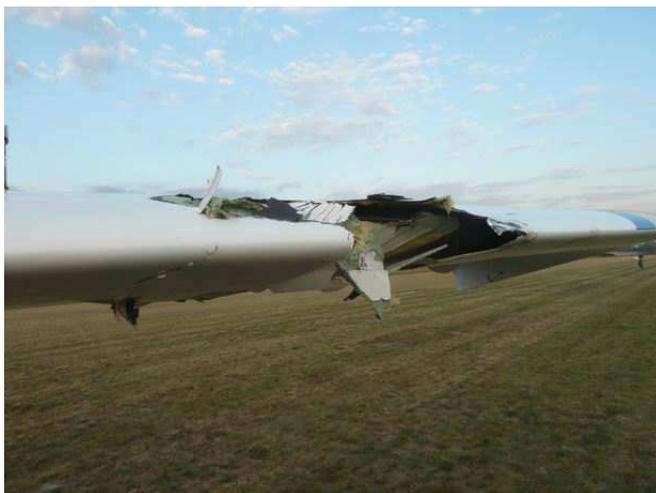
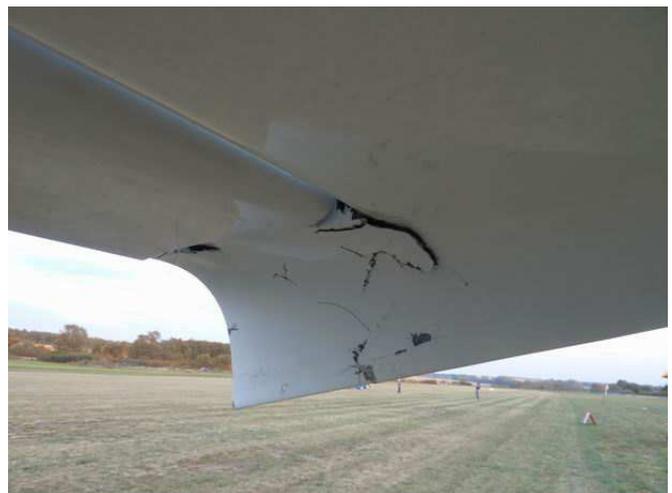
The aircraft CTSW, registration No. OM-M608, was seriously damaged.

The pilot of PPG continued the flight in a left turn with maximum engine output in the effort to fly over the grounded aircraft. But shortly after that the right wheel of PPG landing gear crashed into the leading edge of aircraft CTSW, approximately in its middle. The leading edge of the wing shows visible traces of black colour of the tire, running from the point of initial contact along the leading edge to the middle section, when, having covered a distance of 0.5 m, the tire slipped on the leading edge coat and perforated the coat of the left wing leading edge.

By action of the uplift force of the PPG wing and due to a partial wedging of tire in the leading edge of CTSW wing the front of the aircraft CTSW was lifted so that its lower tail section hit the ground, which is also proved by traces of grass, earth and slight damage to this tail section of aircraft CTSW.

At the moment of collision with its wing the aircraft CTSW probably not only tilted over to its tail, but also slightly turned to the left from its longitudinal axis. When the action of force from the tire of landing gear was interrupted, the reaction force caused the left wing of aircraft CTSW to move downwards, where the windtip hit the ground, which is proved by traces of grass, earth and damage to the windtip.

aircraft body having the same colour as the protective frame of the propeller. The propeller was also damaged when it hit the damaged deformed protective frame and lost the thrust. The front fuselage of aircraft strongly turned to the right and downwards after the impact. At the same time, the inertial motion and decreasing uplift of PPG wing caused that PPG flew over the cabin of aircraft CTSW and in front of the right wing of aircraft CTSW. After impact of the protective frame of propeller the PPG landing gear turned to the left and got to the initial flight direction. The decline in thrust caused a loss of flying speed of PPG and subsequent decrease of height and contact of PPG landing gear with the ground. PPG did not turn over when it touched the ground, thanks to the unchanged direction of movement and harmonisation of the axis of landing gear with this movement.

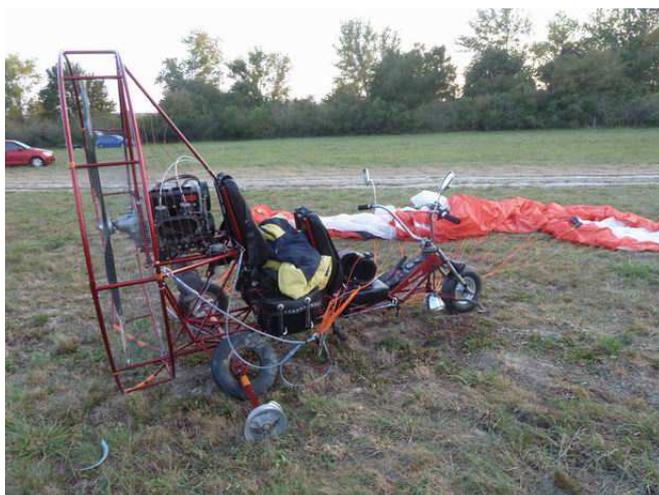
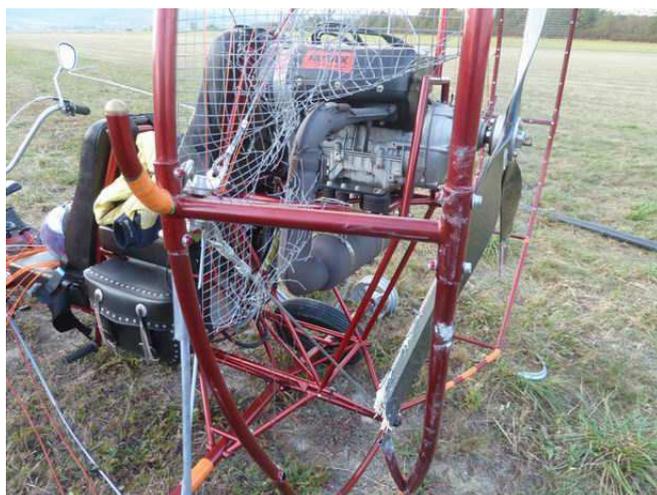
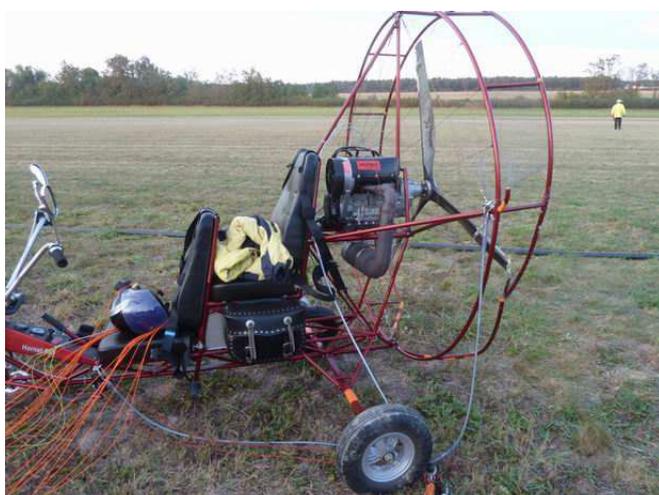
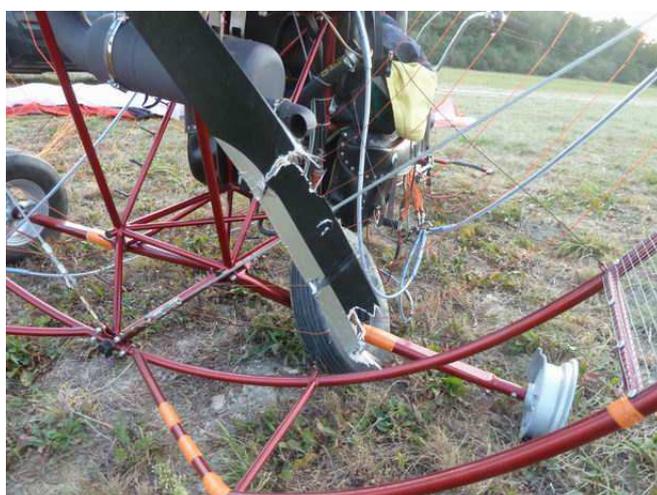
PPG, registration No. OM-P802, was slightly damaged

Due to the impact the PPG landing gear strongly turns to the right, and the protective frame of propeller hit the front fuselage of aircraft CTSW, which is proved by colour traces on the

The PPG landing gear fell into the ground, most probably on its right wheel, and at this moment the tire probably slipped off the right wheel.

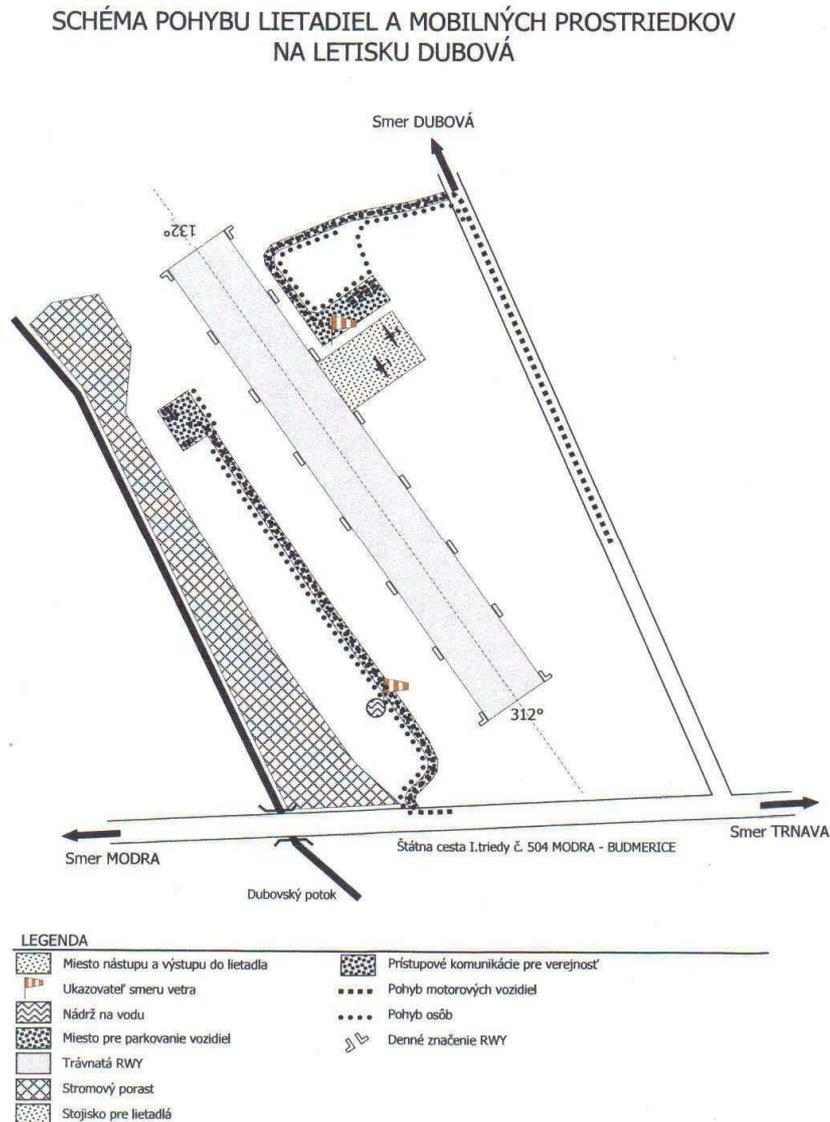
Data on the airport in AIP SR Vol. III. (VFR) in AD (VFR) are not published. According to the Airport Operation Manual – Scheme of movements of aircraft and mobile devices - the airport has an area reserved for aircraft parking left from the threshold of RWY 132°, about 150 m away from the threshold and 50 m away from the edge of RWY. At the time of accident aircraft were grounded outside this area.

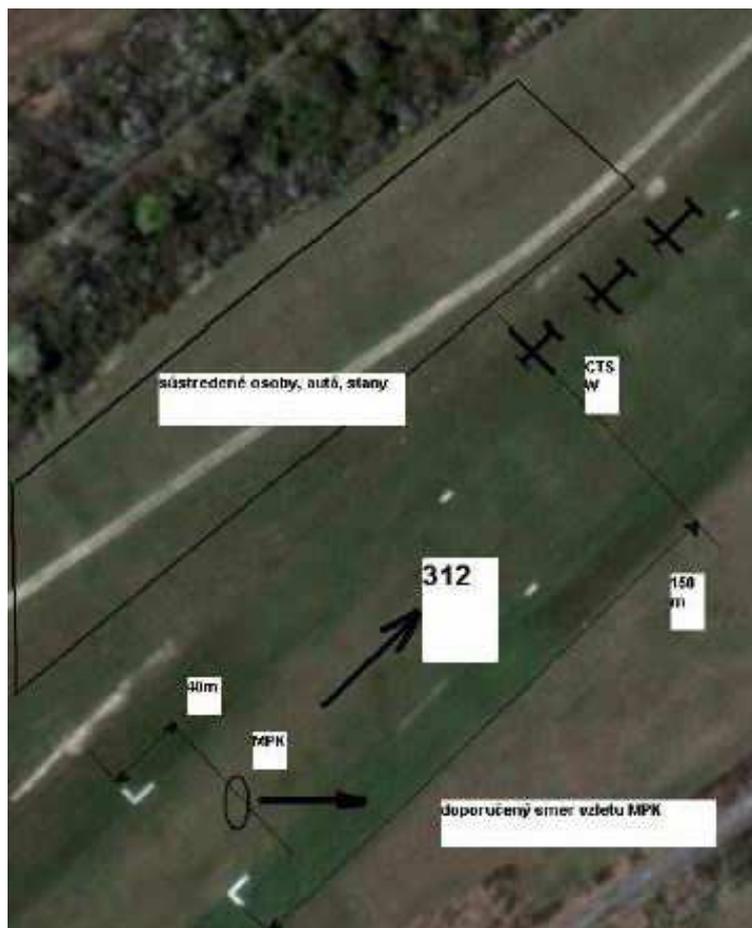
### Situation before the take-off of PPG

Following instructions of the ground movement controller, the pilot of PPG was to make a take-off in the direction right from the axis of RWY 312°, in the direction with course of 360°, because of obstacles formed by three aircraft grounded in a row close to RWY. The aircraft were aligned one behind the other with spacing of 10 m, turned by 132° against the take-off of PPG, about 150 m away from the threshold of RWY 312° and about 15 m away from the left edge of RWY 312°.

The pilot of PPG started the take-off from grass RWY 312° in the approximate direction of 360°, following instructions of the ground movement controller, in view of the larger number of aircraft using the airport at that day. Three aircraft were grounded near the edge of RWY 312°.

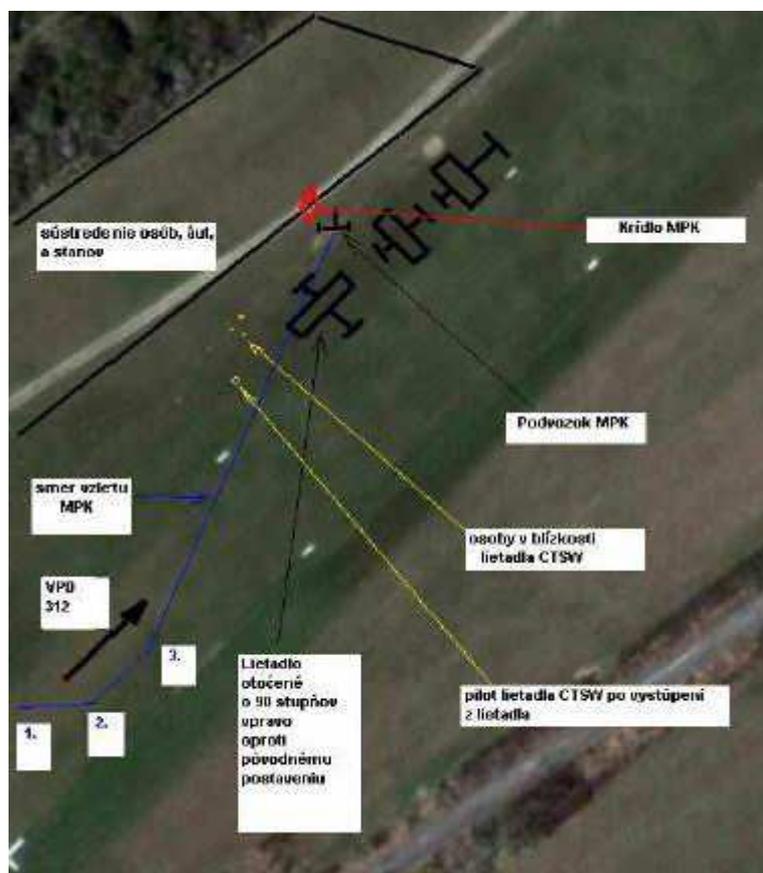
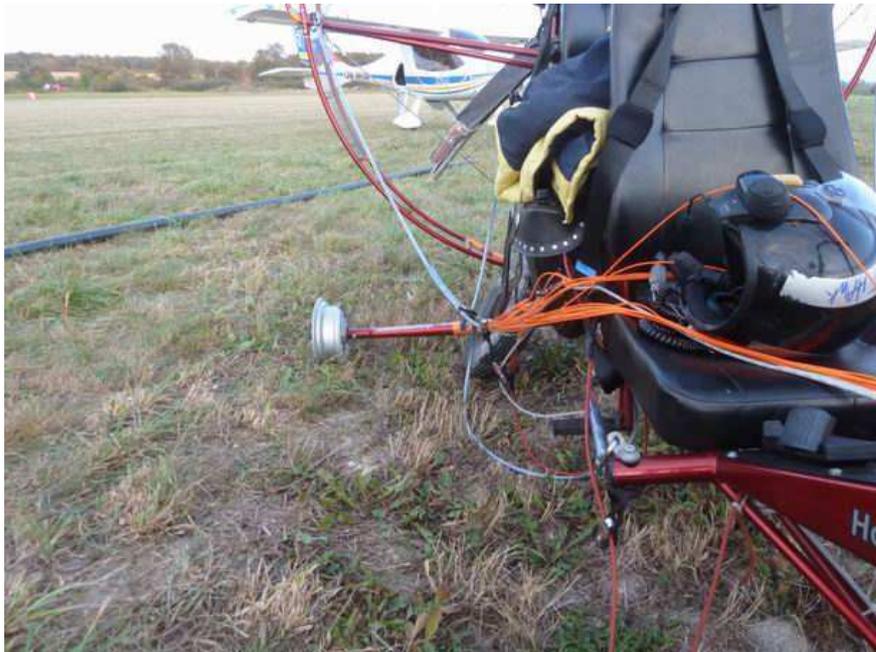
### Final position of aircraft after the accident

The place of accident is situated 150 m away from the threshold of RWY 312°, about 15 m away from the left edge of RWY.

The aircraft CTSW remained after the accident with its tail turned vertically to the edge of RWY. The complicated movements of aircraft CTSW from the moment of collision to their termination were caused among others by braking of aircraft CTSW to stop using the parking brake.

The wing of PPG fell into the ground left in front of the PPG landing gear, in grass cover, and it probably moved along this grass cover. From this perspective the inspection of ropes for presence of massive grass cover might not be objective.
