FINAL REPORT

on investigation of air accident
of aircraft **TATRA T-101**
Registration No. **OK-TAO**

Date: 23.09.2011

Place: Airport Žilina / LZZI

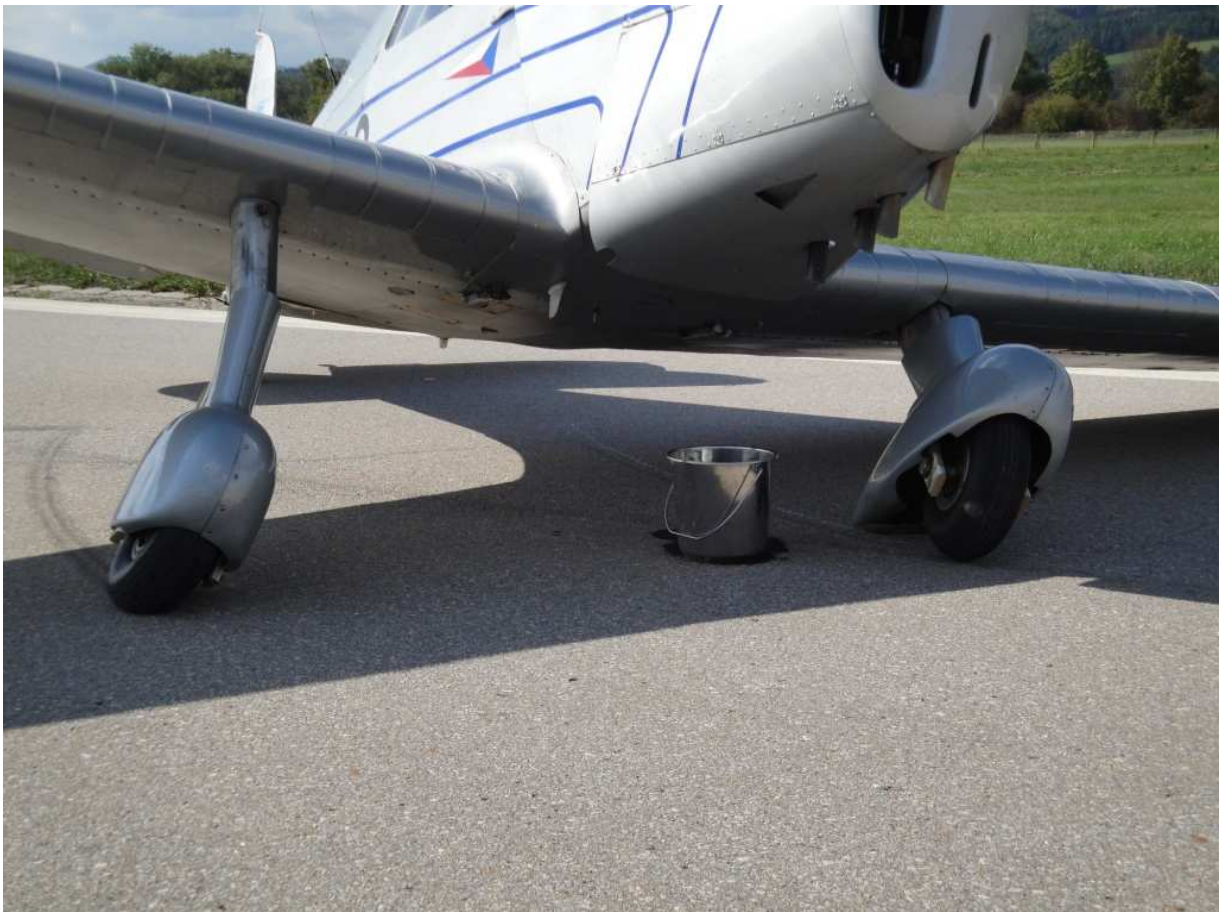
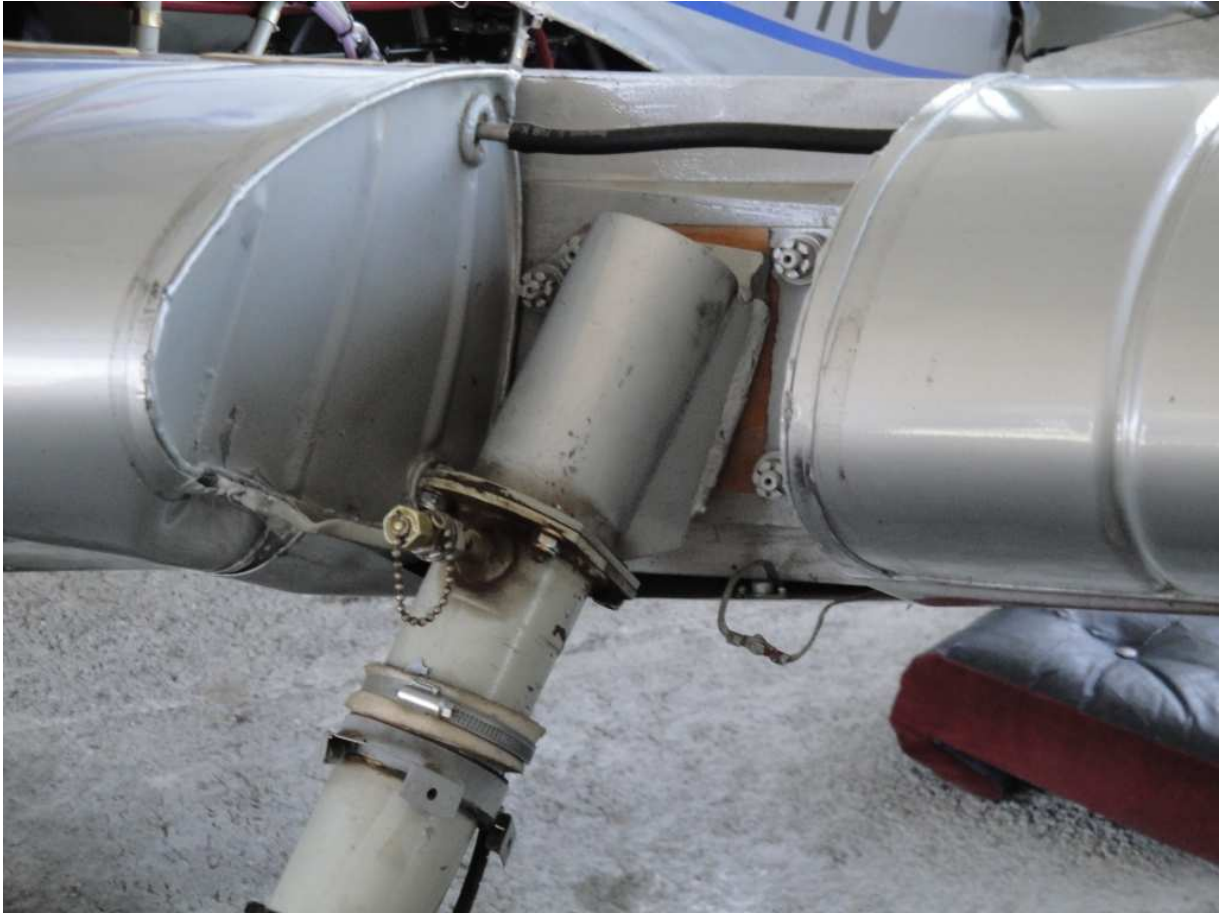
The left leg of landing gear got partially broken off the suspension, the first leg of landing gear got bent to the right side. No other damage to the aircraft was detected.

From conclusions of the expertise it ensues that breaking of attachment was caused by static failure and heavy contamination of steel used (woody fracture) and structural cut (failure on the weld / basic material interface, in the heat affected zone).

- to analyse the air accident with flight personnel
- to consider the aircraft operation from concrete aprons
- to use more suitable material for landing gear anchorage.

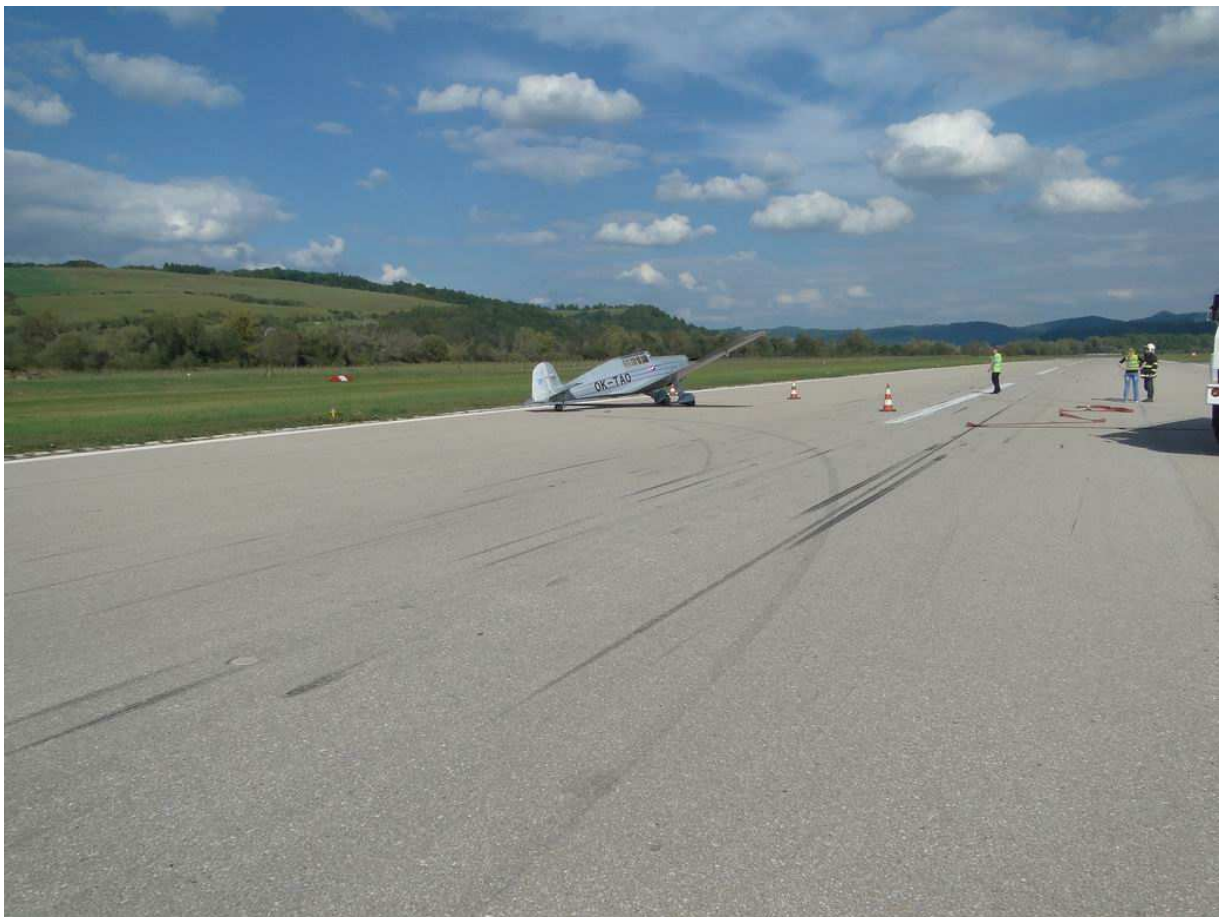
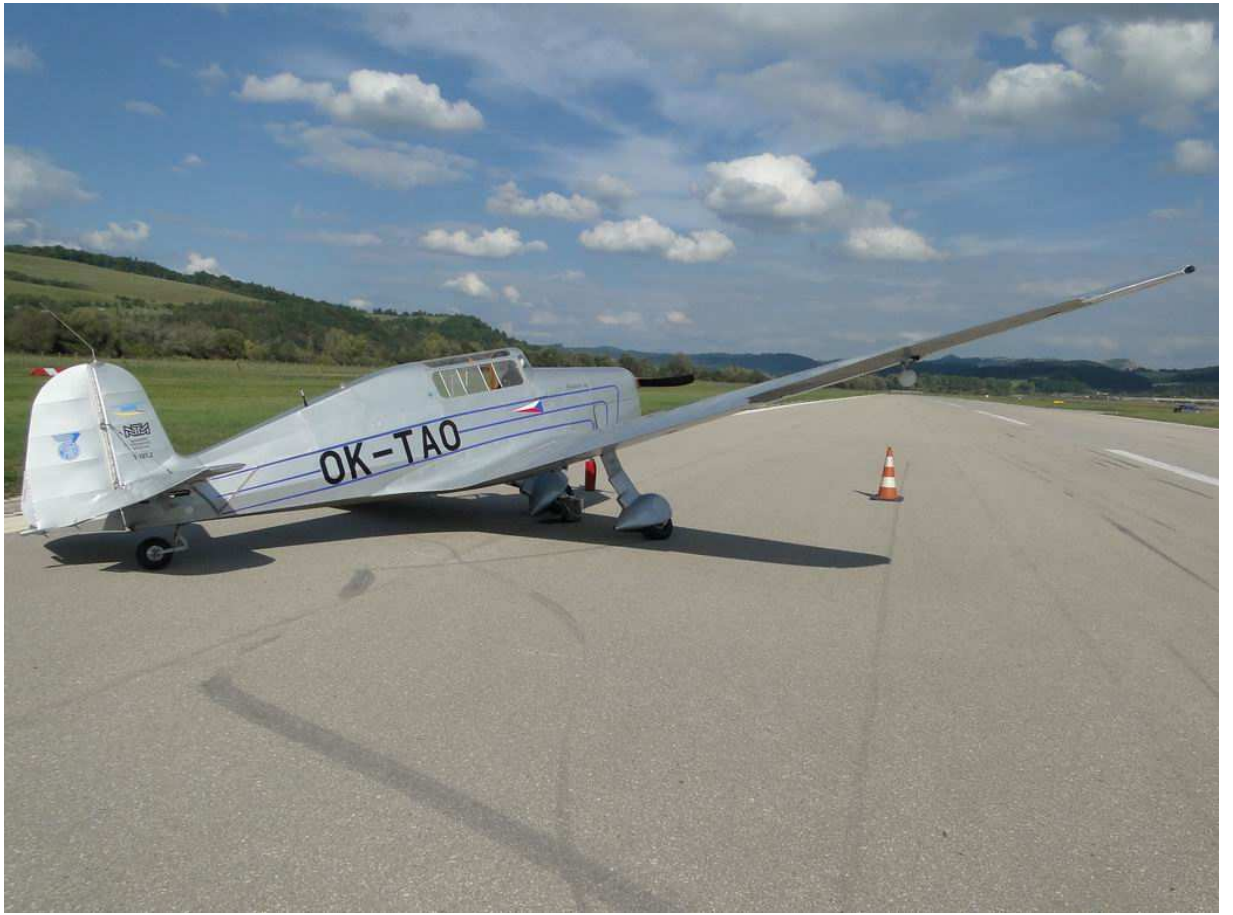
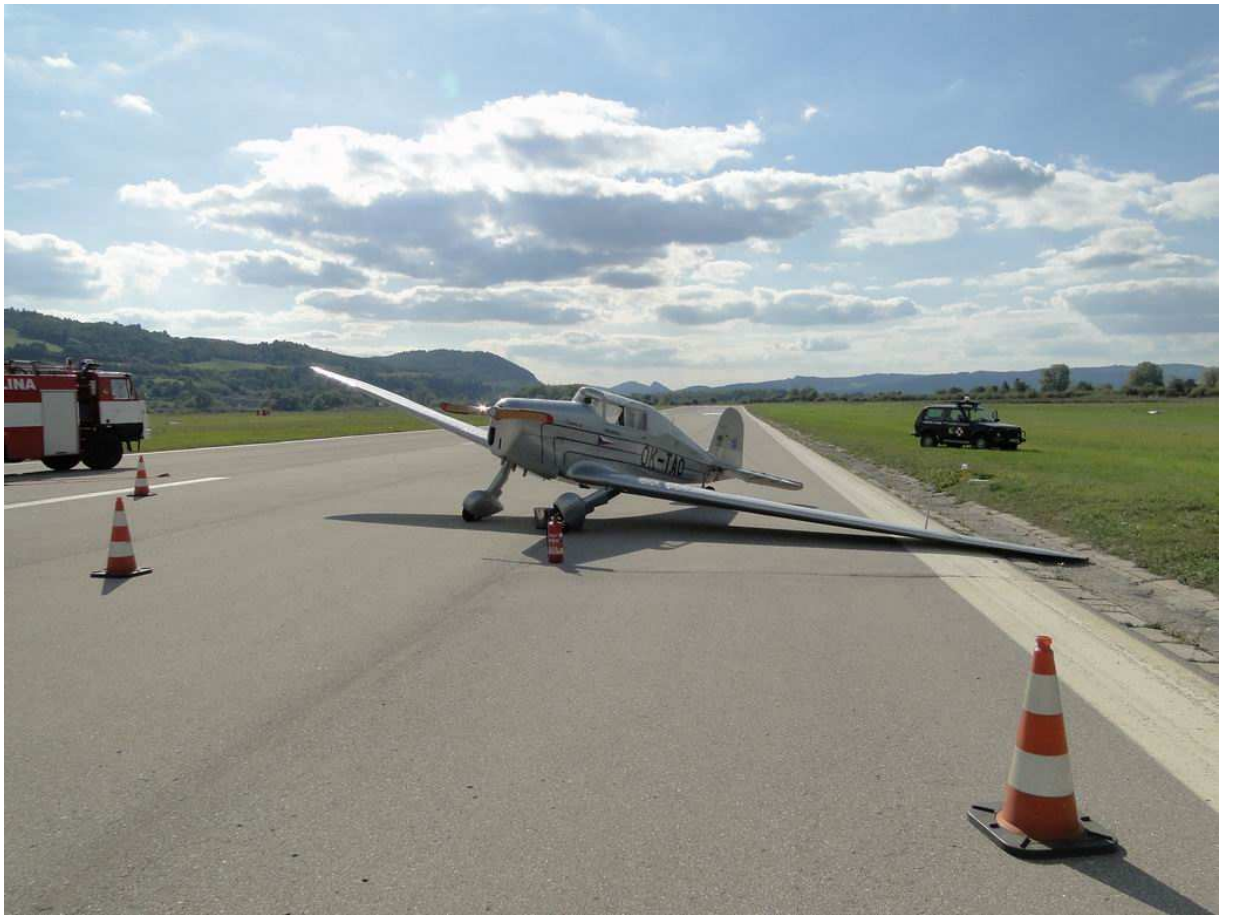
After landing the aircraft stopped near the left edge of RWY, inclined to the left side, leaned against the end of its left wing.
