FINAL REPORT

on investigation of air accident
of aircraft **Zodiac CH601 HD**
registration No. **OM - M407**

Date: 13.12.2011

Place: Partizánske Airport / LZPT

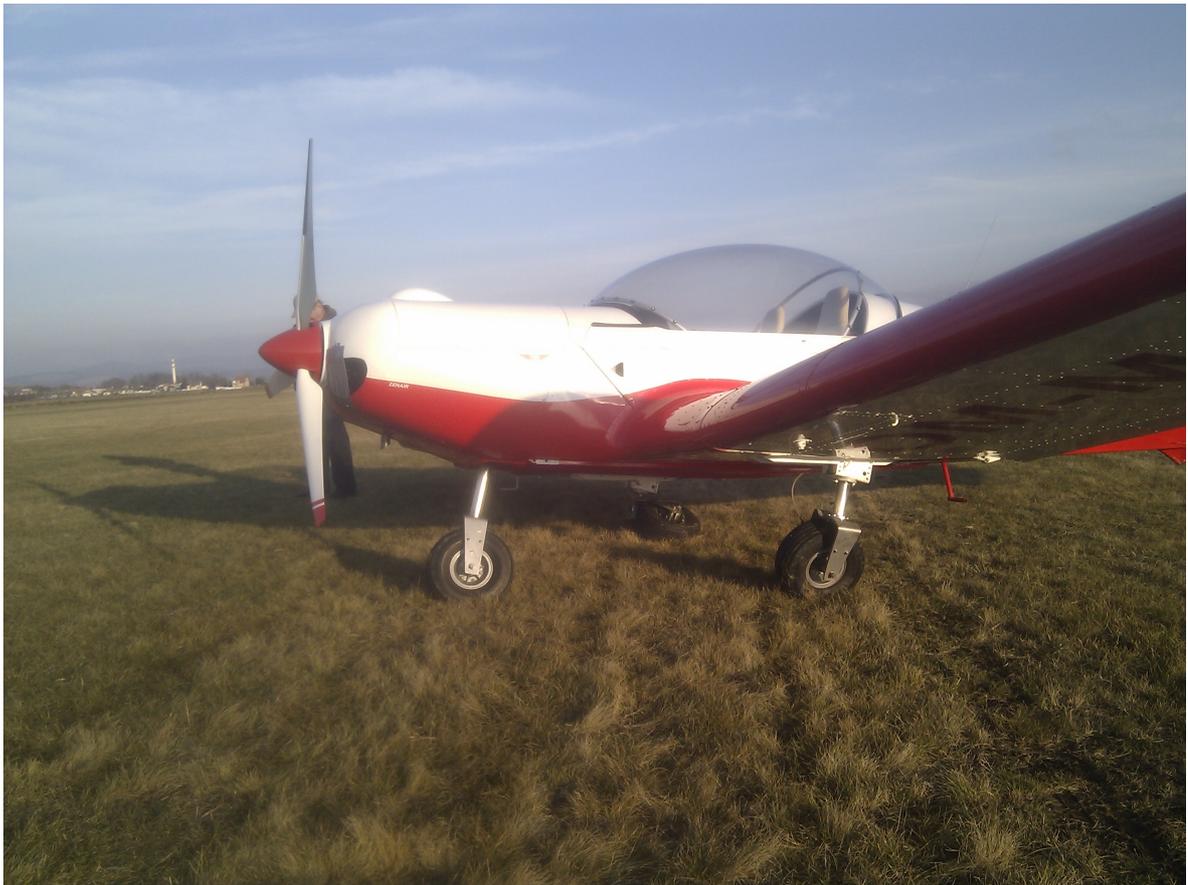
After the landing on the grass runway („RWY“) of LZPT the aircraft bounced up to the height of 2 m. During repeated landing the aircraft made hard traverse landing and the right-side landing gear leg fork became deformed.

The aircraft suffered minor damage.

Due to the pilot's activity and passivity of the instructor who was only giving the pilot instructions for correction of poor landing, the aircraft made a hard traverse landing on its right-side landing gear leg. It caused its higher dynamic loading, followed by deformation of the leg fork.

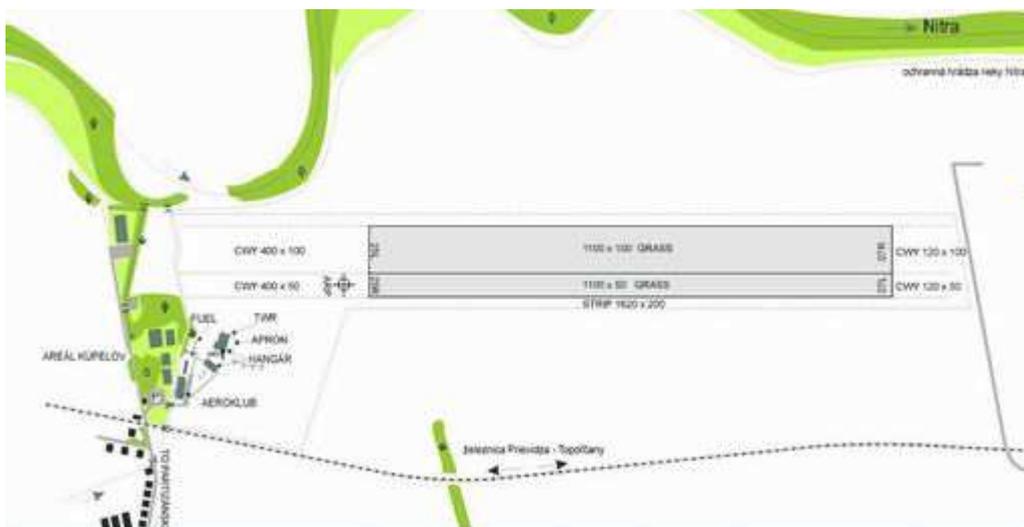
At the time of air accident the runway of LZPT was operable and fit for take-off and landing of this type of aircraft.
