## FINAL REPORT

on investigation of air incident  
of aircraft type **Falcon 2000**  
registration No. **OM - OPF**

Date: 28.04.2011

Place: Airport Moscow - Vnukovo / UUWW

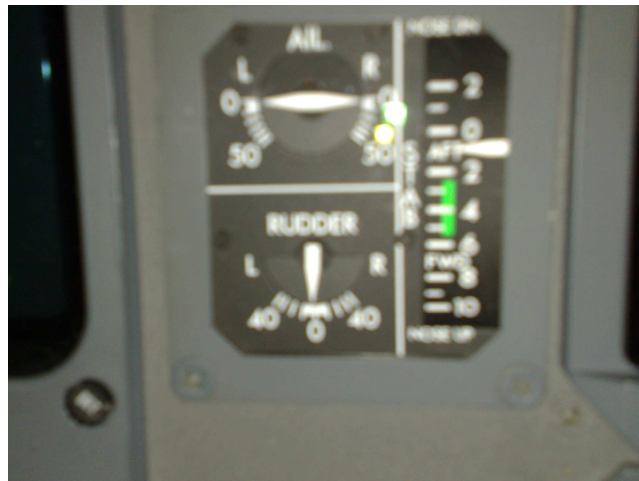
Fig. No. 1: Horizontal tailplane position indicator (right side)

The flight manual requires for the take-off phase the position of horizontal tailplane within a range between  $+2.5^\circ$  and  $+5.5^\circ$  (+ means "tail hea vy") which is, for illustration purposes, marked green on the tailplane position indicator scale (see Fig. No. 1). By a check of the indicator in the cockpit it was also detected that the shape and colour of the tailplane position indicator were similar to those of the indicator scale lines, which can lead the monitoring pilot (sitting on the right side during the taxiing phase) to a wrong assessment of situation (see Fig. No. 2).

- the most probable cause of the incident was accidental change of the position of the horizontal tailplane during a radio communication in the taxiing phase
- incorrect evaluation of the position of the horizontal tailplane by the pilot going through the checklist.

- to include the check of position of horizontal tailplane or aircraft take-off configuration in the checklist used just before the take-off (LINEUP CHECKLIST), which will ensure a duplicate check of substantial parts of the take-off configuration (such as brakes, flaps, balance of controls) and reveal accidental interventions into the aircraft configuration control.

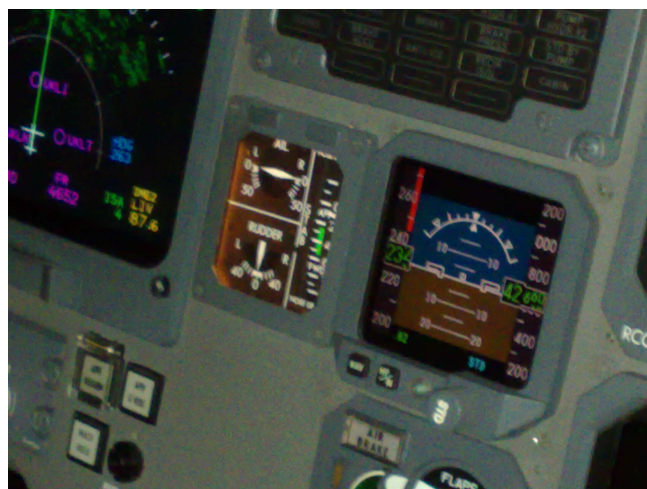
Fig. No. 2: The indicator viewed from the side of the monitoring pilot

- lower visibility of the indicator viewed from the side of the monitoring pilot.
