Reg. No. : SKA2013001

FINAL REPORT

on investigation of accident
of helicopter type **EUROCOPTER EC 120B Colibri**
Registration No **OM-ECI**

Date: 03.03.2013

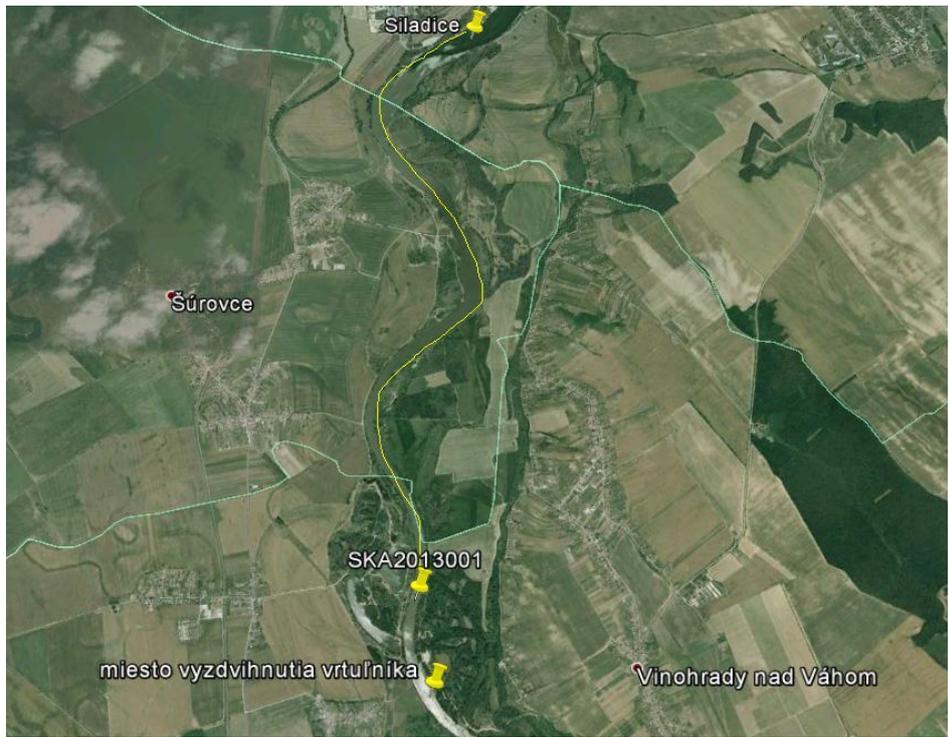
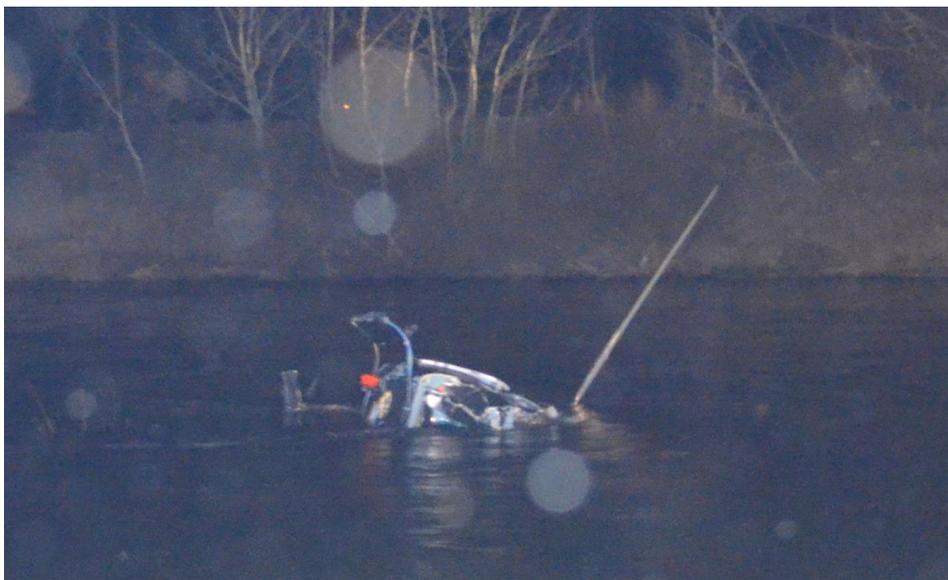
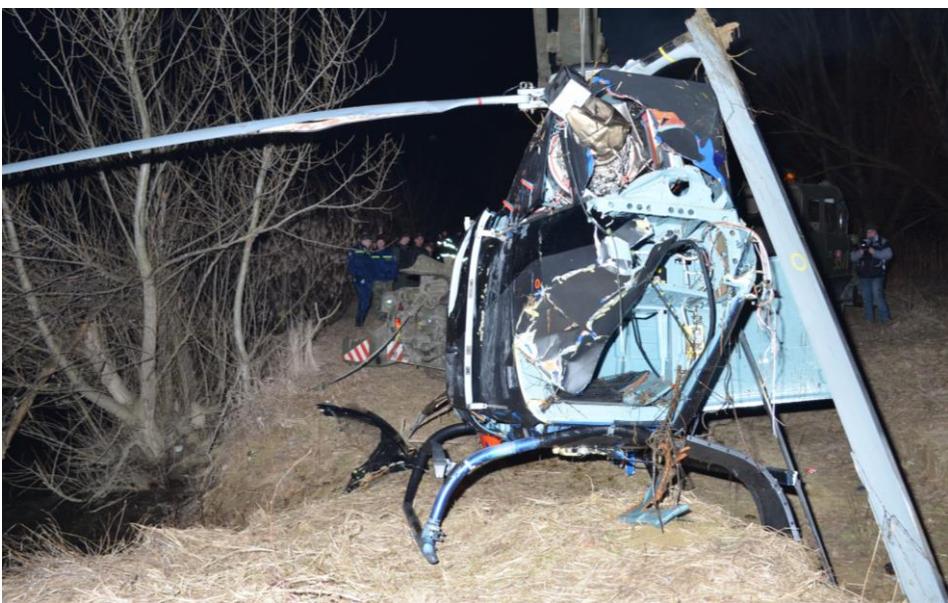
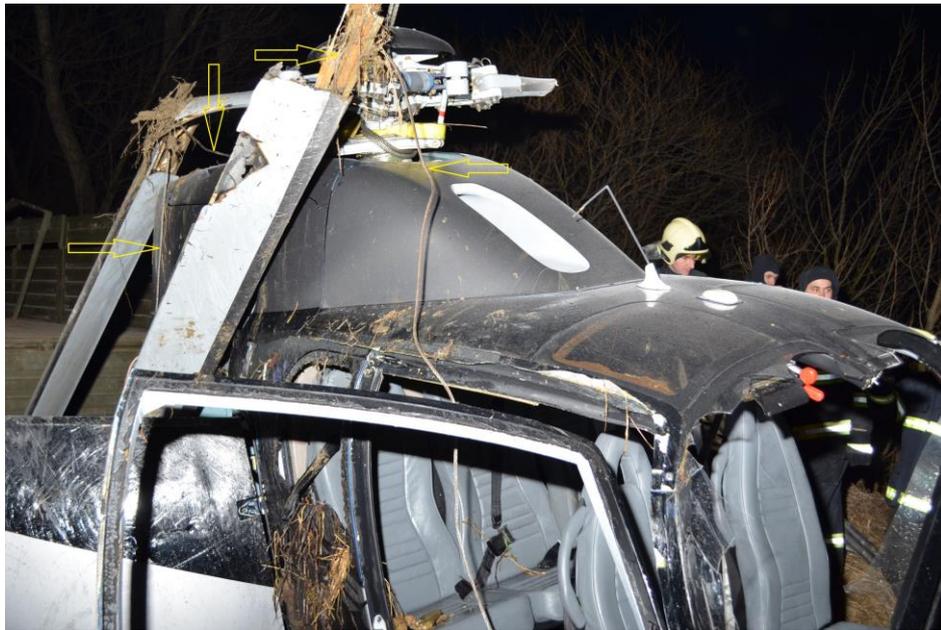
In the area between the communities Vinohrady nad Váhom and Horný Čepeň the helicopter nose hit a steel rope stretched over the river Váh. After the impact the rope slipped over the cockpit to the rotor compartment, which caused the dihedral of the nose of the helicopter, lowering of its tail section, rupture of the rope and fall of the helicopter to the water level.

During this collision of the helicopter with the water level its tail section containing antenna of the device "ELT KANNAD 406 AF-H" (Emergency Locator Transmitter) broke off first, which made transmission of its signal impossible. After the impact of the fuselage on the water the helicopter partially submerged and the river stream carried it to a distance of 670 meters, where it stopped in shallow water.

The helicopter landed in the river Váh.

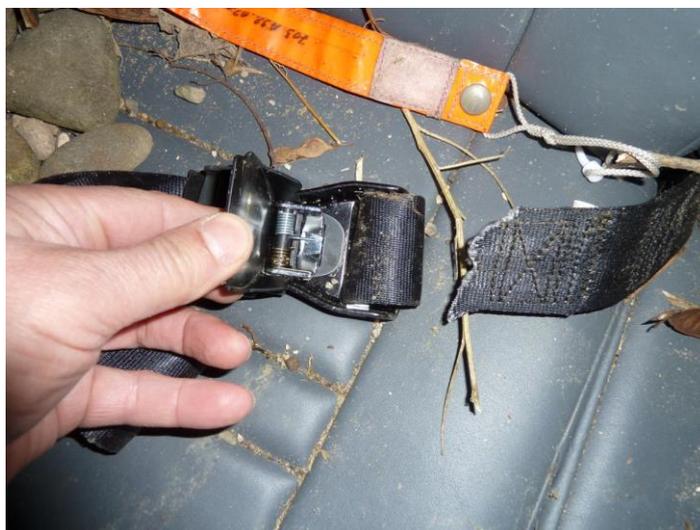
The pilot and the passengers (except for the passenger from the right rear seat) of helicopter unfastened their safety belts on their own. Then they started to free the passenger who did not succeed to unfasten his safety belt. The impossibility to unfasten the safety belt in the attempts at rescue of the passenger by the crew was probably caused by the exalted situation, stress and effects of ice-cold water. In particular the last mentioned may have caused such numbness and lack of feeling in their fingers that none of them was able to properly disengage the belt unlocking lever and rescue the trapped passenger from drowning. If a suitable tool for cutting of the safety belts was available in the helicopter, the trapped passenger probably could have been rescued.

The inspection of the safety belt locking mechanism after the air accident did not detect any faults or damage and the lock was fully functional.

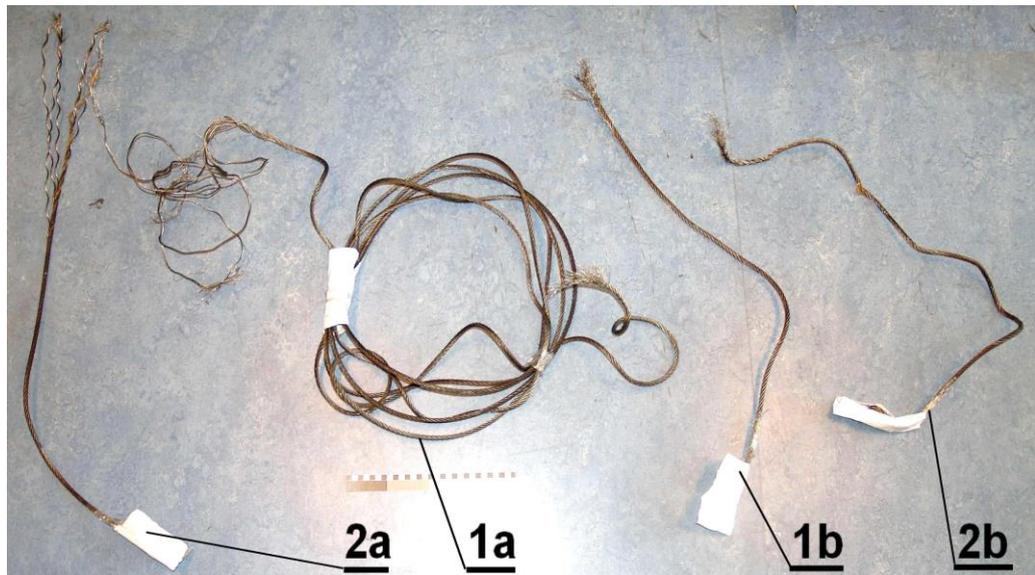
1.16.2 Four parts of steel rope were submitted for expertise to verify whether a part of the rope that was attached directly to the primary rotor of helicopter matches the parts of the rope found on the bank of the river Váh.

In case of all examined parts of the steel rope the type conformity was demonstrated, i. e. in all these parts belonged to a rope with the same construction and the same dimensions – all parts of the rope had a diameter of 8 mm and diameters of all wires lied within a range of, 0.48 to 0.50 mm. Moreover, all parts of the rope showed a regular right-hand lay

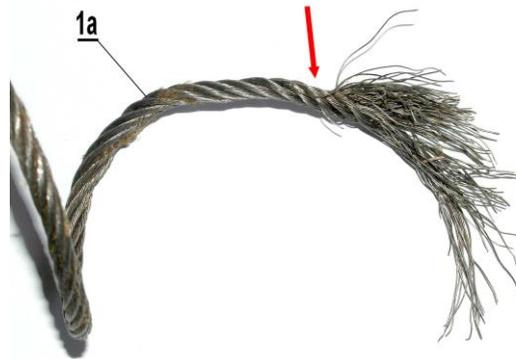
The other end of rope submitted as evidence No. 1a showed signs of forceful twisting at the time of occurrence of damage: visible reduction of the spiral lead of rope strands or even higher density of threads of individual rope strands per unit of its length just in front of the point of rupture (see the area marked by an arrow). It is obvious that this part of rope must have been in contact with a rotating part of the helicopter at the time when it was damaged. It is also clear that rupture of the rope at this point occurred later; the rope got broken in the area between parts 1a and 2a first.

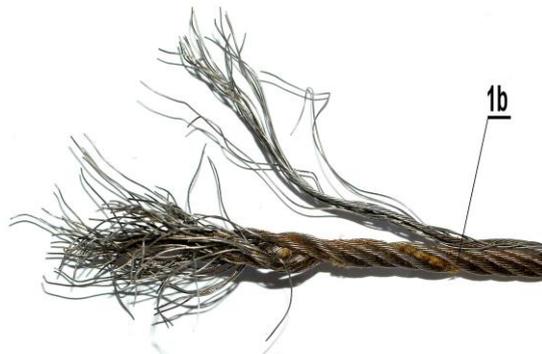
From the mechanism of damage to this part of rope with a marked twisting component it can be concluded that it was connected to a partially untwisted end of rope No.1b, found from the front section of the helicopter, which fully corresponds to the fact that if we damage the rope with marked twisting component by loading it, a higher rate of winding of rope strands will be observed on one side of the damaged area and untwisting of rope strands on the other side.

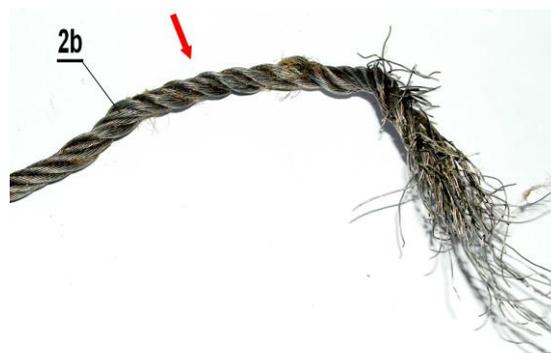
The damaged end of part of the rope submitted as evidence No. 2b again showed signs of forceful rope twisting.

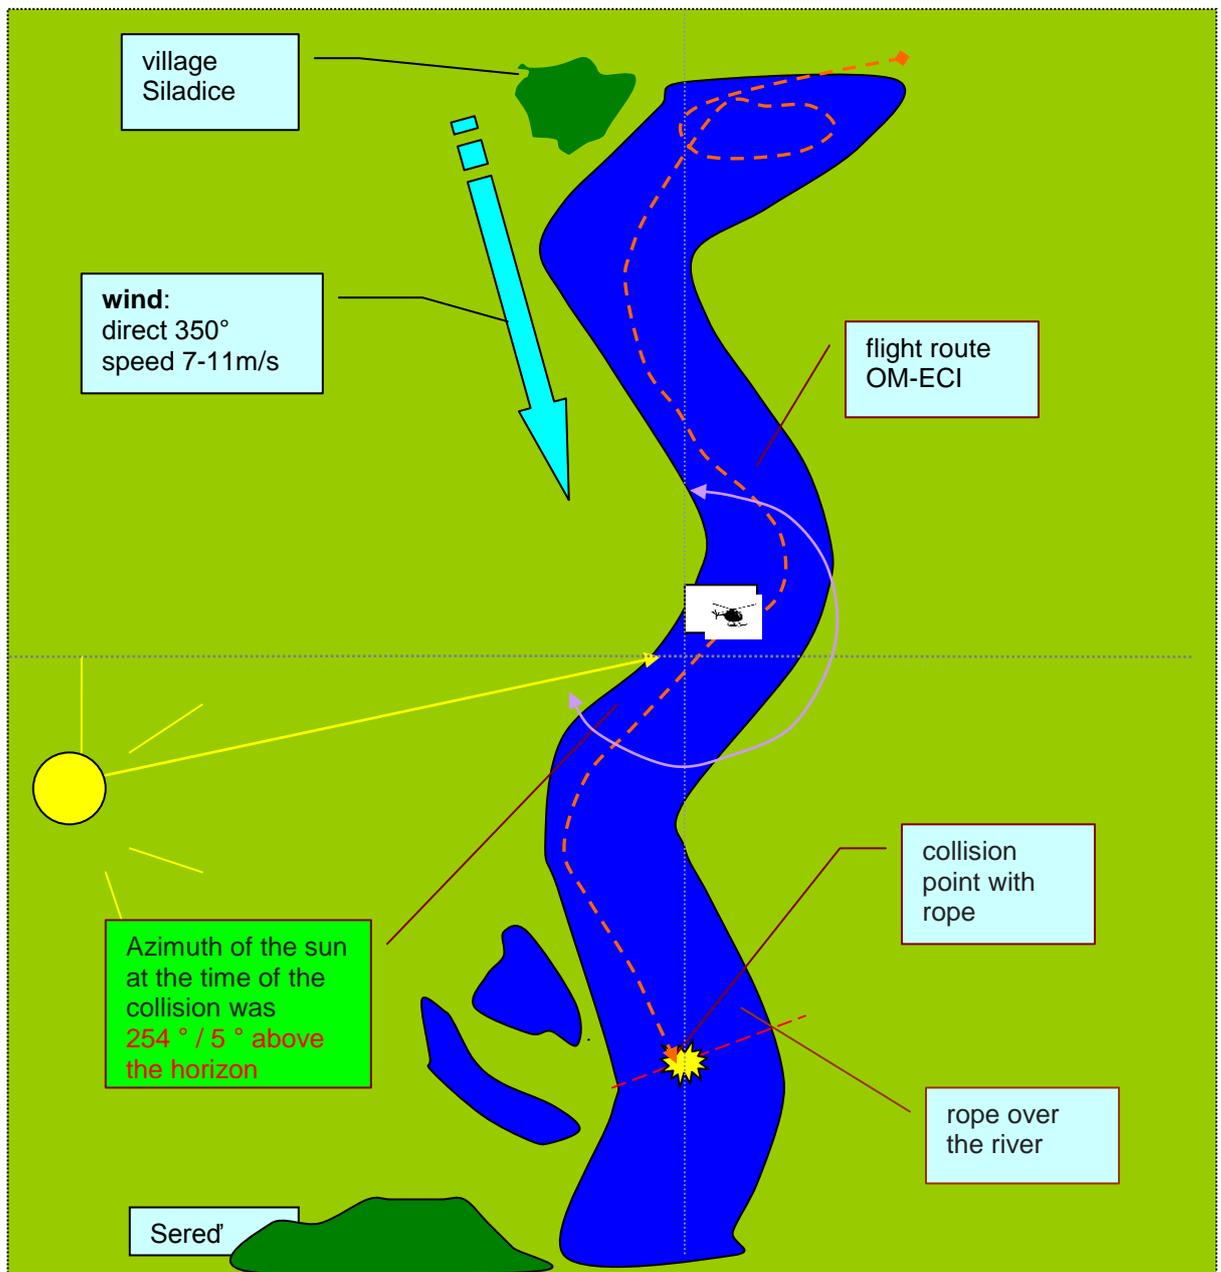
1.18.1 During investigation of accident the inspectors examined the potential effect of setting Sun which at that time was low above the horizon and under certain circumstances could backlight the dashboard. In this case the pilot may have gotten impression that warning lights of CWP went on. The experienced flight instructor, working in the company DSA Hradec Králové, also admitted this possibility in his statement..

At 04:05 PM in Sereď the Sun had an azimuth of 254° and was in a height of 5° above the horizon. The Sun disk could be seen through the thinning clouds on the western to south-western horizon.

Potential effects of the sunshine (see the figure above) on back-lighting of one of the fields of CWP cannot be excluded either. However, in this case these effects would cease after the change of flight course, in view of the trajectory of the flight.

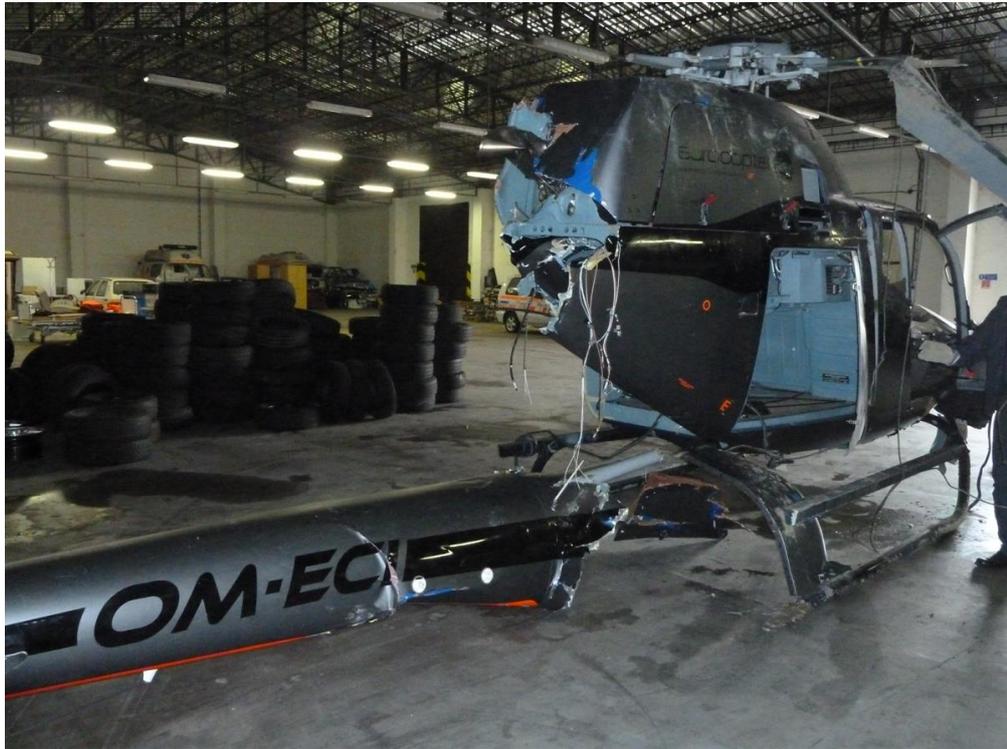
1.18.2 At accidents involving helicopters the tail section is often detached from the fuselage, which causes (if the antenna is installed in the tail section and ELT in the fuselage)

disconnection between ELT and the antenna. Consequently, the signal is not transmitted on a frequency of 121.5 Mhz and the system KOSPAS-SARSAT (*Kosmičeskoje spasenije-Search and Rescue Satellite Aided Tracking*) is unable to locate the place of accident, determine its position and transmit the signal to the control centre and to the ground stations.
