# MINISTRY OF TRANSPORT, CONSTRUCTION AND REGIONAL DEVELOPMENT OF THE SLOVAK REPUBLIC

## FINAL REPORT

on investigation of accident  
of glider type **Standard Libelle 201B**  
registration No. **G-DCMV**

Date: 16.04.2013

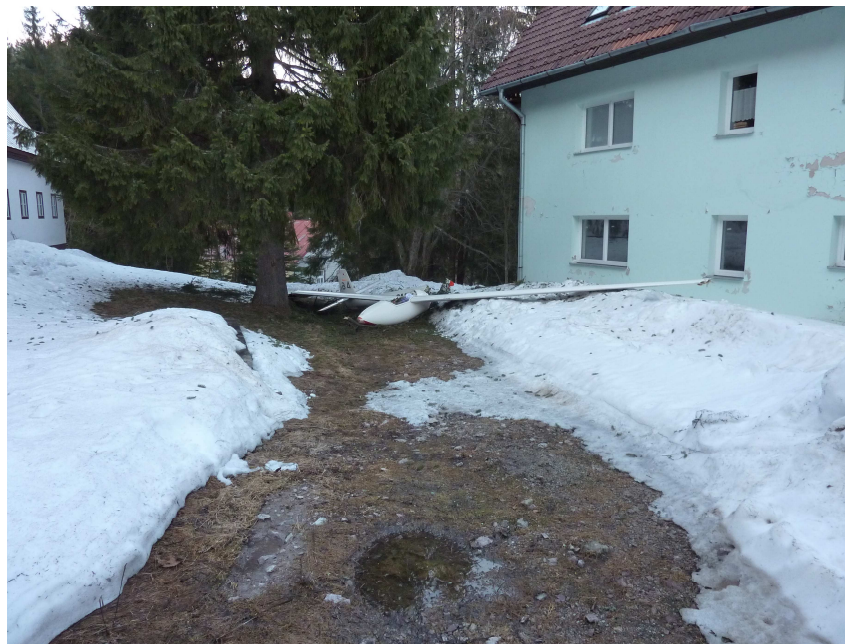
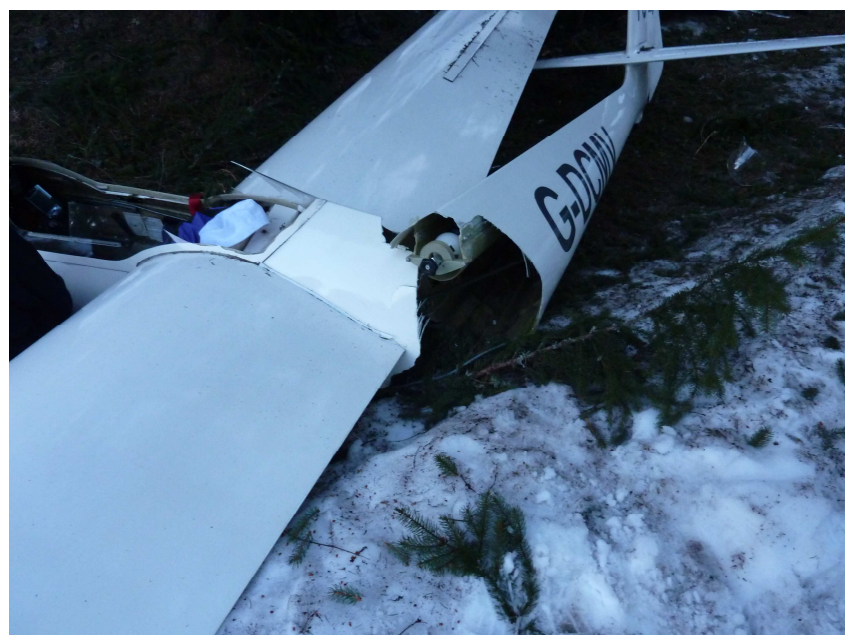
At that moment he saw the roof of residential building “Vila Holubica“ on his left side and a coniferous tree on this right side. In the effort to avoid the building he turned the glider to the right, i.e. to the coniferous tree. The left wing of the glider hit the building roof and the left wingtip arc split off. The glider then touched thick branches of the coniferous tree and fell to the ground. Upon the impact on the ground the cockpit canopy shattered, the fuselage behind the wings got broken and the right wing near the right aileron cracked.

## 1.3 Damage to glider

The glider was destroyed in the accident.

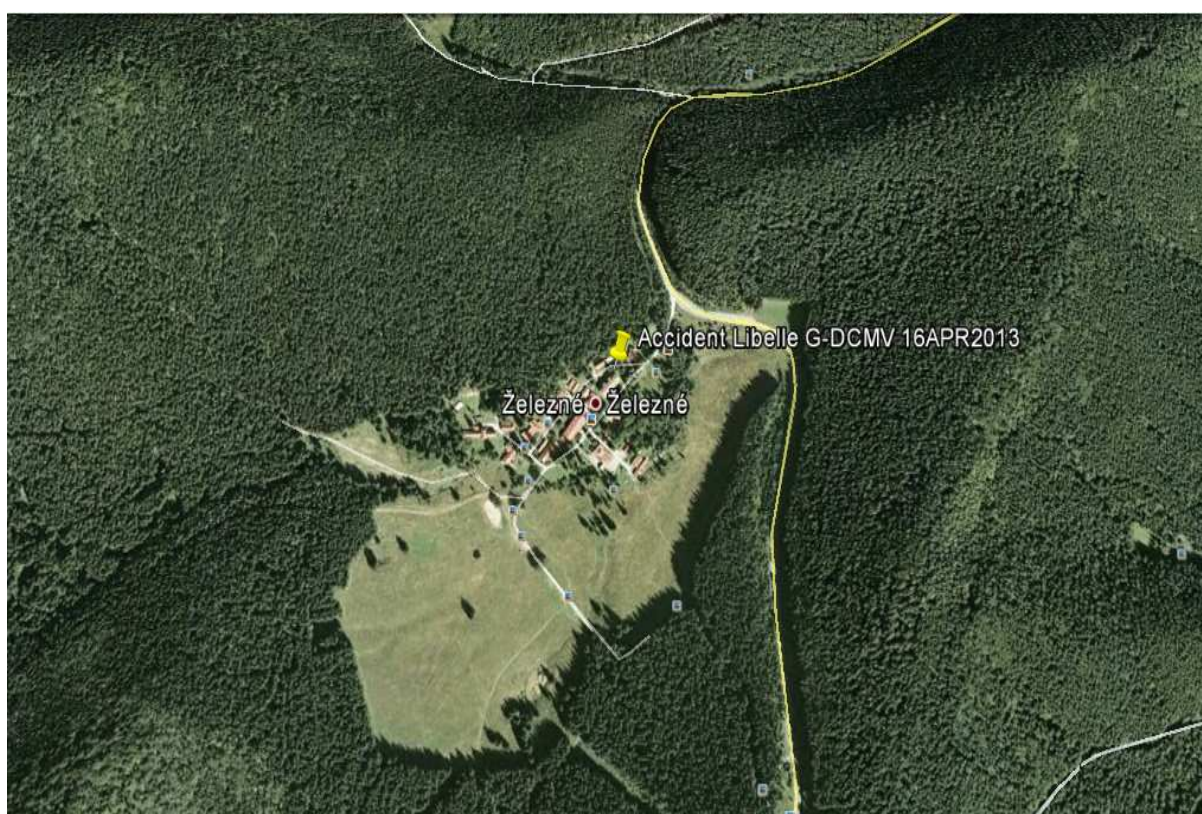
### 1.12 Wreckage and impact information

The place of accident is described by geographic coordinates: N 48°57'15"; E 019°23'37".
