Reg. No. : SKA2013003

FINAL REPORT

on investigation of accident
of glider type **SZD-41A Jantar STD**
registration No. **SP-3071**

Place: Úľanka – football ground

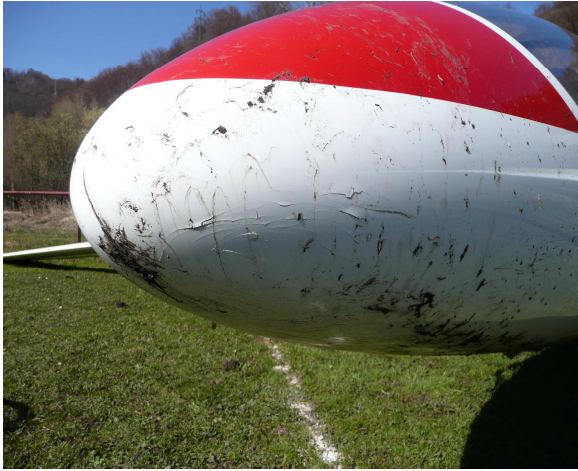
Obr. 1

After landing the front part of the fuselage (fig.1), left windtip arc (fig. 2), left aileron (fig. 3) and tail control surfaces (fig. 4) of the glider were damaged, the rudder wheel (fig. 5) was bursted in and the right side of the fuselage under the right wing (fig. 6) was cracked.
