FINAL REPORT

on investigation of accident of
helicopter type **Dynali H2S**
Registration No. **OM-M959**

Date: 21.04.2013

Place: Landing and take-off area "Trnava – Kopánka" / VPP TK

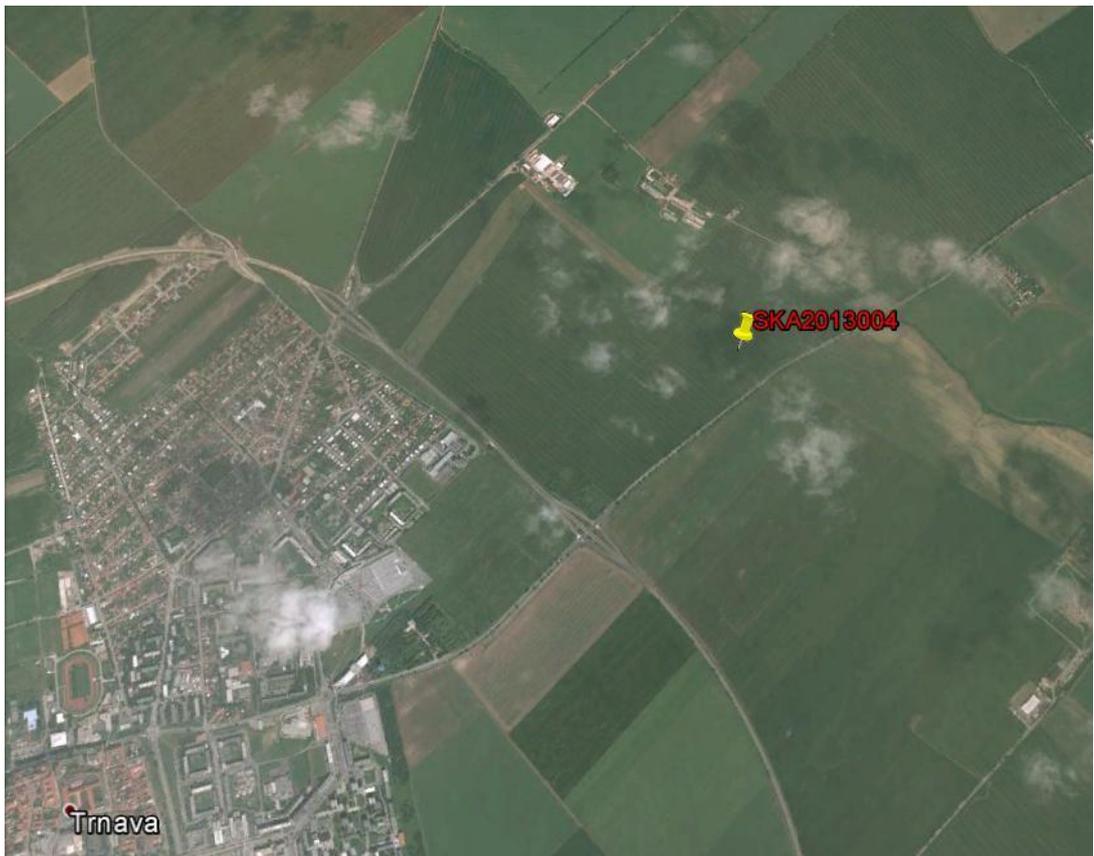
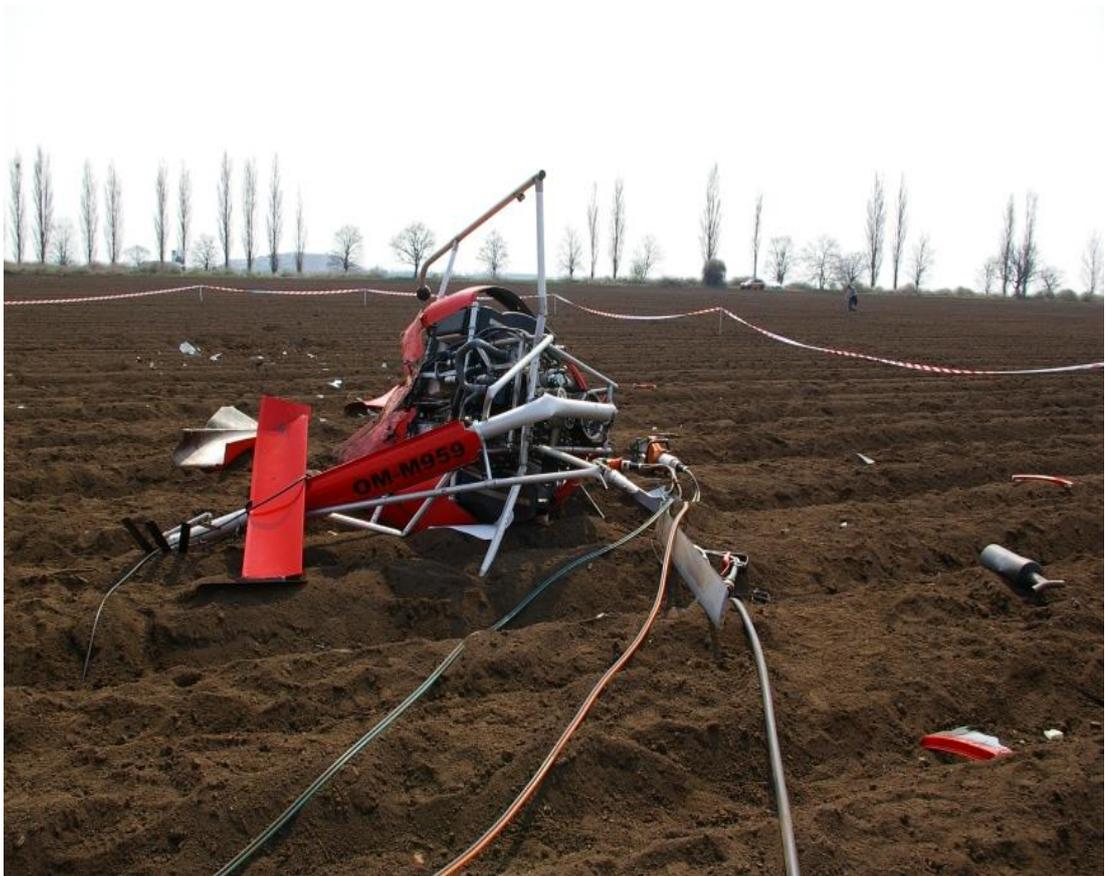
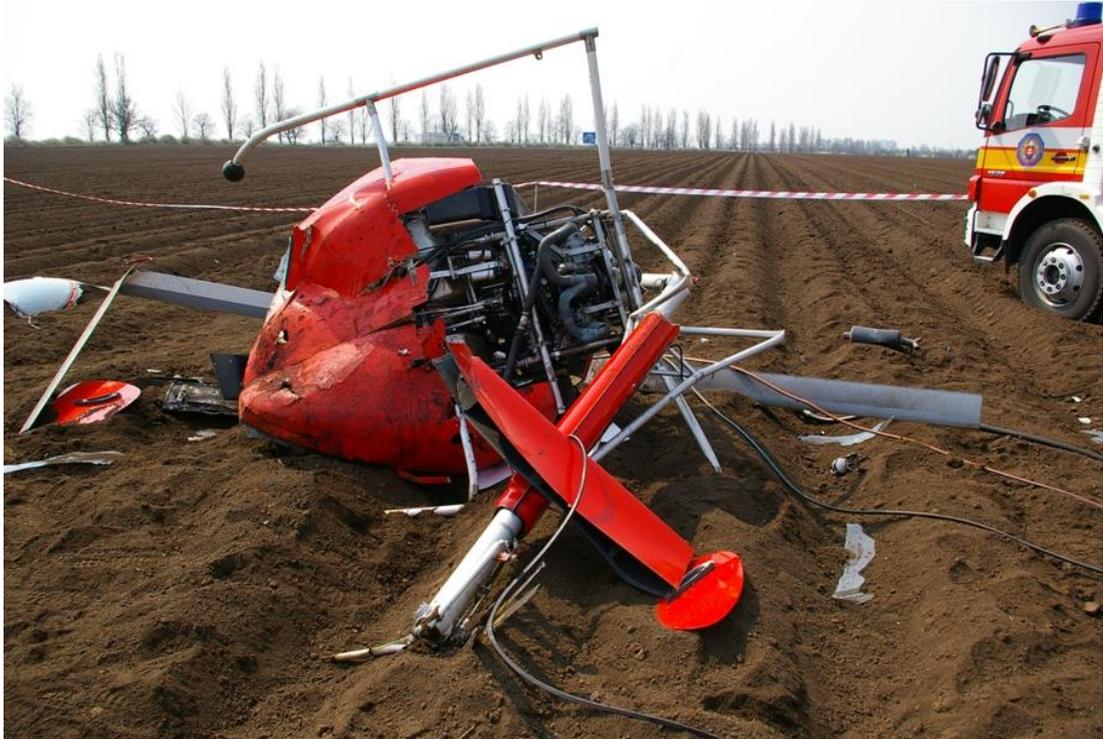
The place of impact of FSV is determined by geographic coordinates:

N 48°23'44''

E 017°37'10''

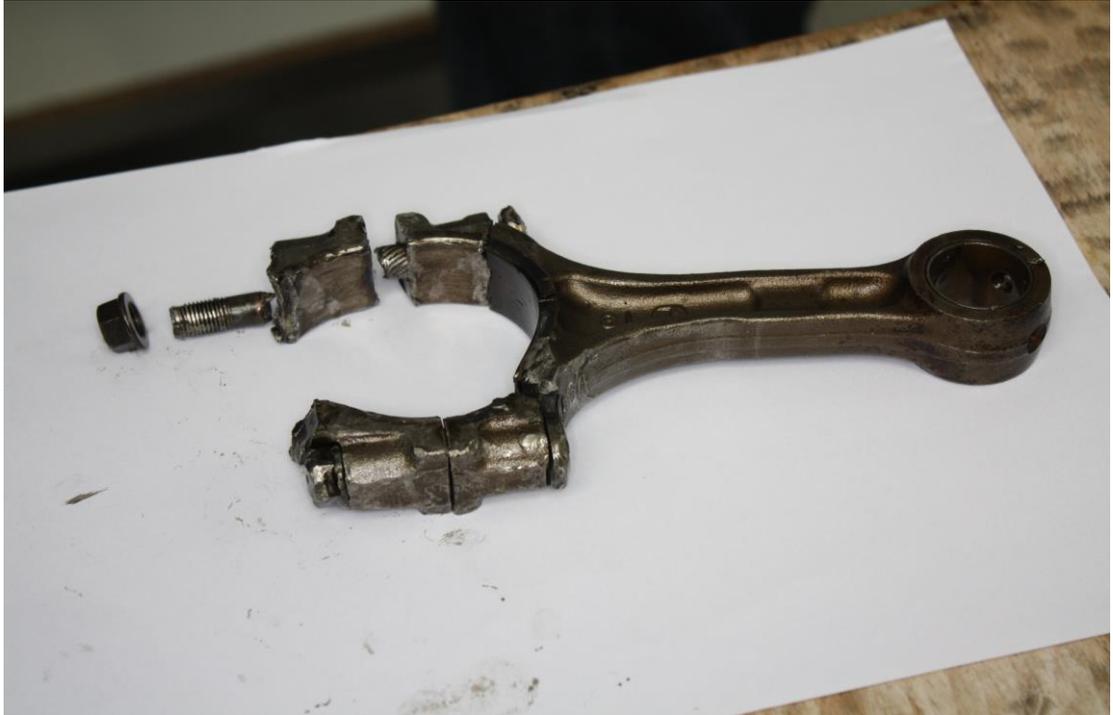
- The **oil** sample taken from the **reductor** confirmed the occurrence of solid particles in oil, visible by naked eye,
- The engine and main reductor were dismantled at the manufacturer of the building kit Dynali Helicopter Company in the presence of a commission member, which proved that during operation the bolt of connecting rod of piston No. 3 gradually became loose, as proved by the visible fatigue rupture on the connecting rod.

After dismantling of the engine the experts detected that the bolt of the connecting rod of piston No. 3 had gradually become loose during operation, which caused the formation of fatigue rupture on this connecting rod, its bending, bump into piston No. 4 and piercing of the engine block. The cause of the bolt becoming loose was most probably its improper tightening by prescribed moment during assembly of the engine in production plant.

- To issue a service bulletin with requirement to check the tightening of bolts on cylinder heads and connecting rods of this series of engines with use of prescribed moment.

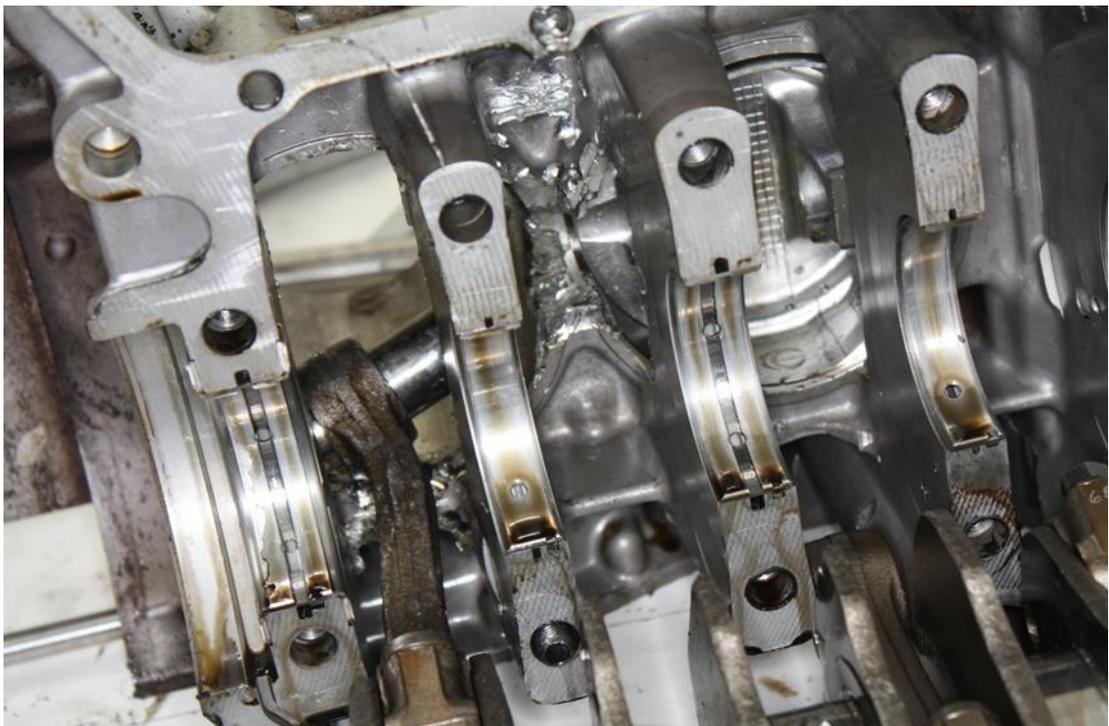
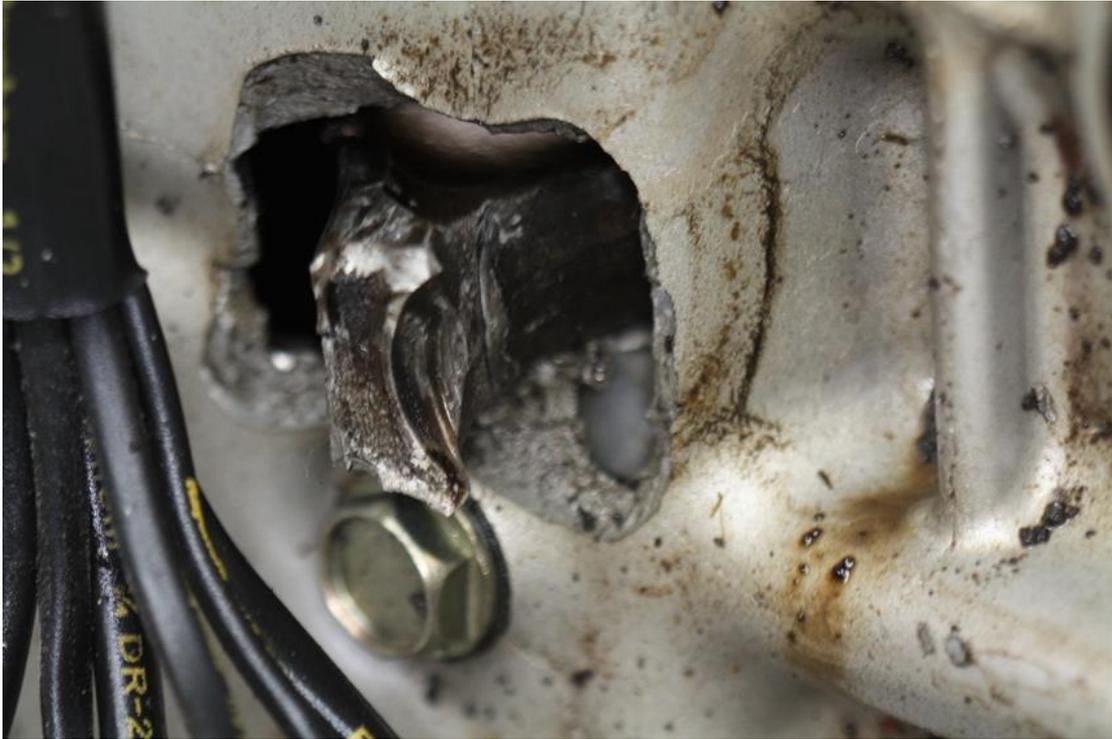
The loose connecting rod bumped into piston No. 4 until it completely destroyed it and pierced the engine block, thus making it unfunctional.

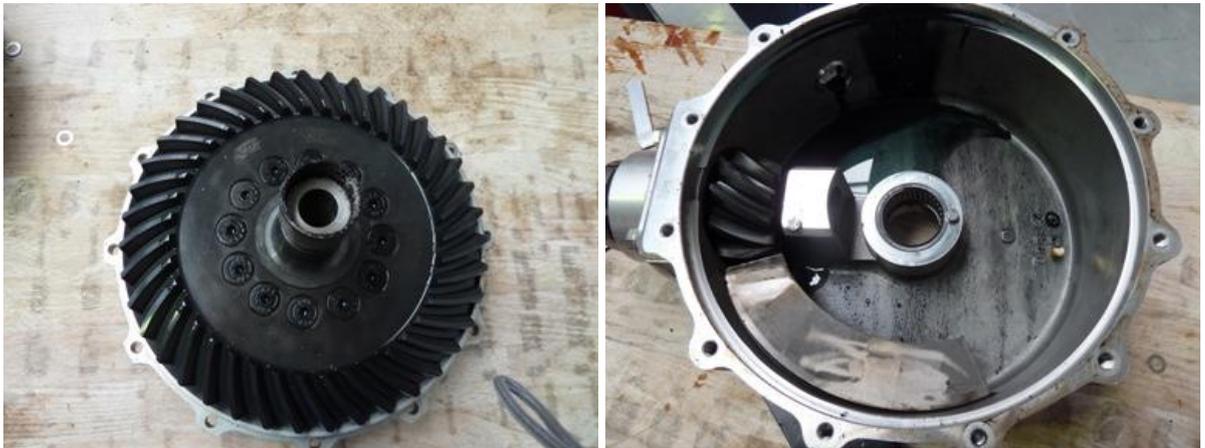
The main rotor transmission gearing did not show any excessive wear, in spite of the collected data on the quality of oil used during operation and metal particles detected in oil. The metal parts found in the detector were within tolerance limits.
