Reg. No.: SKA2013005

FINAL REPORT

on investigation of accident

of aircraft types **Schleicher ASW 27-18E** and **WT-9 Dynamic**
registration No. **D-KJIL** and **OM-DYB**

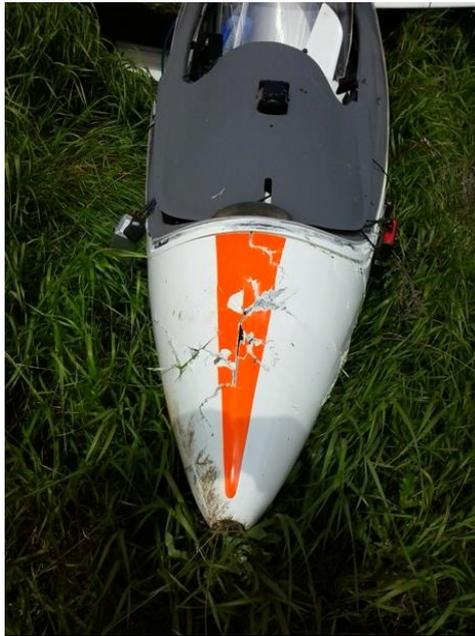
Fig. 1

ASW – after the forced landing the front fuselage was damaged (fig.1) and the left wing, fuselage and tail control surfaces were broken (fig. 2), (fig. 3) and (fig. 4).

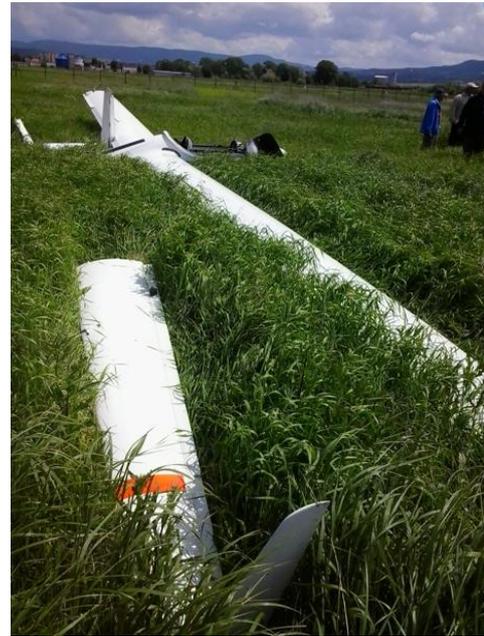
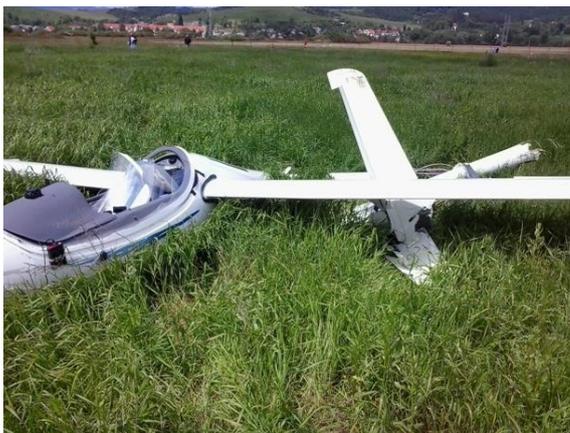
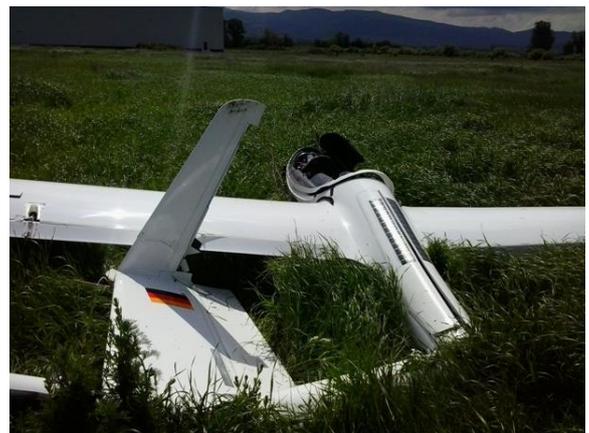
Fig. 2

The pilot of **ASW** observing the abortion of the take-off of WT9 handled the situation under pressure and did not make the landing on remaining RWY 22R in front of him, where he had a sufficient number of suitable surfaces, but instead attempted a landing in the opposite direction with down-wind by making a left-hand turn at a low height, in which he brushed with the left wing against the post of the industrial park enclosure.

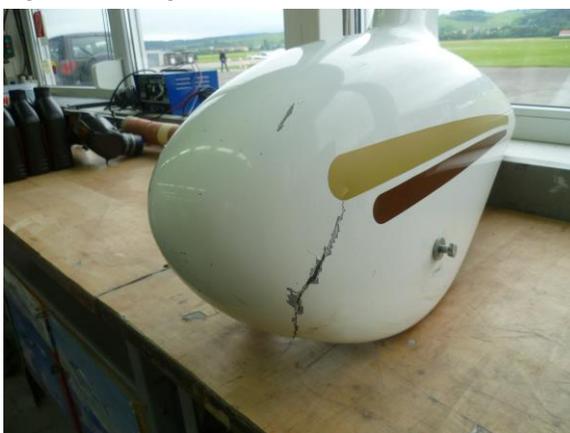
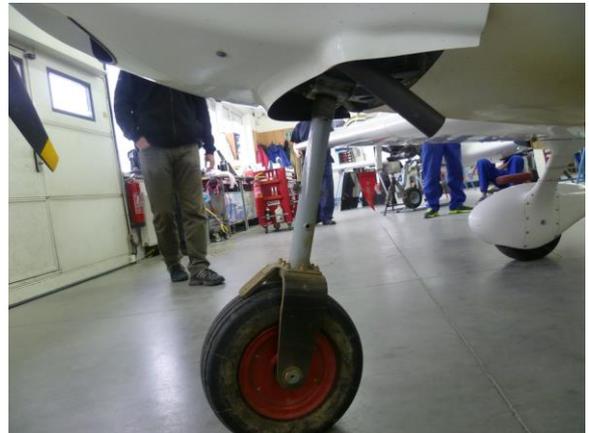
Fig. 5

WT9 – after the bounced landing the front landing gear leg of the aircraft was damaged (fig.5) and (fig 6).

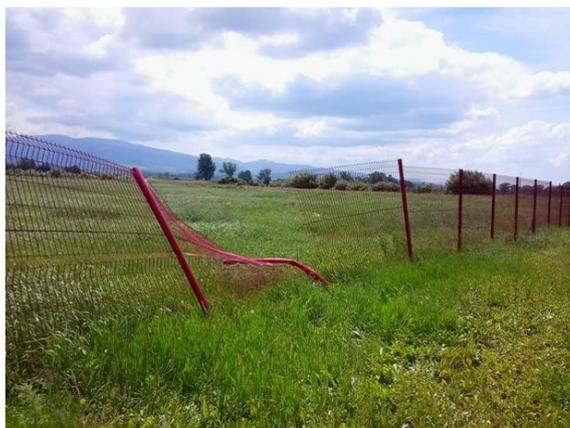
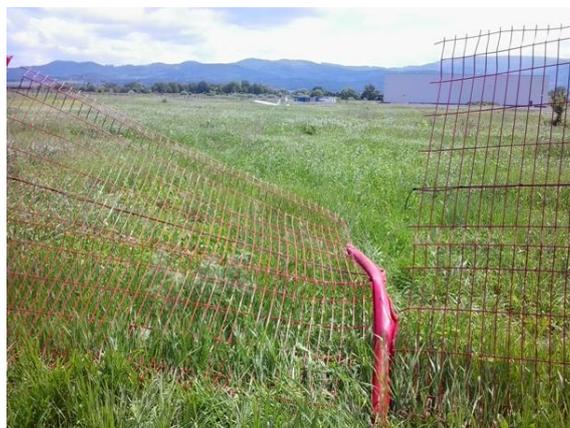
Fig. 7

Damage caused to the industrial park enclosure was notified to the Aviation and Maritime Investigation Authority.

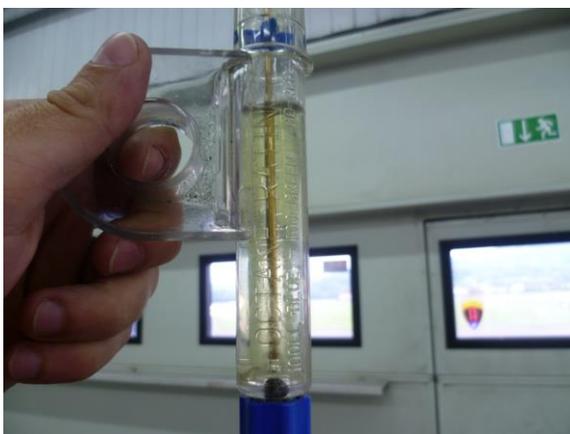
Fig. 9

The WT9 engine was inspected on 28 May 2013. The fuel from fuel tanks was sampled and visually checked for the presence of foreign bodies and water (fig. 9) with negative result. Afterwards both carburettors were removed from the engine (fig. 10) for the purpose of inspection of the float chamber. The right float chamber was without finding (fig. 11). In the left float chamber (fig. 12) was detected the presence of vegetable impurities (fig. 13 and fig. 14). After cleaning of the float chamber the carburettors were mounted back in the WT9 engine. After a thorough check of the fuel installation in the engine bay both carburettors were adjusted and the ground engine test was implemented. During the engine test the engine was running without problems in all modes and showing parameters according to the Operating manual of engine ROTAX 912.

During the inspection of **WT9** engine the fuel from fuel tanks was sampled and visually checked for the presence of foreign bodies and water with negative result.

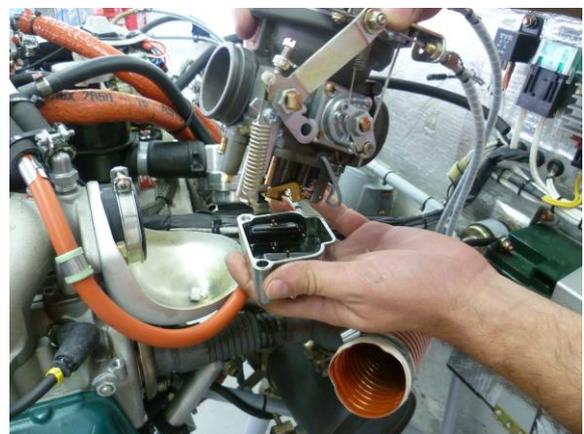
Fig. 10

During the check of carburettors the potential risk of penetration of impurity into the float chamber from the carburettor drip tray through the airbox overflow hose and the float chamber vent hose was detected because they were connected to the same overflow hose. The penetration of impurity could cause an irregular engine run or a drop of its power.

During the analysis of engine carburetors vegetable impurities were detected in the left float chamber, which probably caused the drop of engine power during the take-off.

- the drop of power of WT9 engine was probably caused by the presence of vegetable impurities in the left-hand float chamber with subsequent abortion of the take-off and release of the towed aircraft,
- mishandling of the emergency and poor mastering of flying technique by the pilot of glider during the aborted take-off in the phase of acceleration after unstick.

- issued BINDING TECHNICAL BULLETIN No. ZBWT9 18A / 2013 for all aircraft equipped by airbox up to the serial No. DY-470/2013 (inclusive), with the exception of aircraft with the following serial numbers:

to prevent the penetration of impurities from the carburettor drip tray into the float chamber through the airbox overflow hose and the float chamber vent hose during the connection of overflows/vents of the airbox and carburettor.

- introduced in its internal fuel filter replacement procedures measures to prevent the penetration of impurities into the fuel system.
