Reg. No: SKA2013006

FINAL REPORT

on investigation of air accident
of flying sport vehicle / FSV
type **Fides 2 Evo M-Sky** paragliders
Registration No. **OM-P097**

Date: 12.06.2013

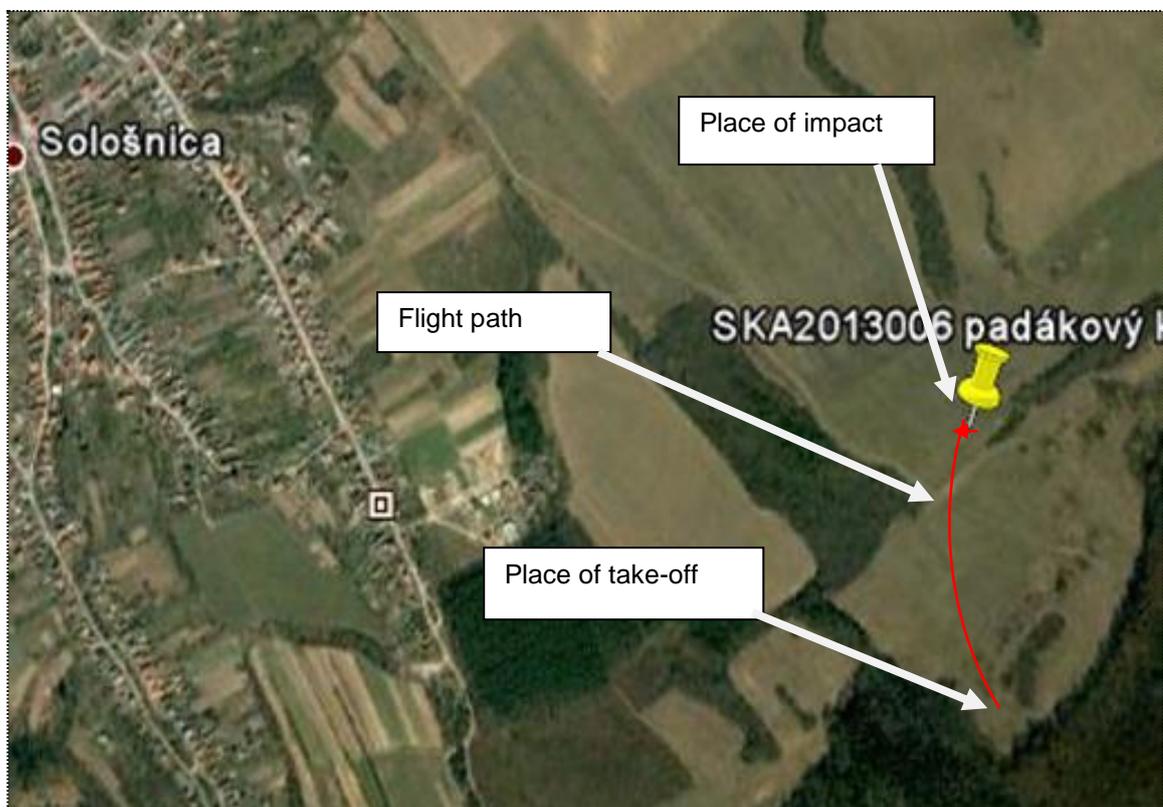
1.12 Wreckage and impact information

Place of impact of the pilot: meadow, approximately 650 m away from the eastern margin of the community Sološnica.
