# MINISTRY OF TRANSPORT, CONSTRUCTION AND REGIONAL DEVELOPMENT OF THE SLOVAK REPUBLIC

Reg. No.: SKA2013007

## FINAL REPORT

on investigation of accident of  
sport flying device / SFD  
type FITI 128  
Registration No. **OK-NZR02**

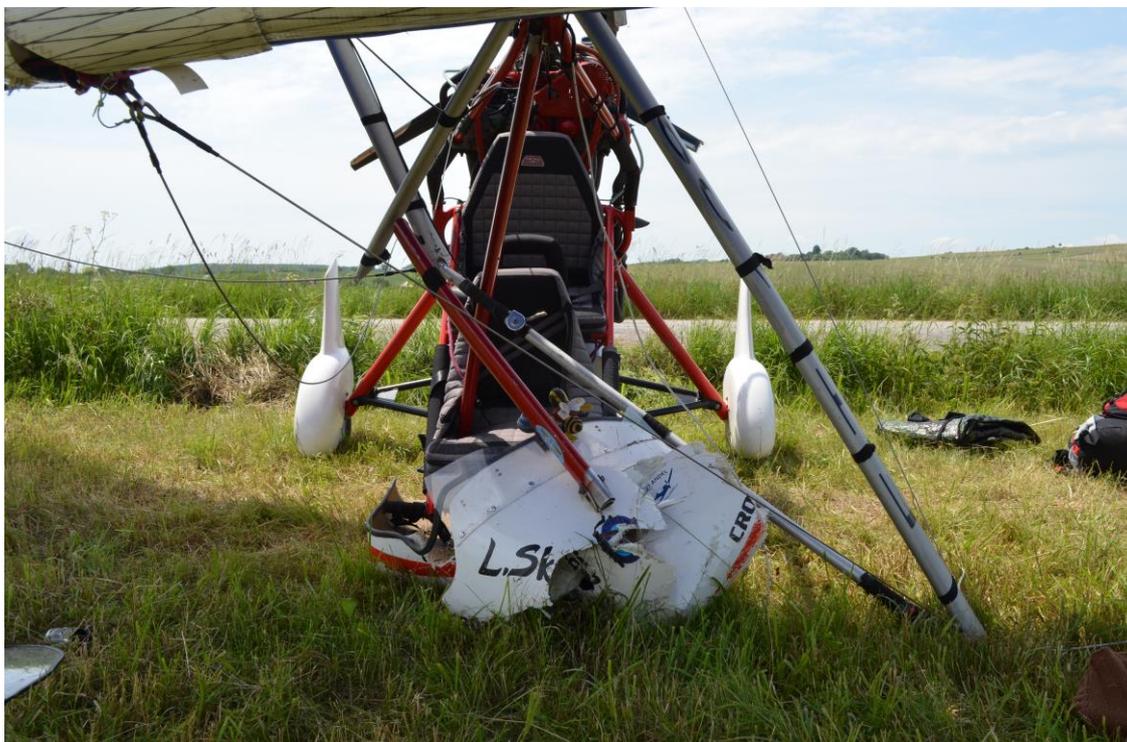
## 1.3 Damage to PPG

PPG suffered a serious damage.

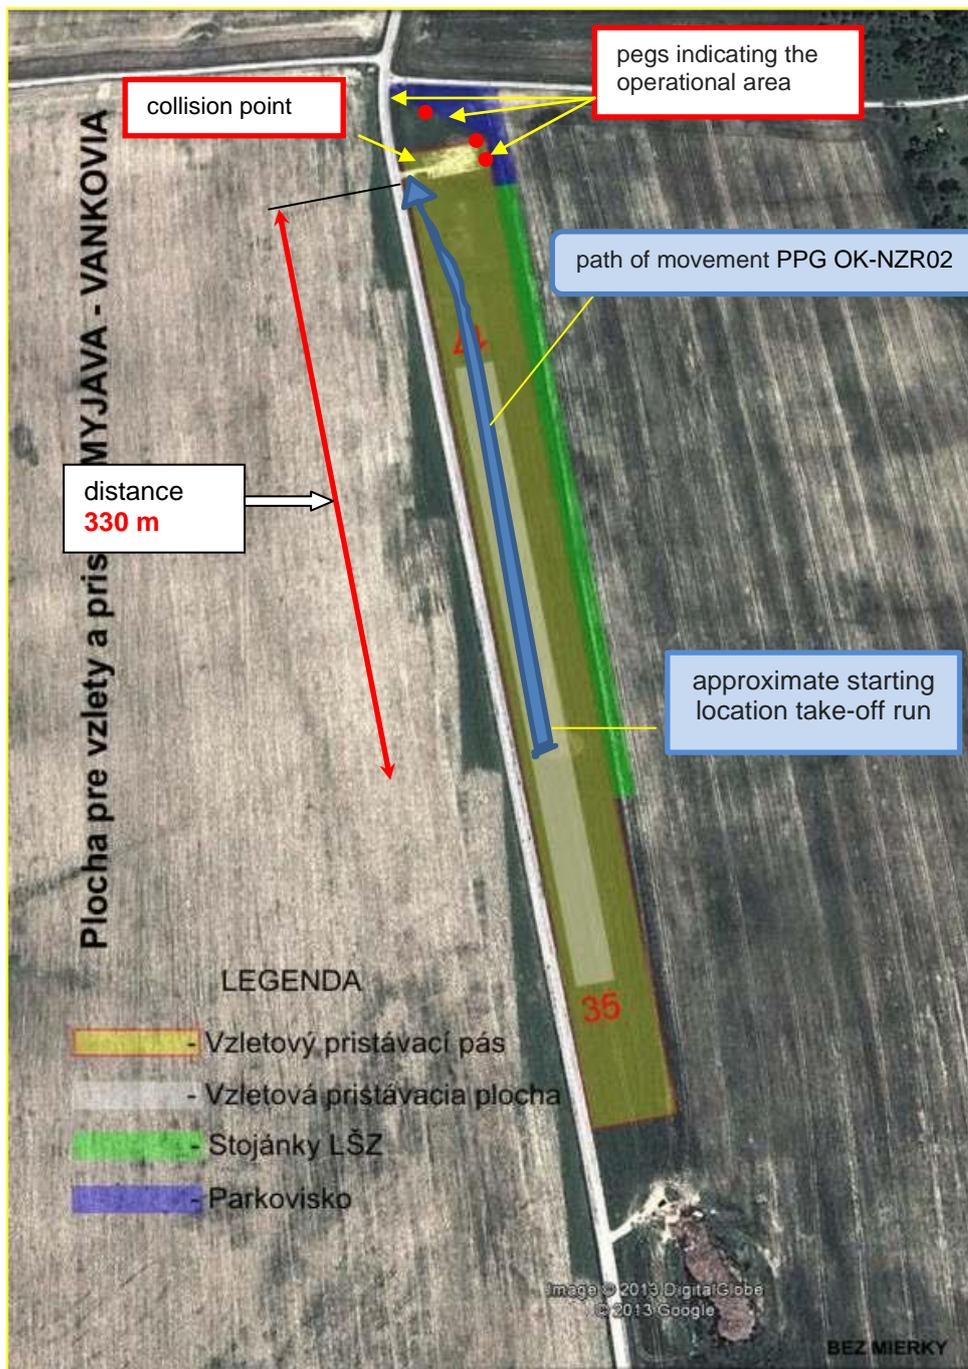
Rough sketch of movements of PPG and its collision with the person

The runway was marked by white tissue stripes and the clearway in its extension was marked by wooden pegs. The injured person stayed in the prolonged axis of the runway in the marked territory during the accident, i.e. from the viewpoint of flight operation safety this person stayed in the unauthorized area.

Based on data in the report on flight tests of the affected PPG, the pilot was supposed to reach the minimum height of 15 m after coverage of approximate distance of 100 m from the point of ground roll. If the pilot reached the minimum height at this point the collision of the person with the landing gear of PPG would not occur and the pilot of PPG would miss this person with sufficient height spacing in spite of the fact that he did not use the whole length of the runway for the take-off.

- when organizing events similar to this one to put more stress on prevention of access of unauthorized persons and occurrence of obstacles in the operating areas.

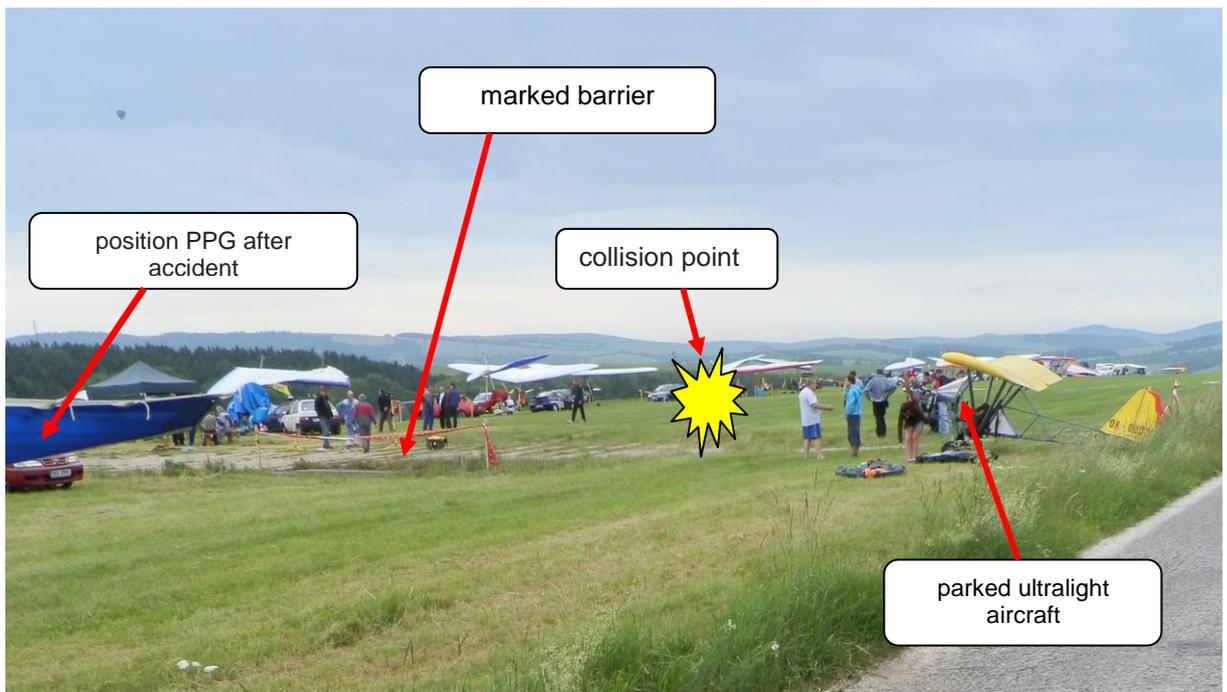
Approximate situation at the point of collision at the time of accident

As for the obstacles situated in the area of collision, it was only by chance that PPG hit the present person instead of the ultralight aircraft parked in the area marked as operating areas, which the injured person was inspecting at that time, or the pegs with tape marking the obstacle.

- the cause of the accident was the collision of PPG with the person situated in the prolonged axis of the take-off of PPG in the area marked as operating areas.
- mishandling of the flying technique during the take-off by the pilot of PPG.
- presence of a person in the unauthorized area.
