Reg. No.: SKA2013009

FINAL REPORT

on investigation of air accident
of glider type **VSO-10 Gradient**
Registration No. **OM-5611**

Date: 03.07.2013

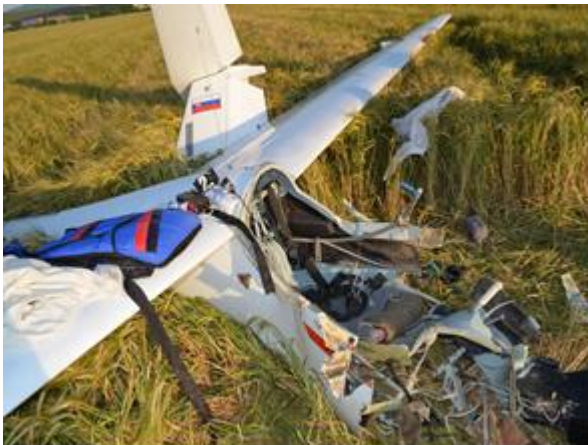
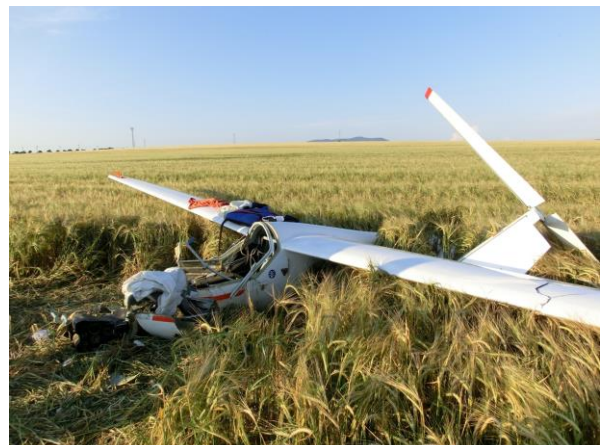
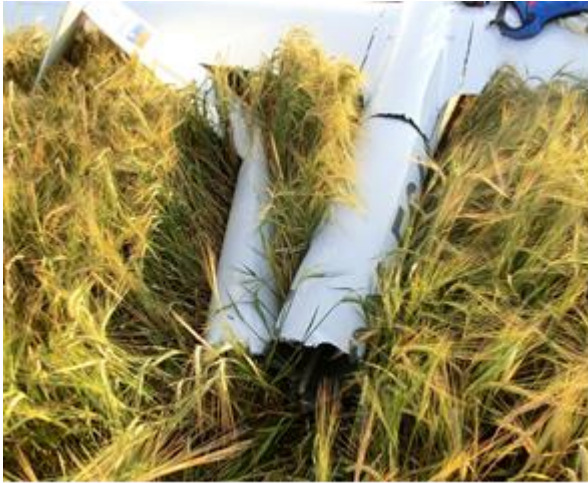
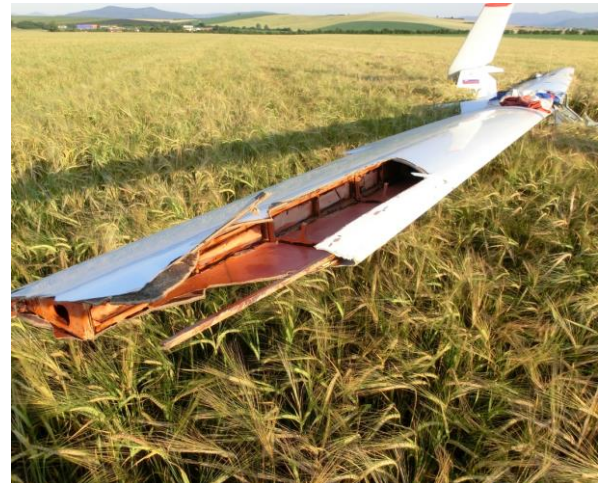
The glider VSO was destroyed in the air accident – the fuselage front section was fully destroyed, the fuselage got broken and wingtips were damaged.

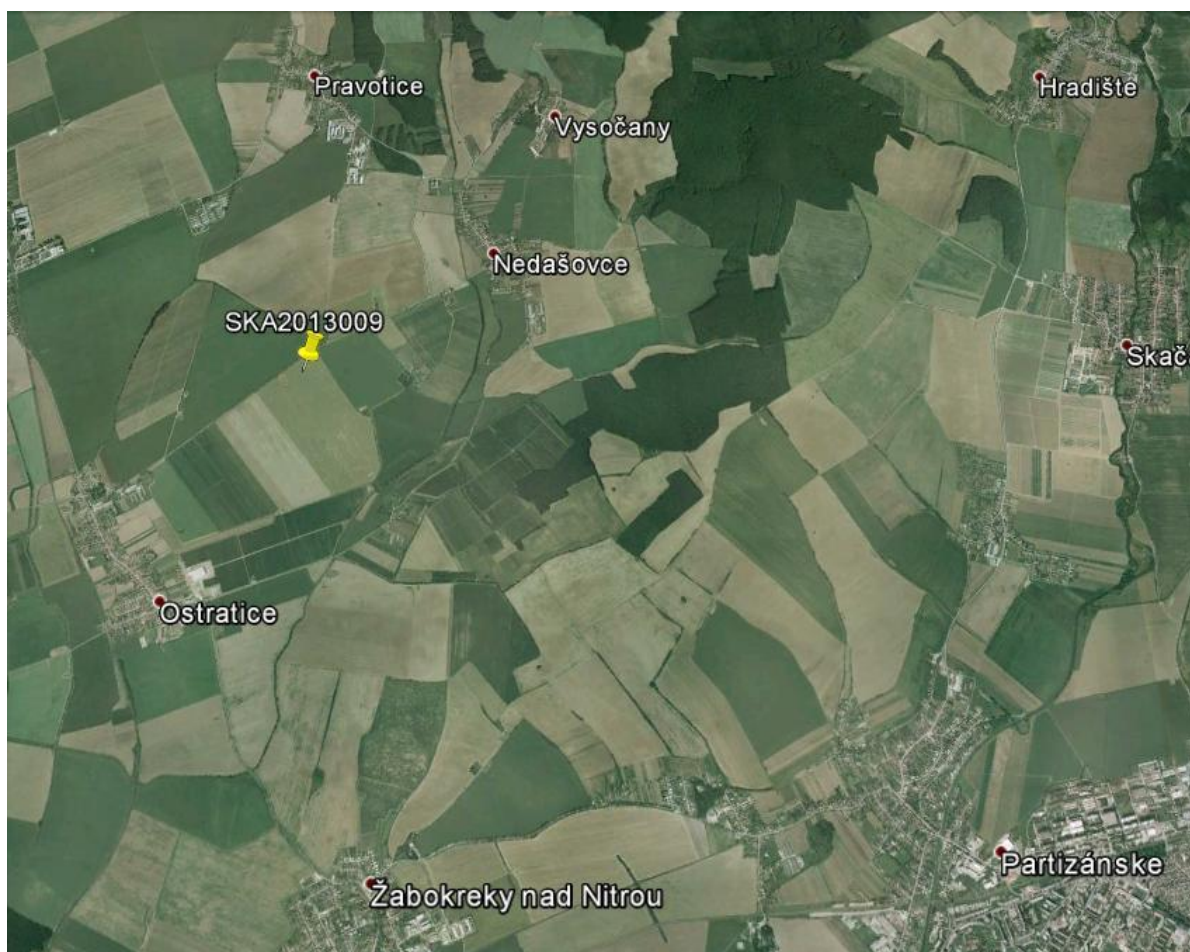
VSO landed on even ground without major obstacles.

The place of air accident is determined by geographic coordinates:

N 48° 39' 36'' E 018° 17' 37''.
