Reg. No. : SKS2013001

## FINAL REPORT

on investigation of serious incident  
of aircrafts **WT-9 Dynamic** and **Z-37-2**  
Registration No. **OM-PDB** and **OM-YJG**

Date: 19.04.2013

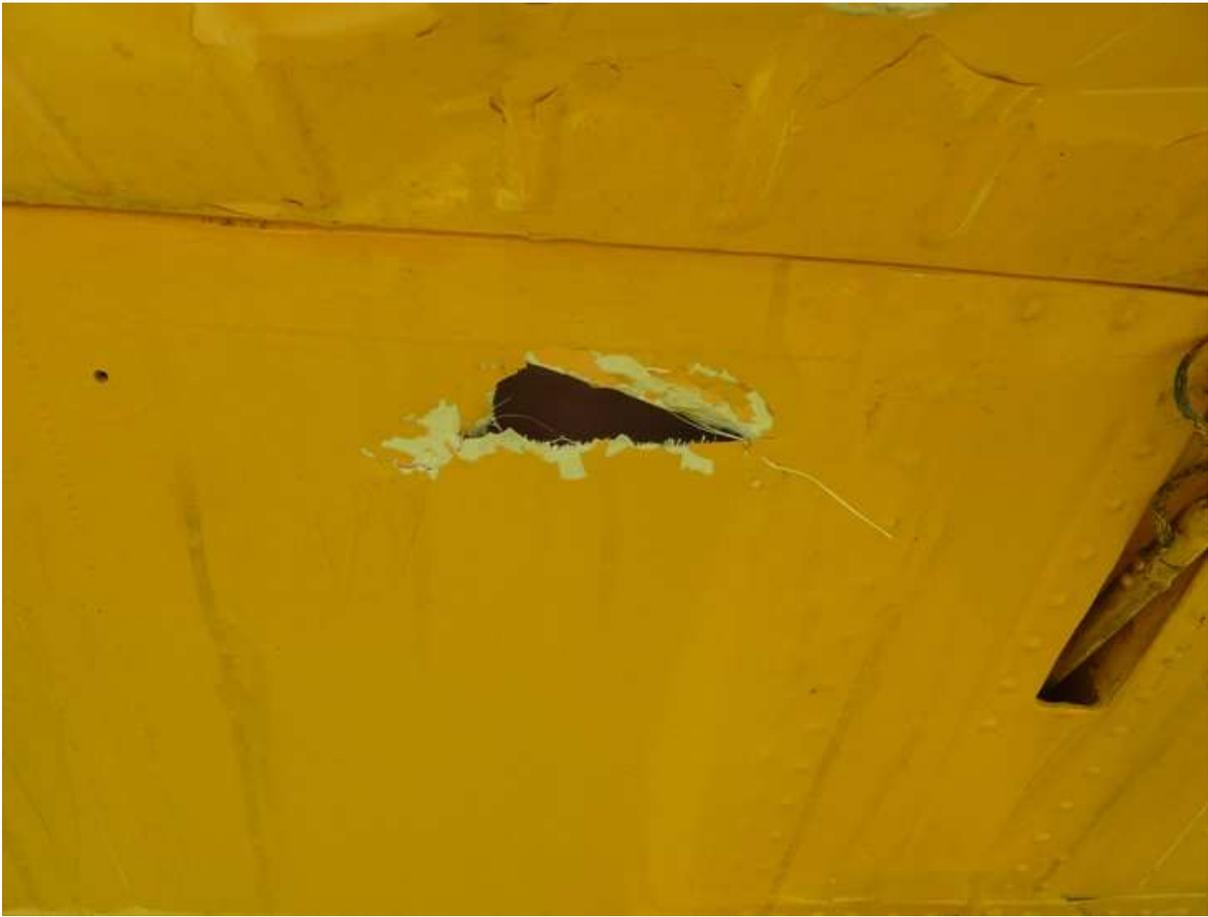
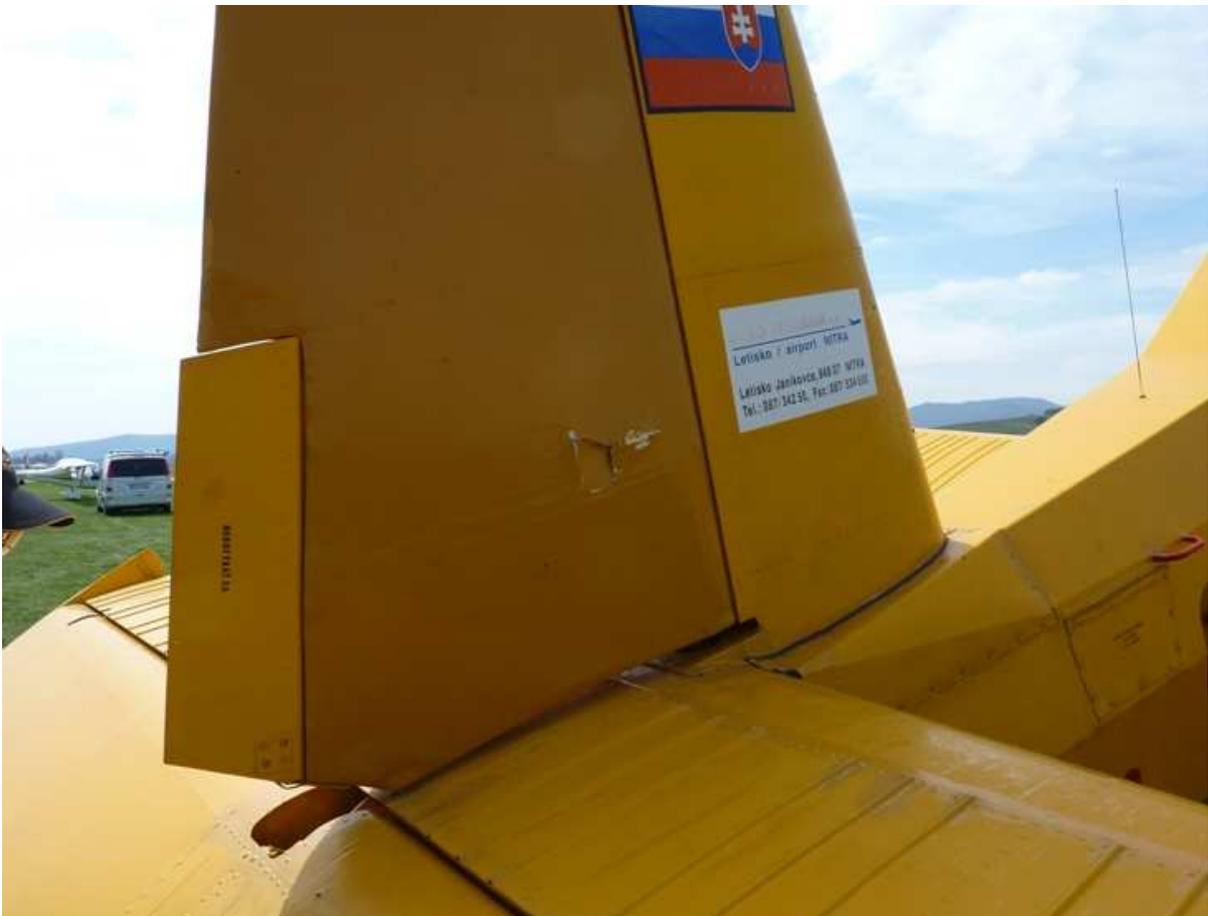
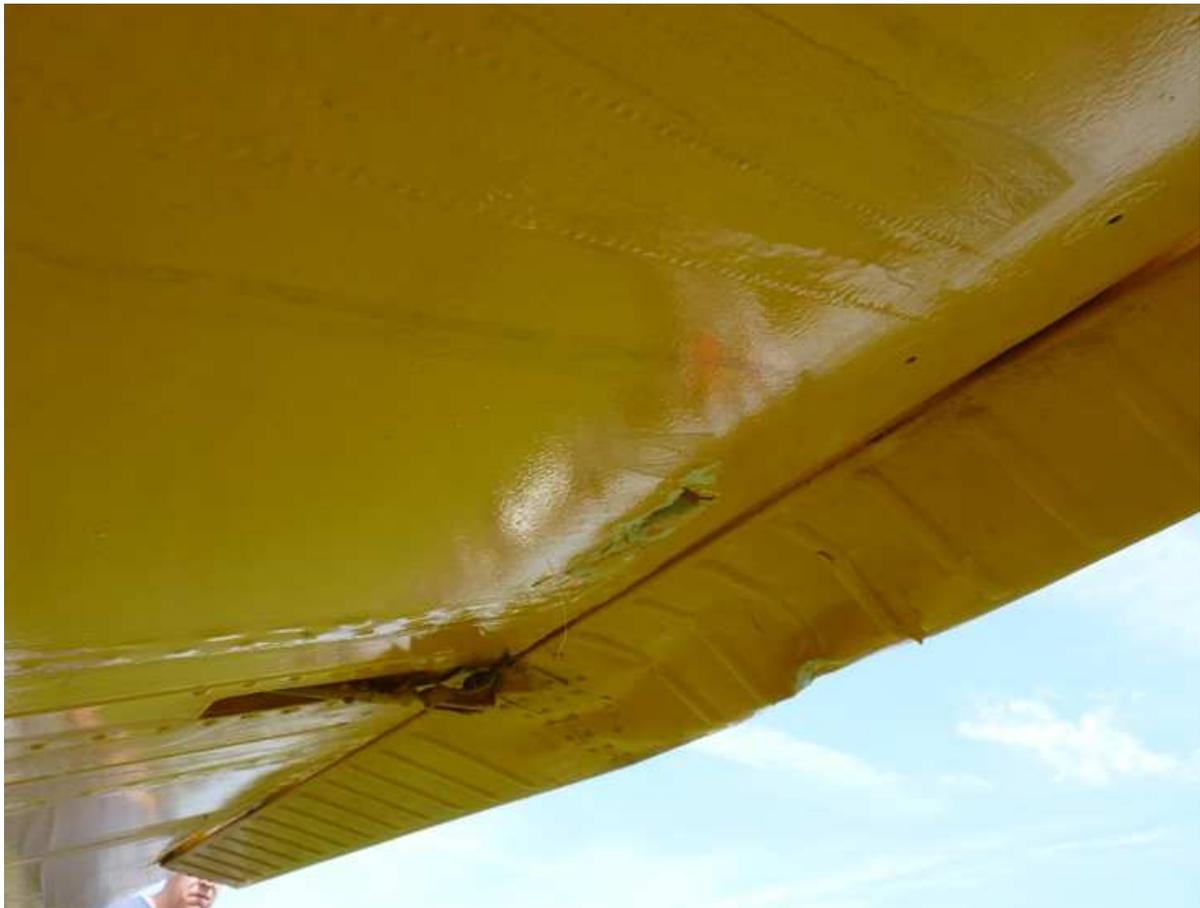
The released rope fell over the rear section of aircraft Z-37-2 Čmelák, partially twined around its rear fuselage and elevator and damaged its trimming tab.

Aircraft Z-37-2 Čmelák suffered the following damage:

- puncturing of elevator cover on both sides,
- puncturing of elevator cover in its upper left section,
- slight deformation of trailing edge of the elevator trimming tab,
- breaking-off of elevator trim-tab rod.

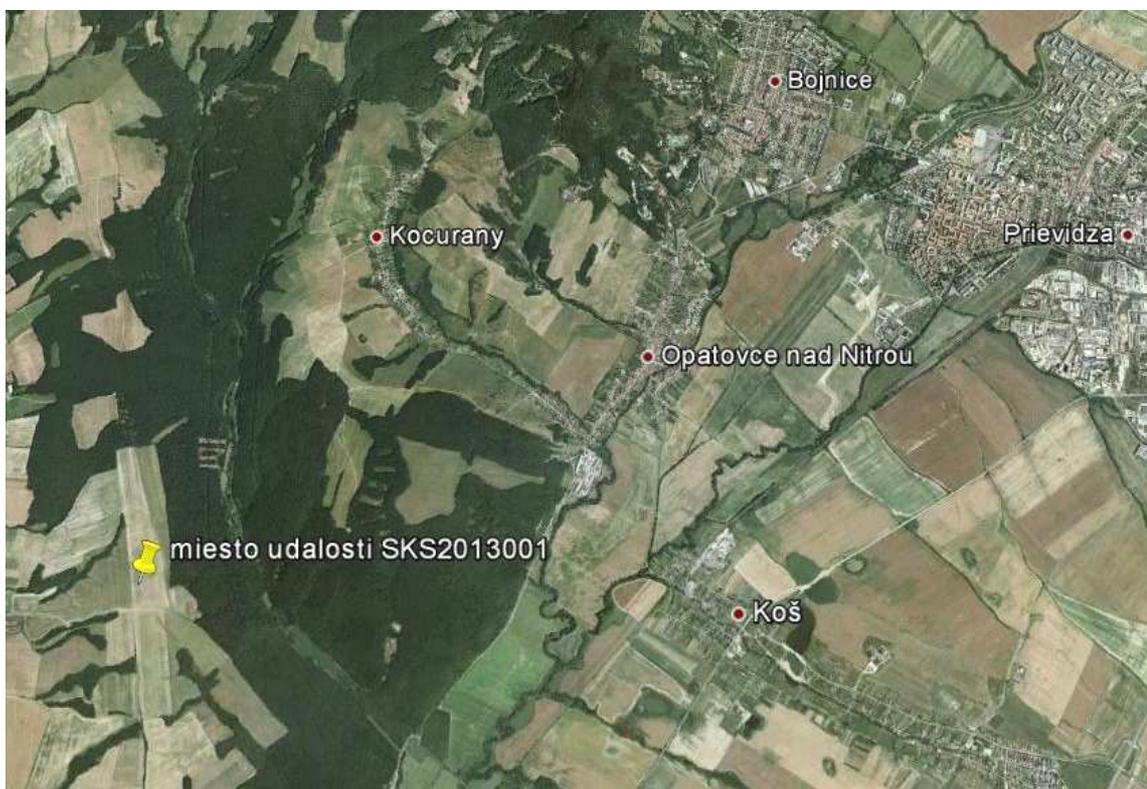
The place of collision of the aircraft with the rope is described by geographic coordinates:

N 48°45'03'',

E 018°31'15''

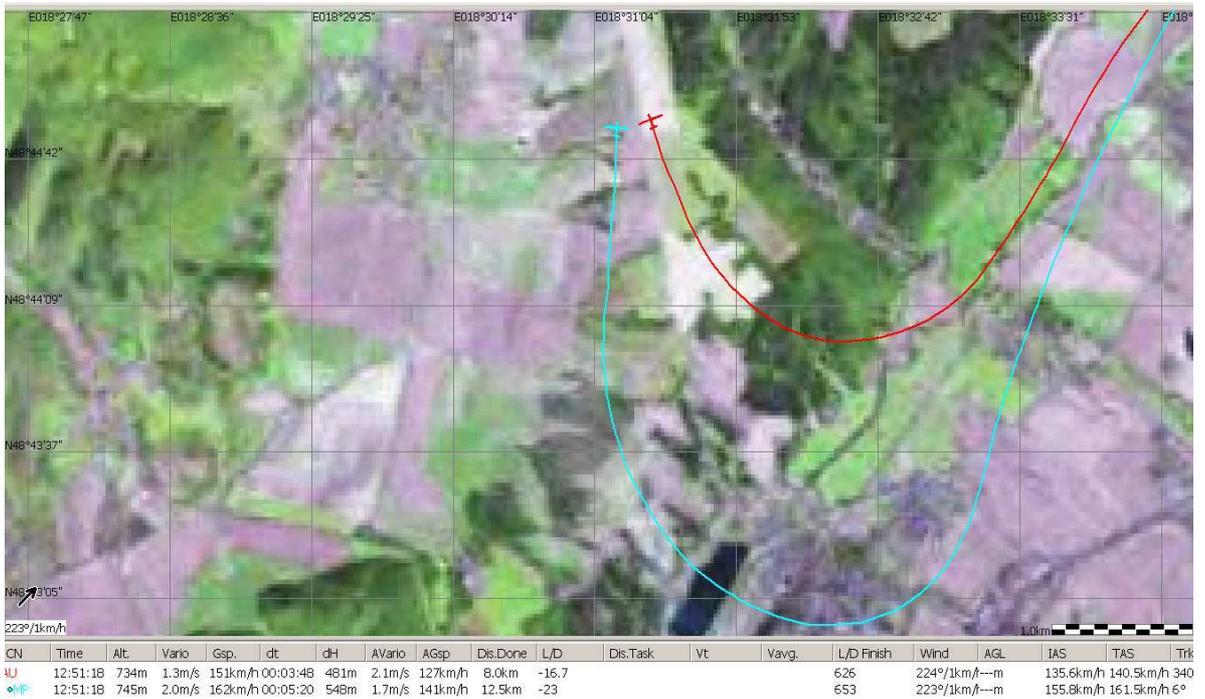
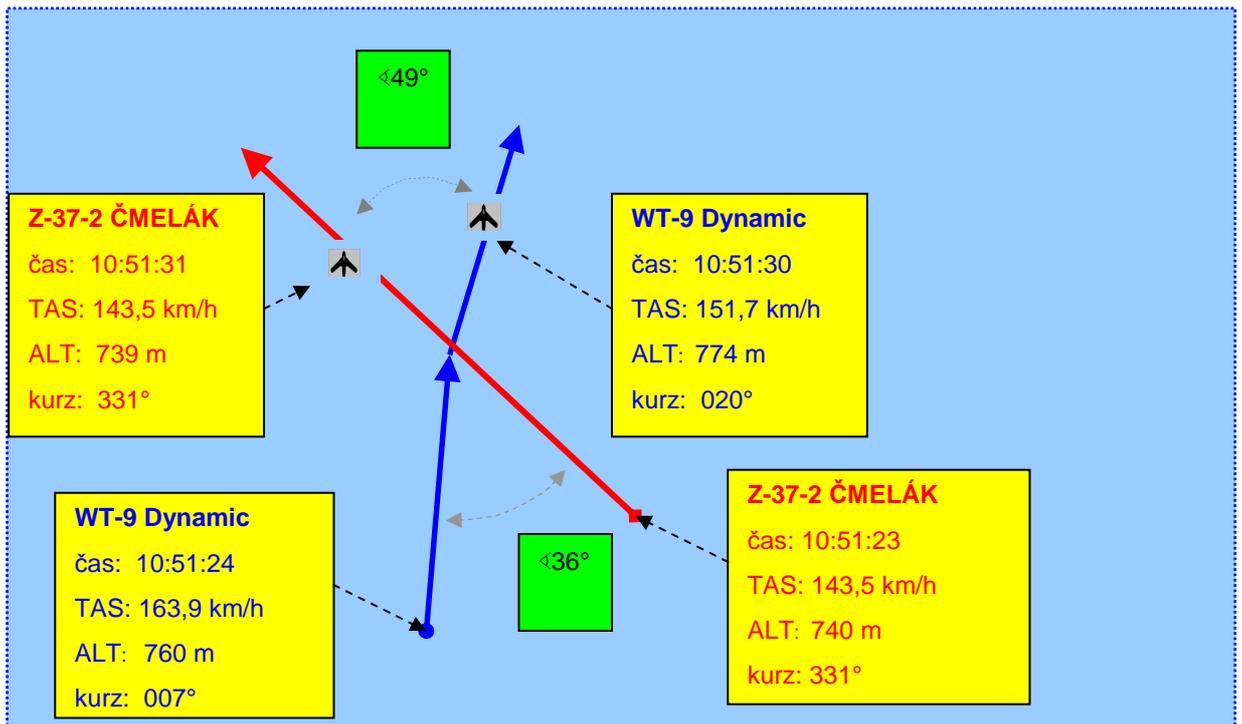
The data used in the table and graph were obtained from recorders of the towed gliders through the programme "SEE YOU".

From data shown in the table and figures in paragraph 1.18 it can be concluded that overtaking aircraft was aircraft WT-9 Dynamic, which flew with a higher speed and was approaching the aircraft Z-37-2 Čmelák from the left side and with elevation.

The overtaken aircraft was aircraft Z-37-2 Čmelák, which flew with a lower speed. The flight paths of both aircraft at the time of crossing formed an angle of 36°-49° (according to the record from devices installed onboard the towed aircraft).
