FINAL REPORT

on investigation of serious incident
of aircraft type **PS-28 Cruiser**
Registration No.**OM - SCA**

Date: 26.05.2013

Place: Airport Očová / LZOC

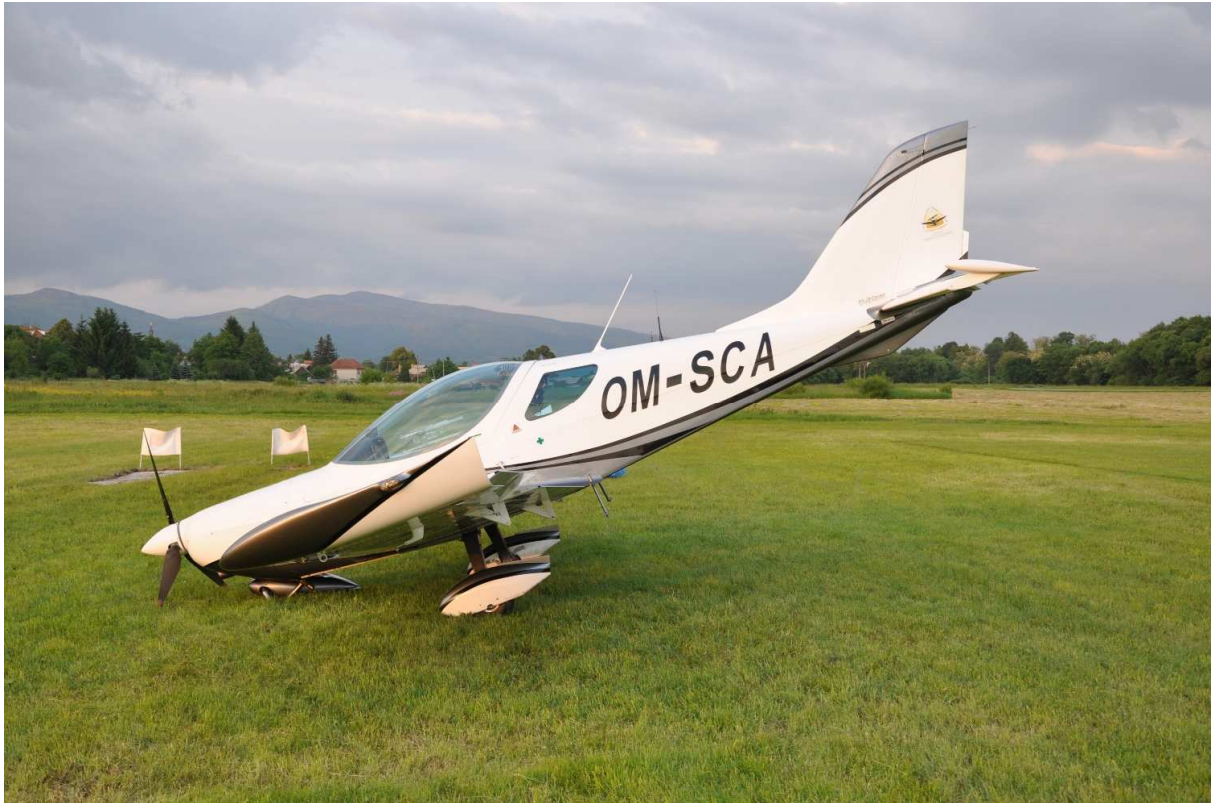
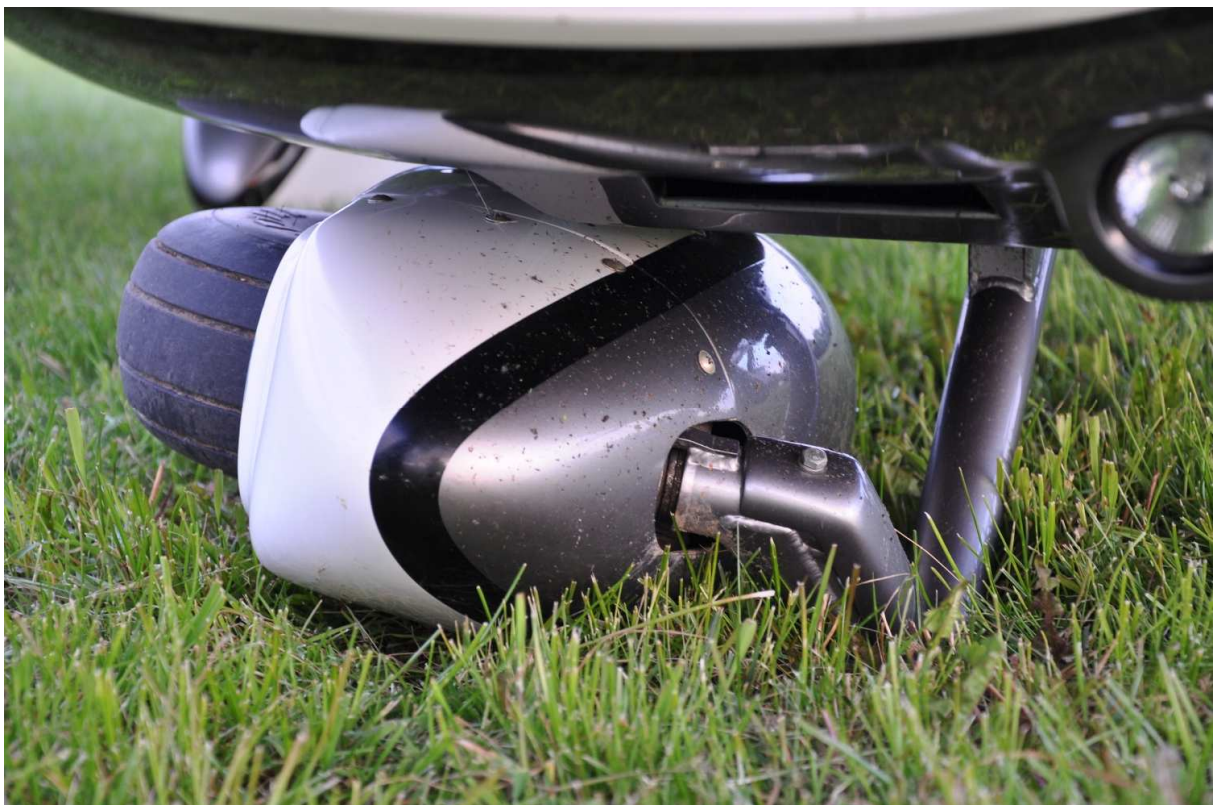
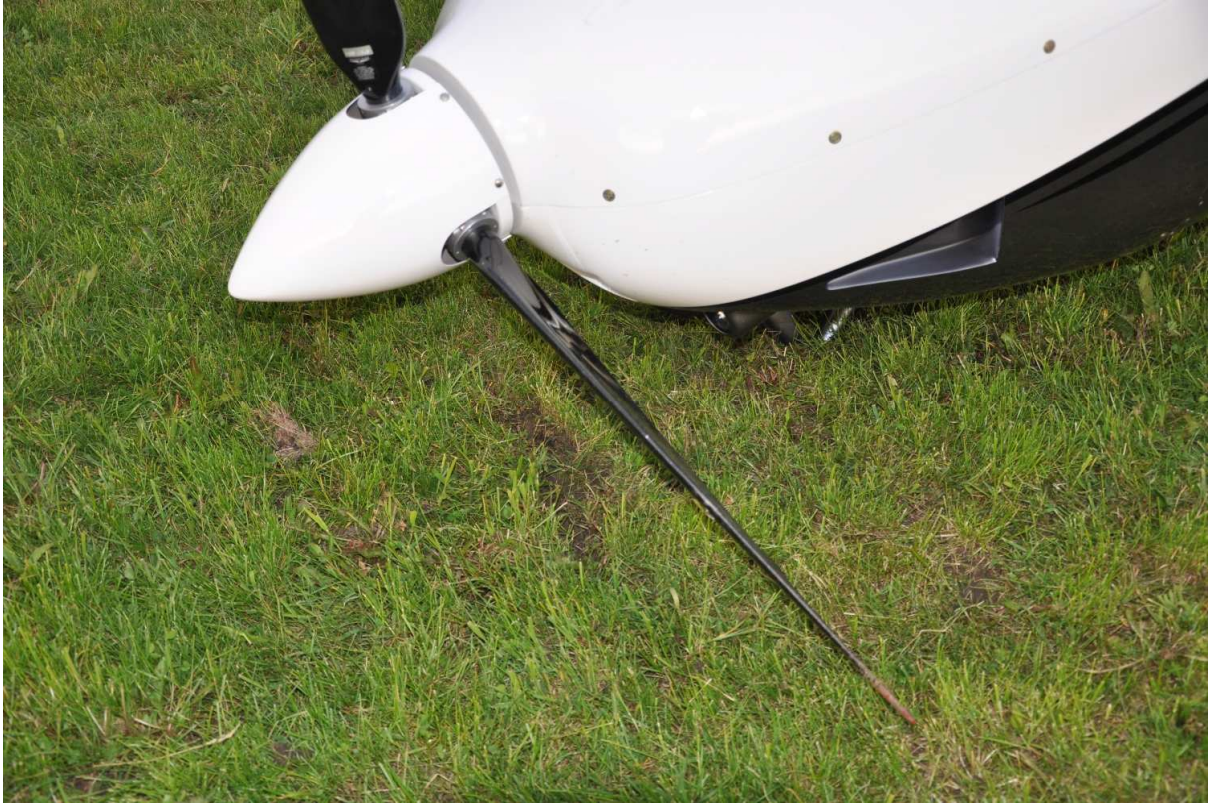
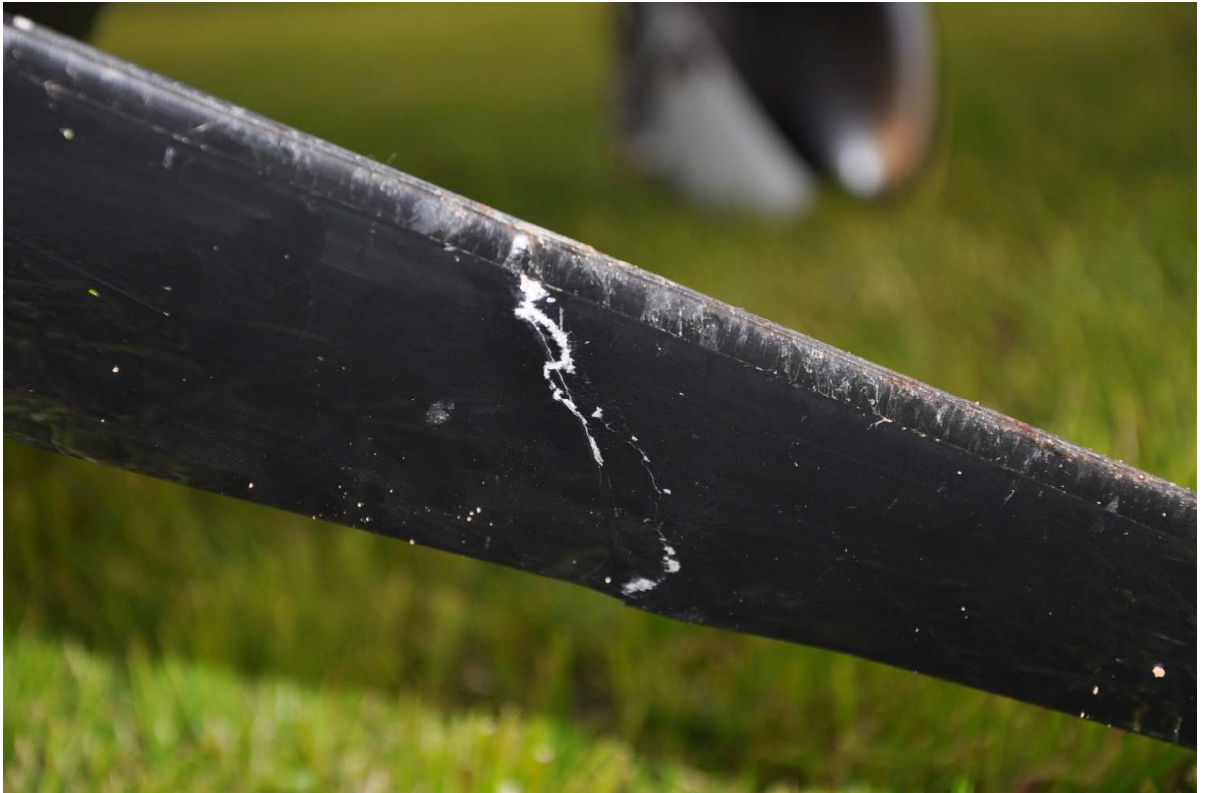
The aircraft was seriously damaged in the serious incident. Due to the breakage of the front landing gear leg, followed by the contact of the nose of the aircraft with the ground, the propeller (blades) and the front landing gear cover were damaged and the engine was stopped by force.

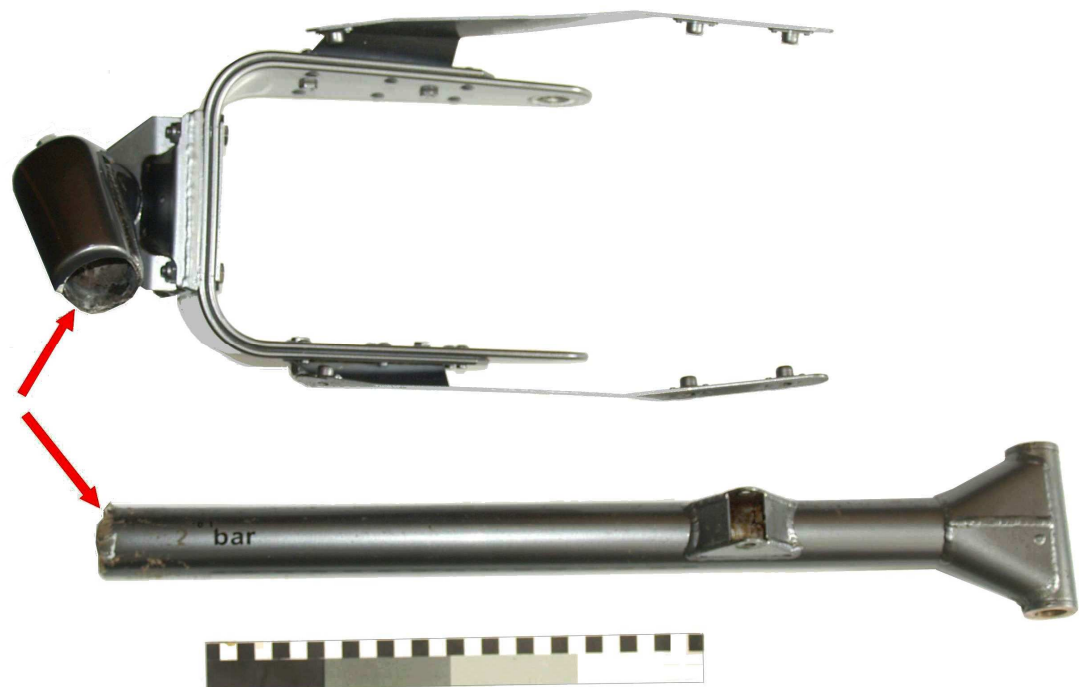
The arrows mark the fracture surfaces under inspection (fig.1)

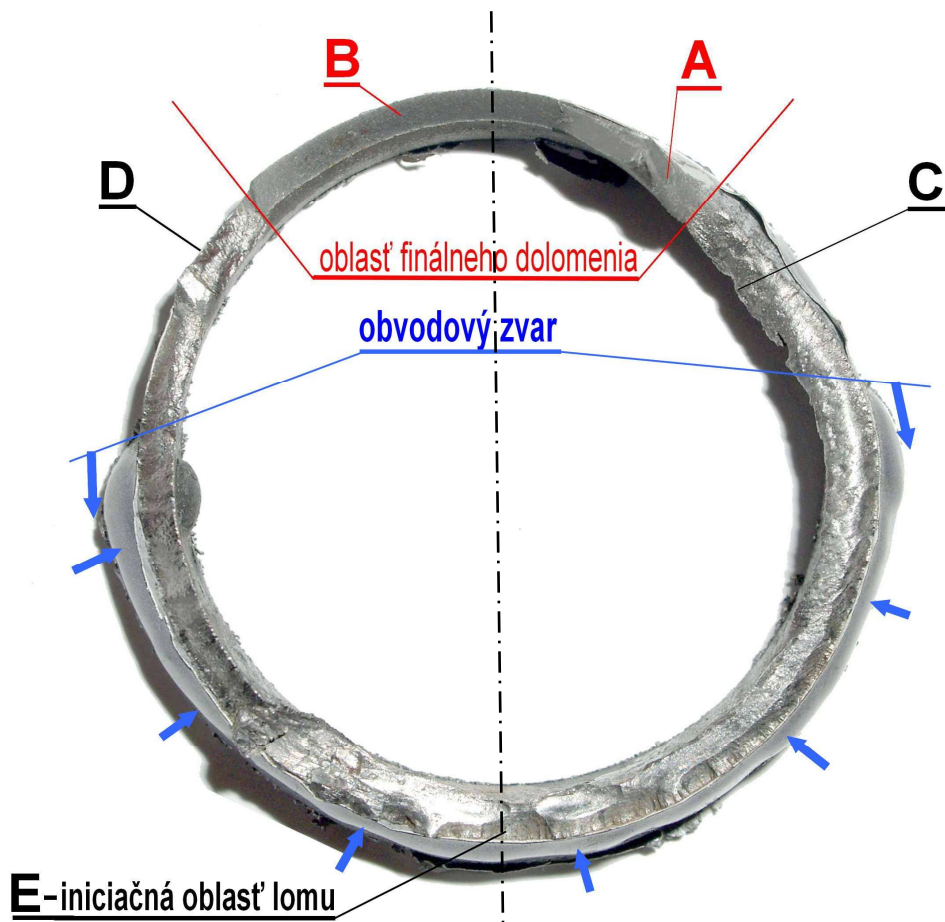
The fracture under inspection showed a visible area of final rupture of material, which represented less than a quarter (22%) of the initial supporting cross-section of material in the damaged area.

Overall view of the fracture surface with visible area of final rupture of material (fig. 2).

Opposite to the area of final rupture of material was situated the fracture initiation area (lower part of fracture surface on Figure 2 marked by position "E"). Also this area showed here and there visible secondary bruises.

From the overall character of the fracture it was clear that it was a fatigue fracture initiated in the lower part of the landing-gear leg section on the margin of the weld joint, by which the stiffener was welded to the supporting landing-gear tube and the welded area marked by blue arrows in Figure 2.

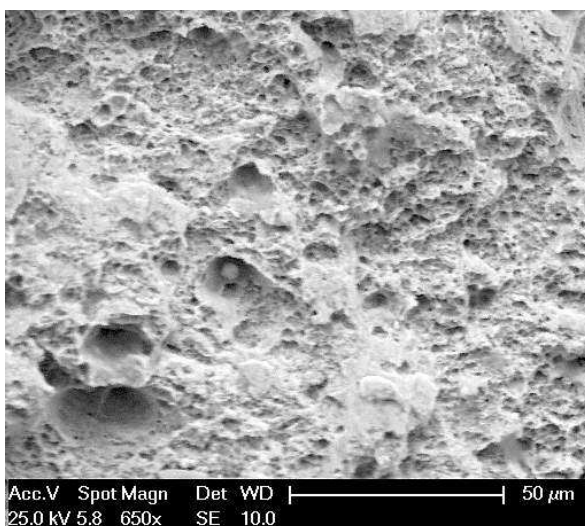
Inspection of the fracture surface by means of scanning electron microscope showed that material in the area of final rupture had been damaged by a ductile cup-and-cone fracture.

Cup-and-cone fracture in the area A

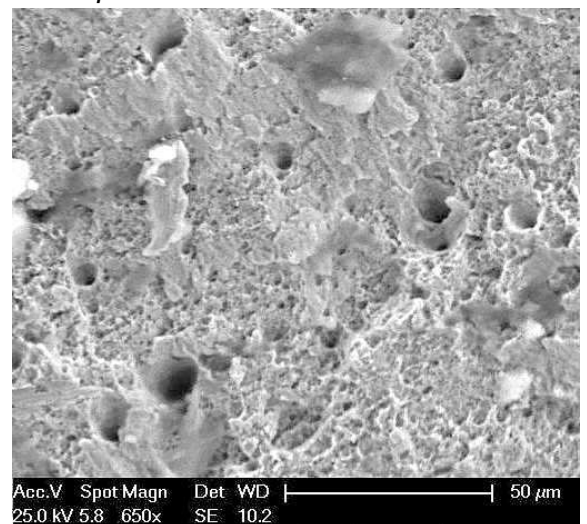
Cup-and-cone fracture in the area B

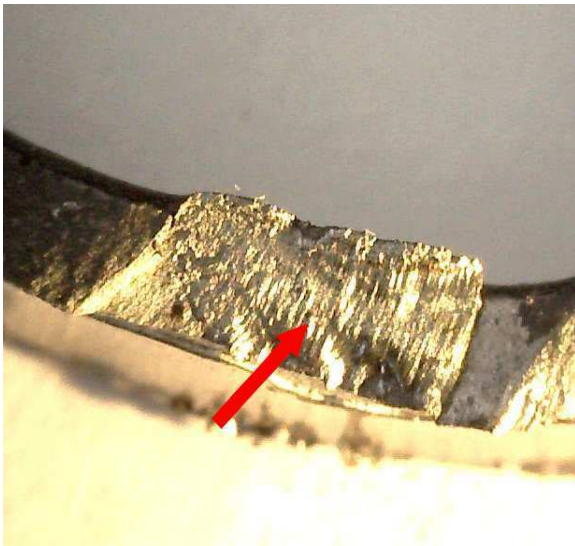
In the area "D", just in front of the area of final rupture of material, parallel stripes similar to those caused by fatigue damage of material exposed to high nominal load were visible on the fracture surface.

The side view of this fracture area revealed that its inner margin was deformed inwards into the supporting land-gear tube and from its outer side it appeared as if it was driven into the material, which proved that the stripes were not standard progression or relaxation stripes of fatigue fracture, but that they were caused by sliding of a solid hard object along this part of the fracture surface.

Parallel stripes on the fracture surface in the area "D"

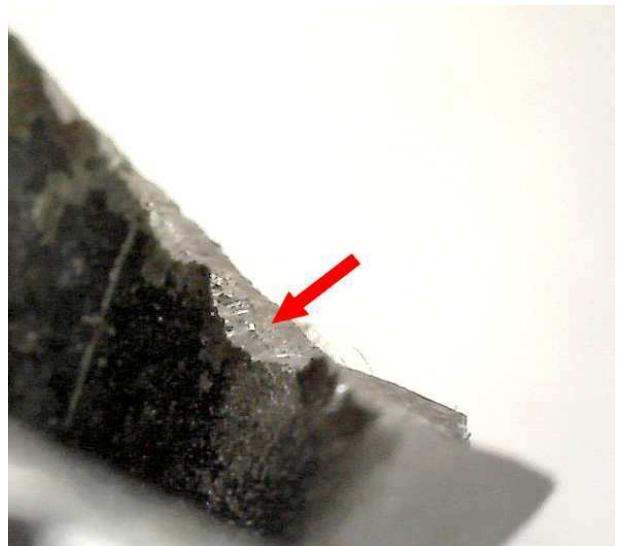
Deformation of the fracture surface margin in the area "D" inwards into the tube

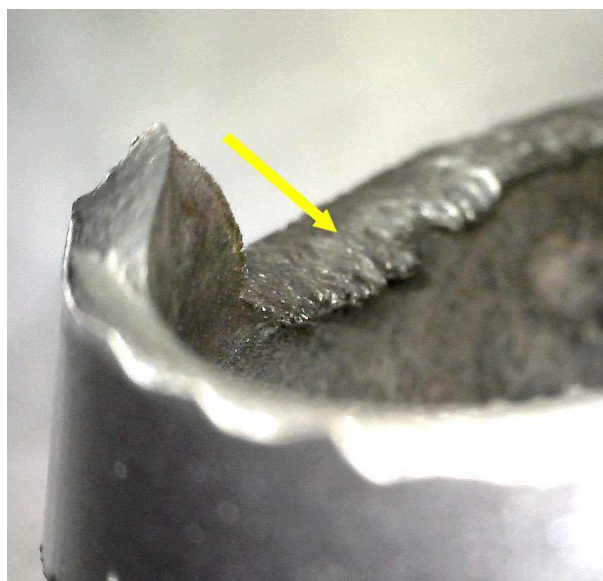
On the opposite side of the fracture in the area "C" a similar bruising of material was even more visible.

Bruising of the fracture surface in the area "C"

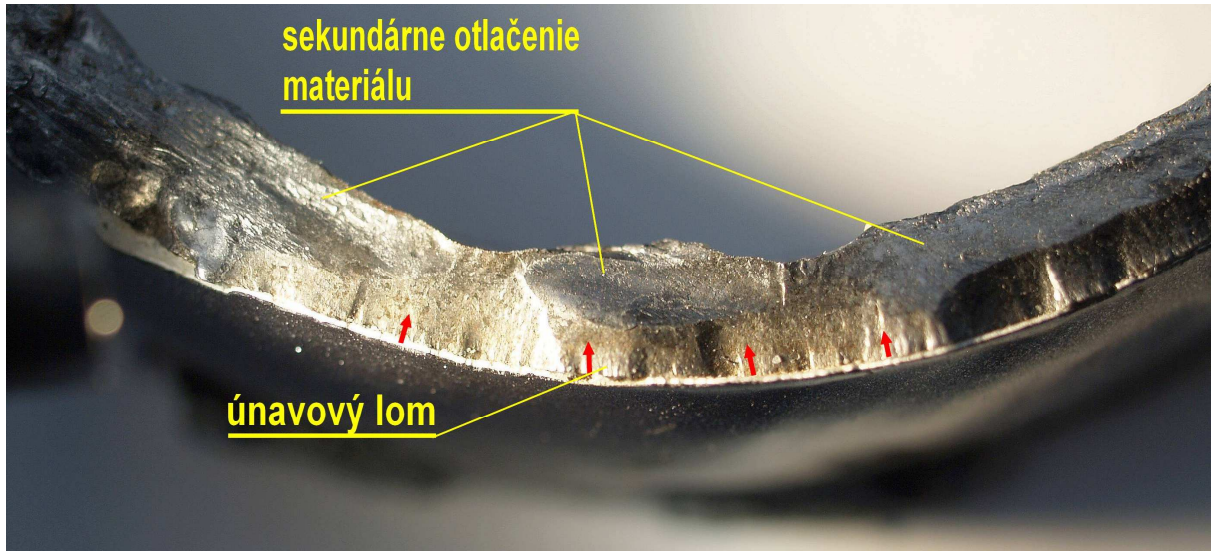
In the marginal parts the rupture did not show any accompanying deformation of material, was relatively smooth in the direction of progression (shown by arrows) and had visible radial stages on the outer margin.

Area of fatigue fracture initiation and direction of its progression

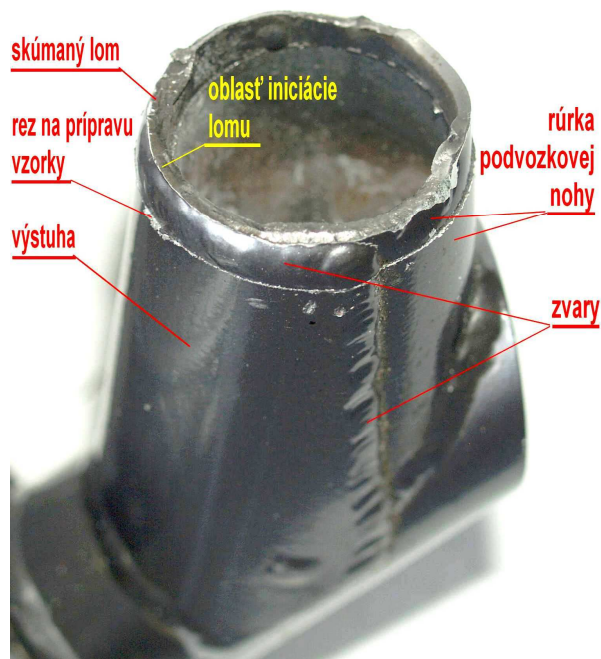
Fracture initiation area in the lower part of damaged landing-gear leg cross-section

The margin of transverse weld joint between the supporting landing-gear tube and its stiffener was in this case a significant stress concentrator. This fact, together with variable loading of the landing gear (aircraft taxiing on non-reinforced surfaces, aircraft handling during its manual pulling or pushing on the front landing gear) enabled in this case the initiation and development of a fatigue mechanism. In the damaged area the tube material (chrome and manganese alloyed steel) – could have decreased strength properties because it was so-called “weld heat affected zone“.

The visible secondary bruising of the fatigue-affected section of the fracture surface proved that the landing gear had been operated also with partial fracture.

- to issue a binding service bulletin for inspection of the front landing-gear legs of all operated aircraft of this type using the NDT (Non-Destructive testing) method,
- to determine the cycles and methods of non-destructive testing for early detection and evaluation of structural changes and physical properties of materials used in the front landing-gear leg and to incorporate them in the maintenance manual of this aircraft type,
- to introduce potential technological changes in production of the front landing-gear leg to eliminate the formation of fatigue fractures.

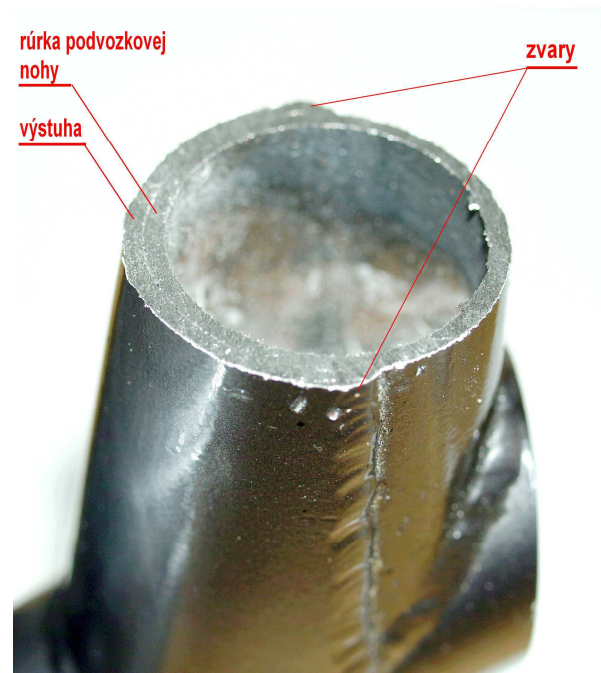
Landing-gear leg and stiffener (after taking of samples for electron microscopy)
