## FINAL REPORT

on investigation of serious incident  
of aircraft type **EuroFOX VISION**  
registration No. **OM-LIV**

Date: 02.08.2013

Place: Tesárske Mlyňany

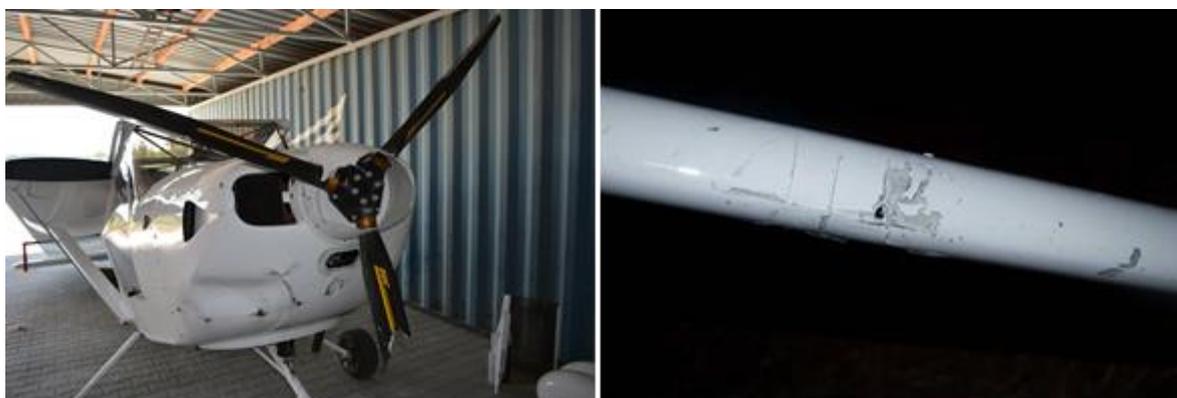
The aircraft was substantially damaged in the serious incident (damaged propeller blades, right front fuselage and right wing leading edge).

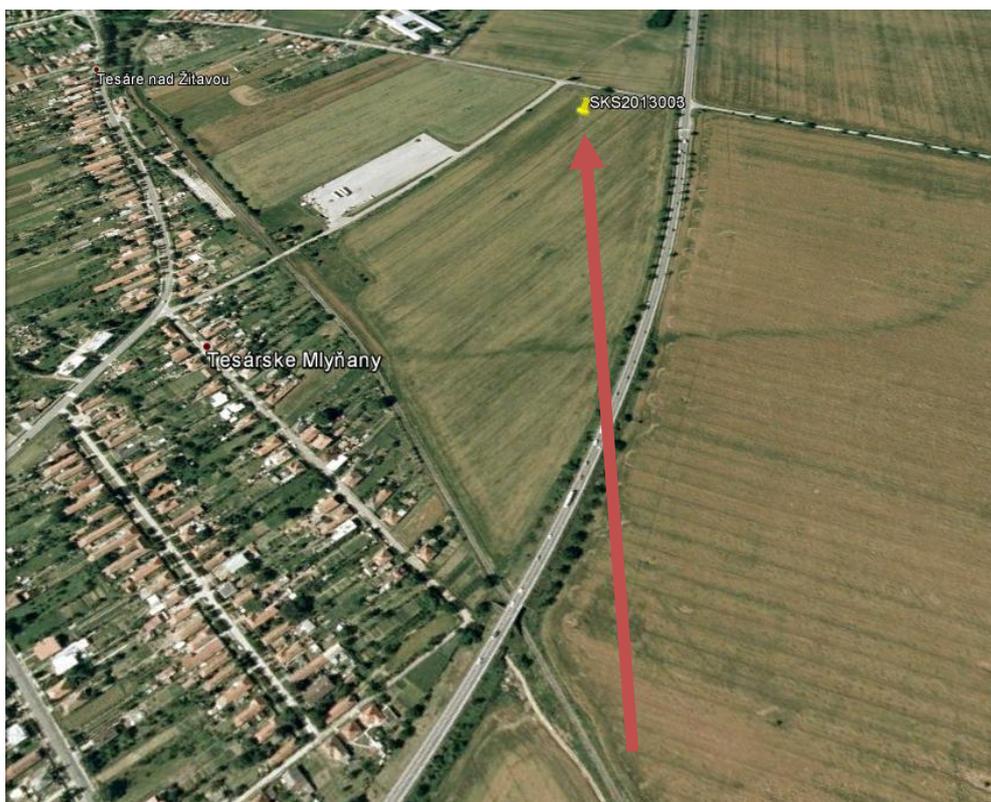
The place of collision of the aircraft with electrical wires is described by geographical coordinates: N 48°20'57,56'', E 18°21'38,23''.
