FINAL REPORT

on investigation of serious incident of
aircraft type **CESSNA U206 F**
Registration No. **HA-SVU**

Date: 11.08.2013

Place: 1750 m south-east of the Airport Kráľova pri Senci / LZKS

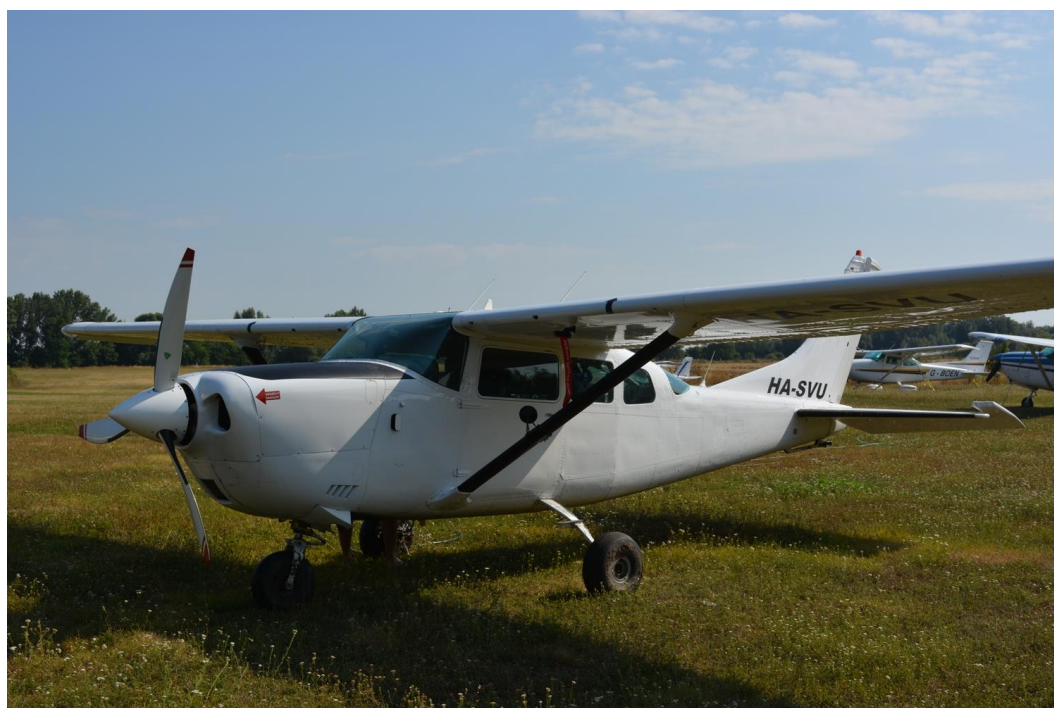
Type of operation:	general aviation / sport and recreational flying
Type of aircraft:	CESSNA U206 F
Registration No:	HA-SVU

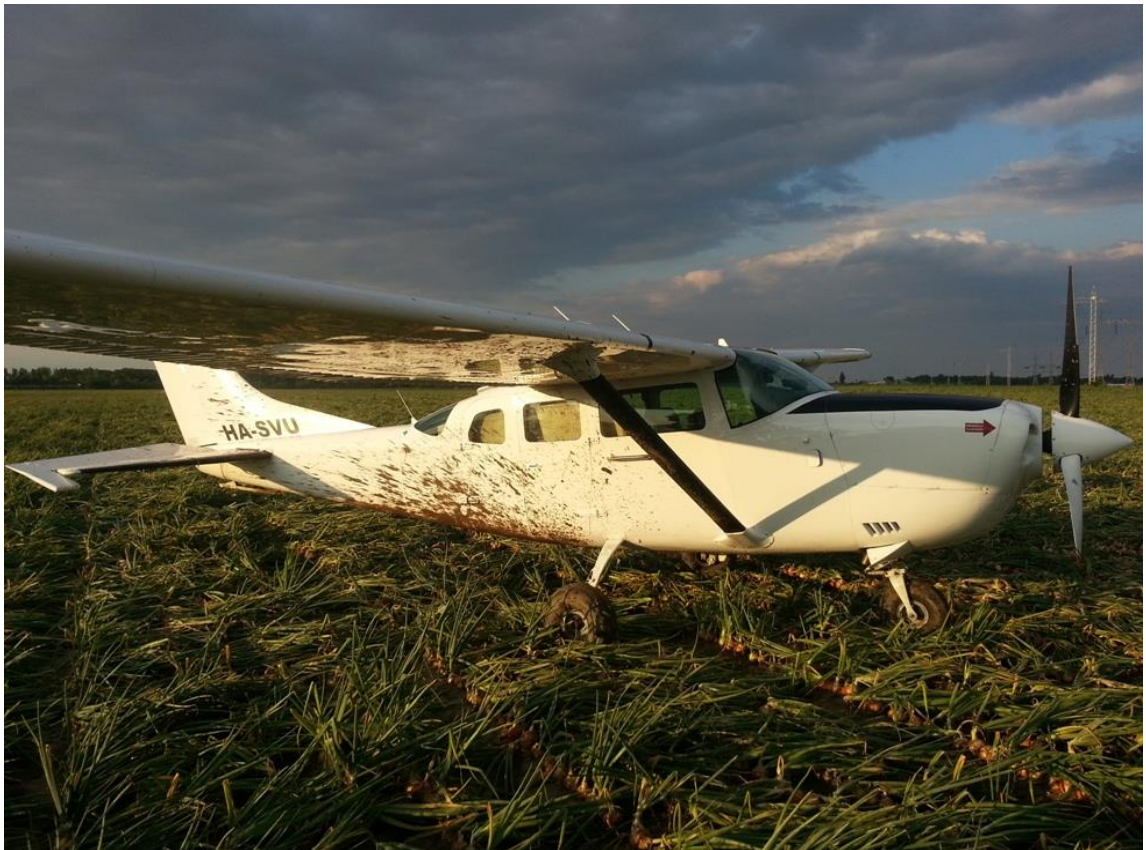
- Significant engine power reduction caused by technical fault of the engine fuel supply system, which was caused by failure of fuel booster pump.
