## **FINAL REPORT**

on investigation of serious incident  
of aircraft type **EuroFOX 912 3k-Tow**  
Registration No. **OM-LAN**

Date: 18.08.2013

Place: Airport Nitra / LZNI

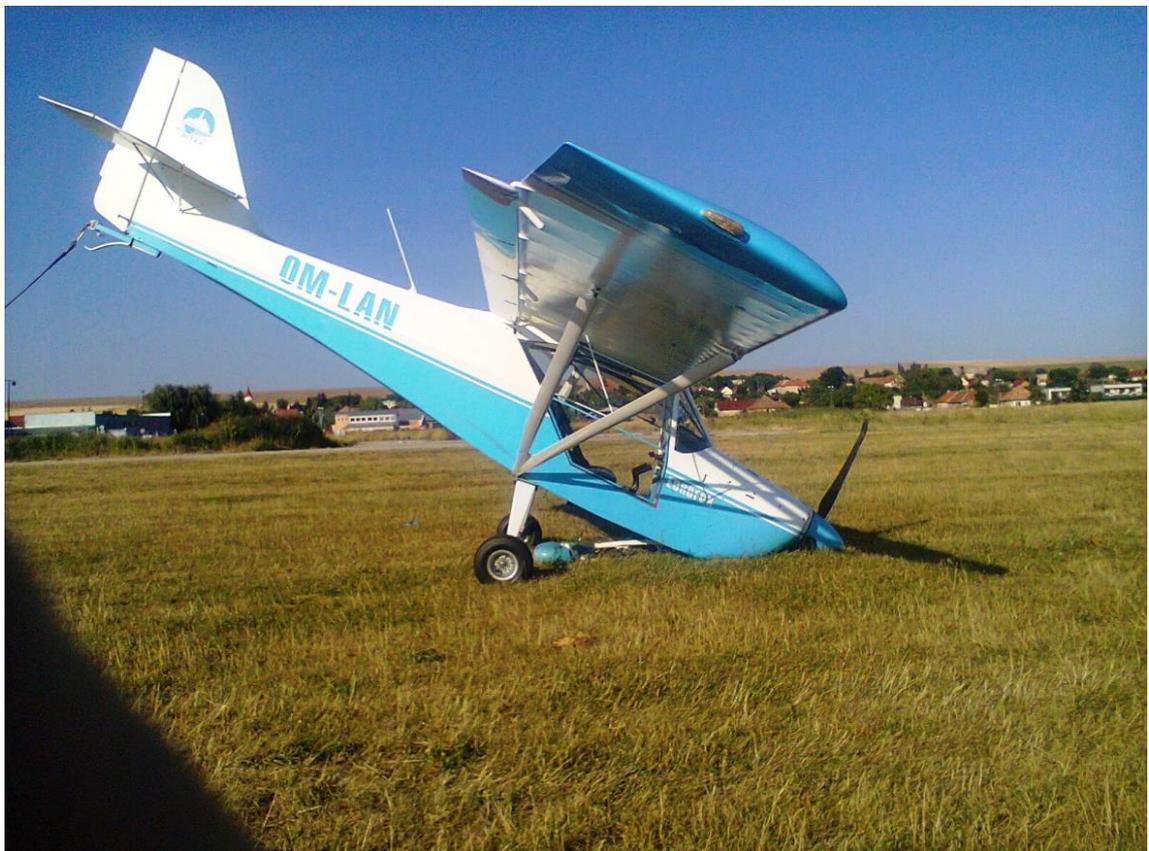
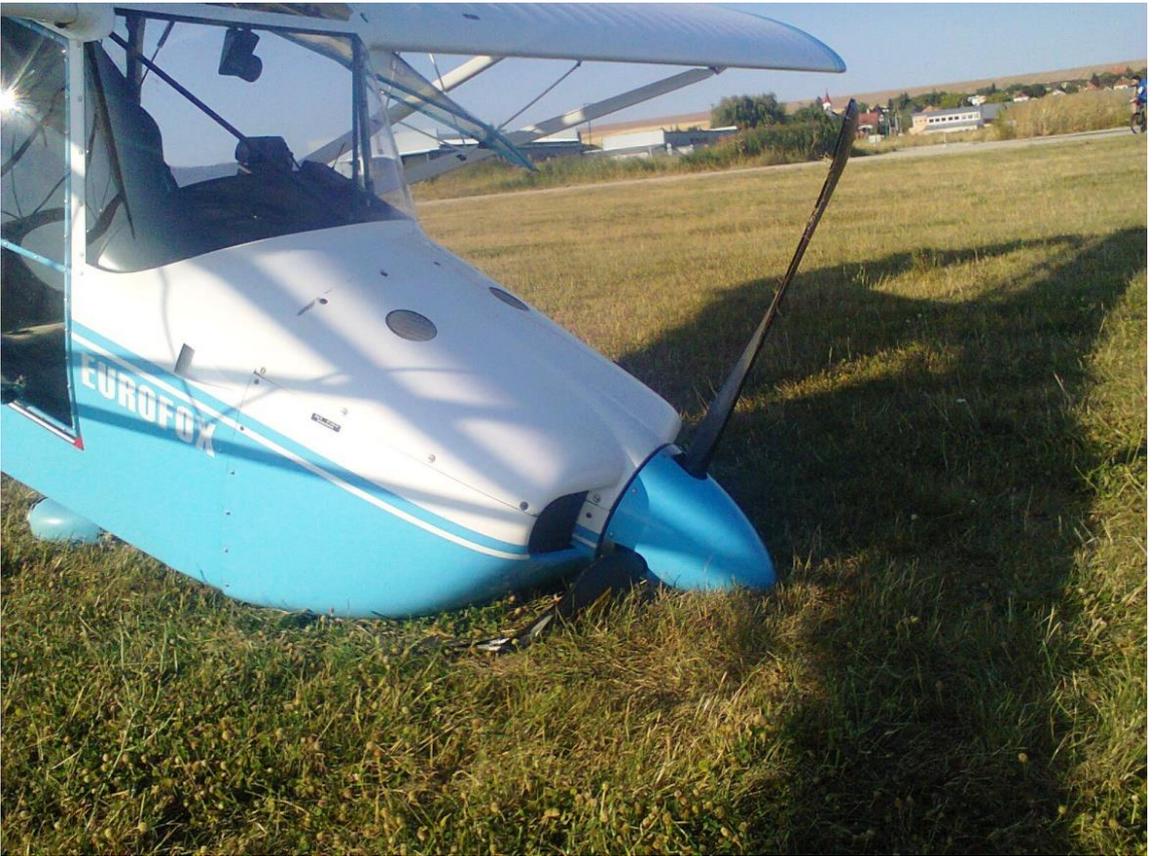
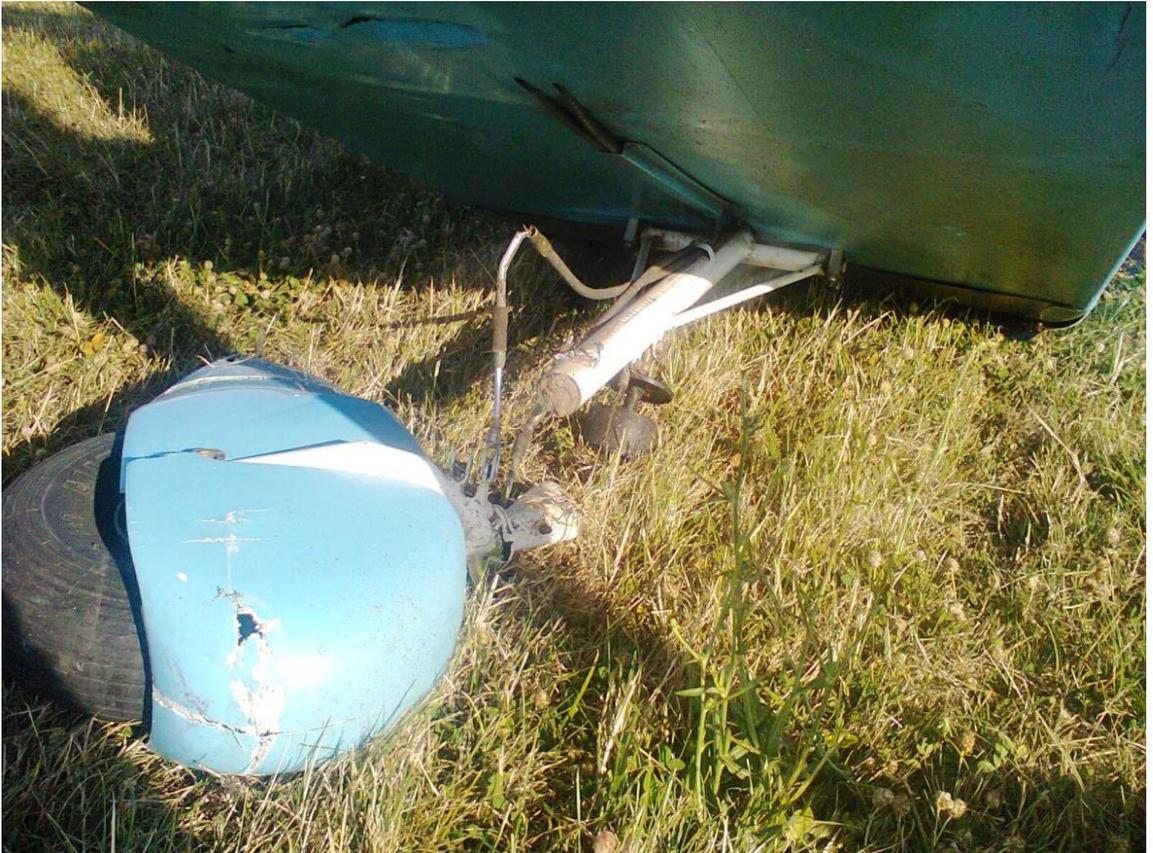
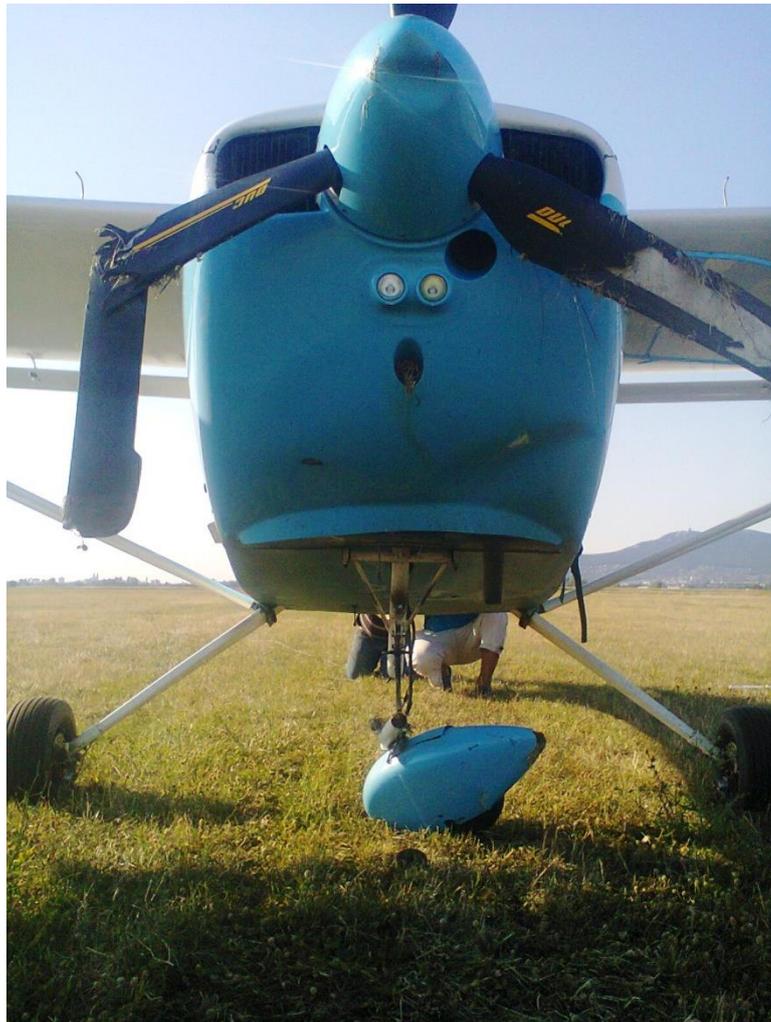
In view of the significant depth of the undulation the front landing gear leg got broken, the aircraft tilted over hard to its nose, the rotating propeller came into contact with the ground and the engine was stopped by force.

Scope of damage: front landing gear leg broken, engine stopped by force, all three propeller blades destroyed, front landing gear wheel spats, sump guard and propeller spinner damaged, strut frame of the front fuselage deformed in the area of attachment of the front landing gear leg and canvas cover of the underbody broken.

The running into an undulation in the take-off run phase, which caused the breaking of the front landing gear leg and subsequent damage to the aircraft.

before the start of the flight day to check RWY of LZNI for potential occurrence of major undulations.

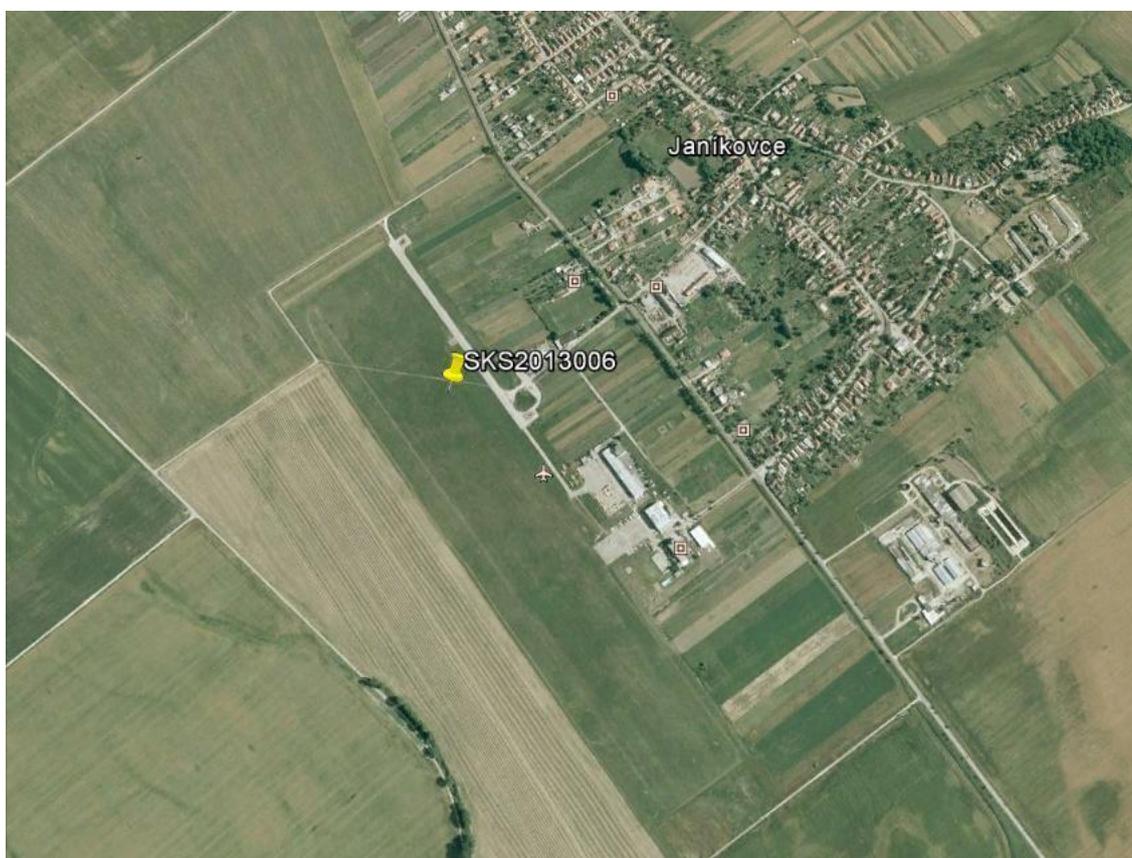
The place of serious incident was RWY of LZNI. The final position of the aircraft after the serious incident was documented and photo documentation was taken.
