## FINAL REPORT

on investigation of serious incident

of aircraft type **WT-9 Dynamic**

Registration No. **OM-AKM**

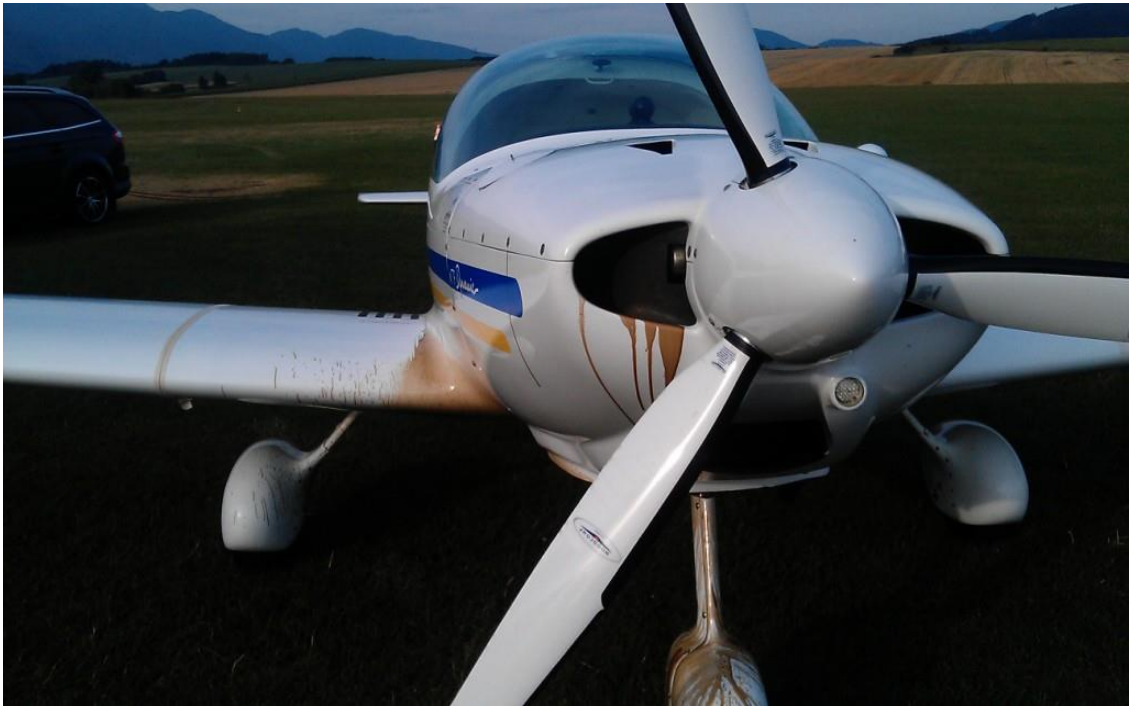
No damage was detected on the airframe other than pollution of the aircraft surface from a large oil leak. The following inspection detected a destruction of the engine caused by puncturing the engine block.

Fig. 1 Oil leak

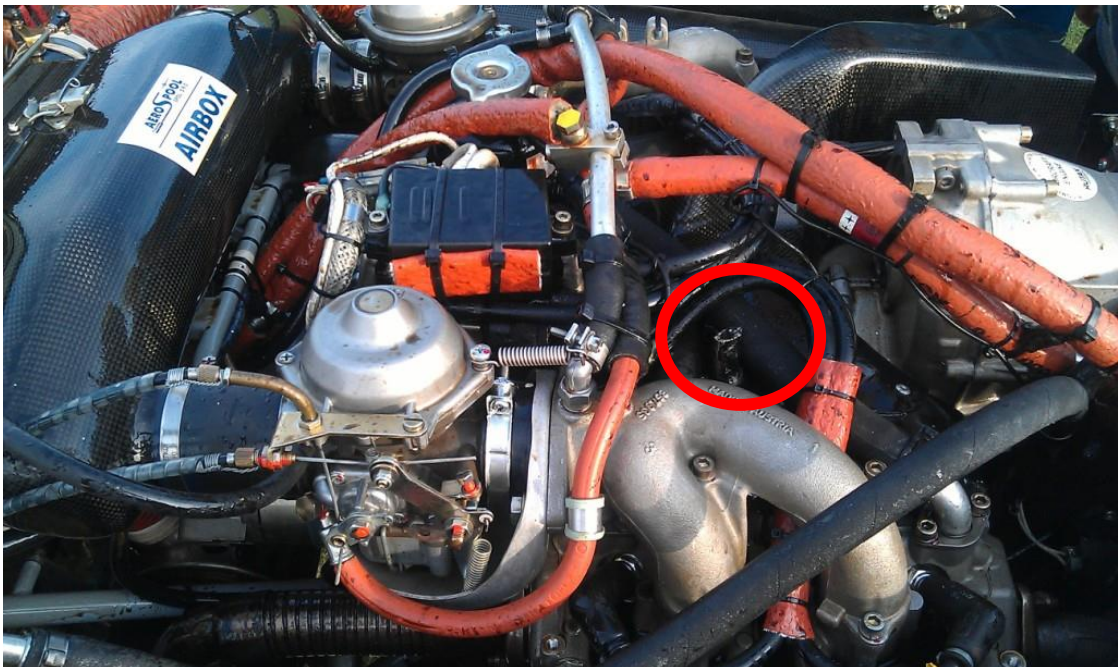
Fig. 2 Punctured engine block

The puncturing of the engine block and oil leak from the engine caused fire in the aircraft, which was extinguished by the pilot during the flight.

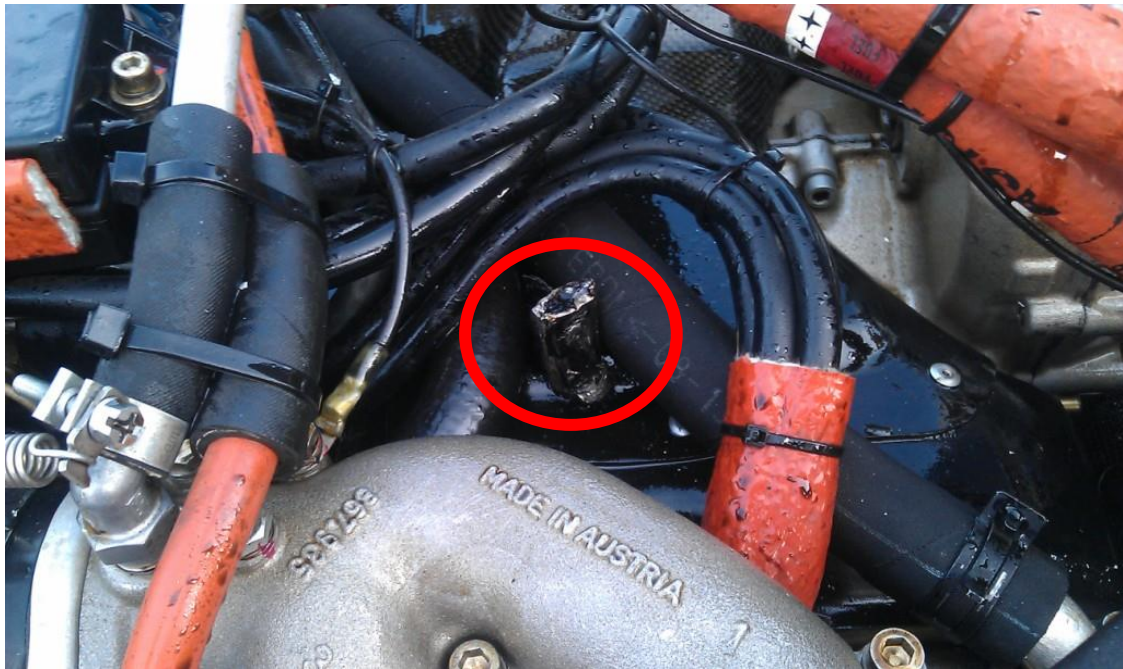
Fig. 3 Punctured engine block, fragment of connecting bar No 3 of the engine cylinder

- Rupture of the connecting-rod eye of gudgeon pin No 3 – puncturing of the engine block due to the insufficient lubrication of the gudgeon pin bushing No 3,
- The engine pressure lubrication system showing no apparent defects
- No possibility of detection of the cause of insufficient engine lubrication
- Estimated causes of insufficient engine lubrication:
  - Inssufficient quantity of oil
  - Incorrectly installed oil hoses
  - Hose blocking, oil leak.

The probable cause of the serious incident was insufficient engine lubrication.
