FINAL REPORT

on investigation of serious incident
unauthorized entry of vehicle to active RWY04

Date: 31.08.2013

Place: M.R. Štefánik Airport Bratislava / LZIB

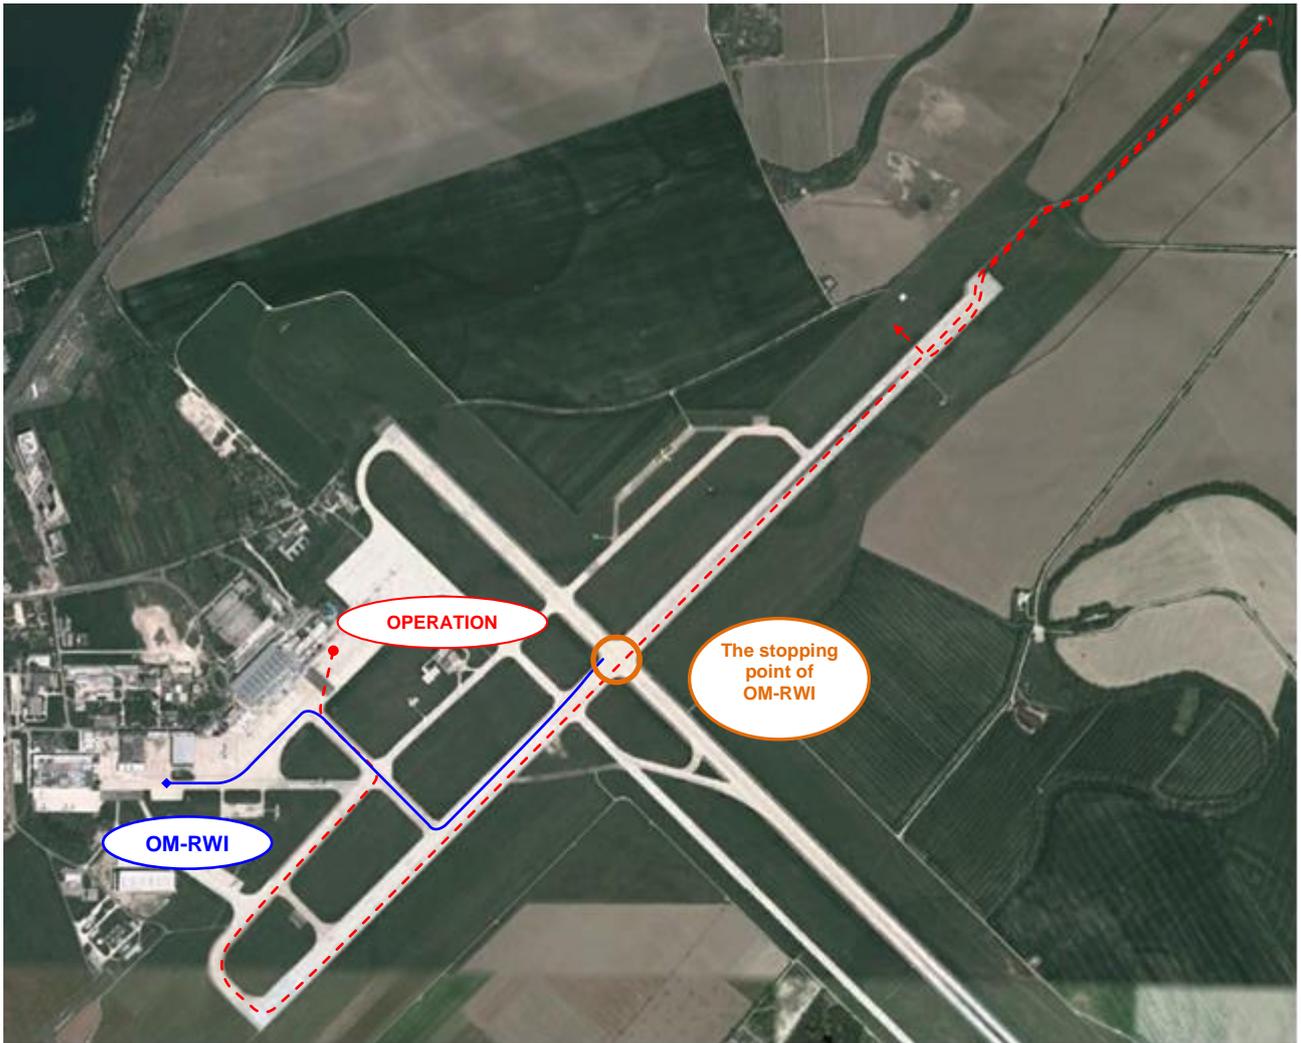
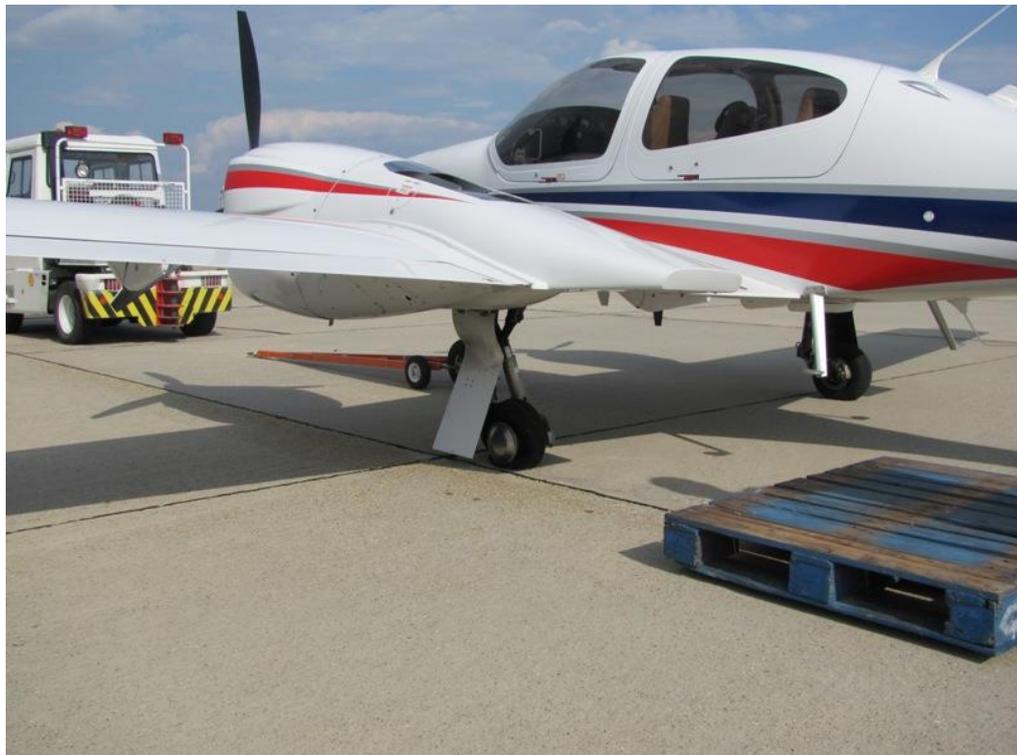
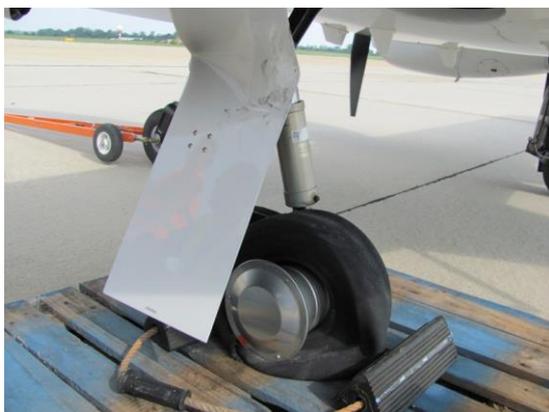
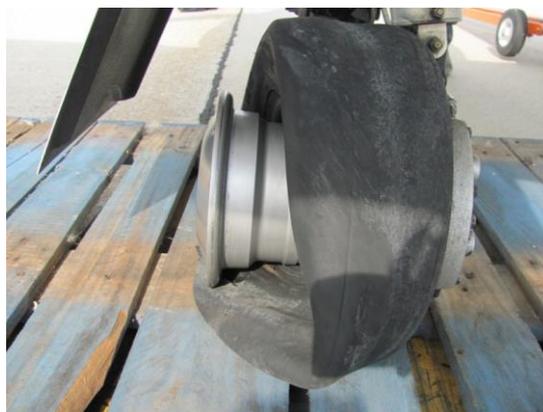
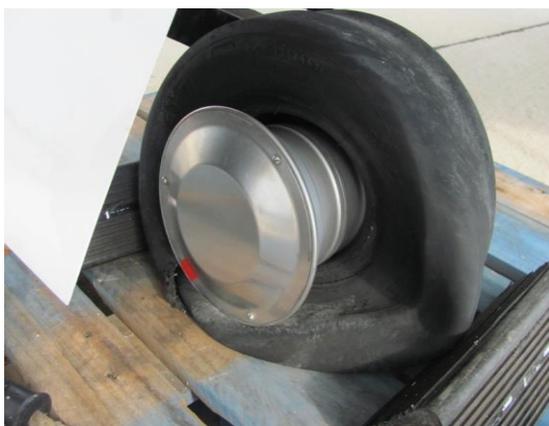
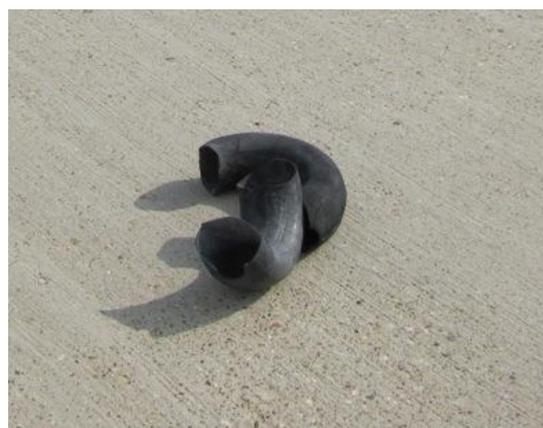
1.12 Wreckage and impact information

During intensive braking the tire of the left main-wheel unit, including its inner tube, blew out. The vehicle was not damaged.

- it had valid documentation and did not show any faults before the occurrence,
- it fulfilled the conditions of airworthiness before the critical flight,
- it was damaged in the serious incident – blowed-out tire and air hose of left-handed main-wheel unit.
