FINAL REPORT

on investigation of serious incident of

aircraft type **Cessna 182P**

Registration No. **G-BMUD**

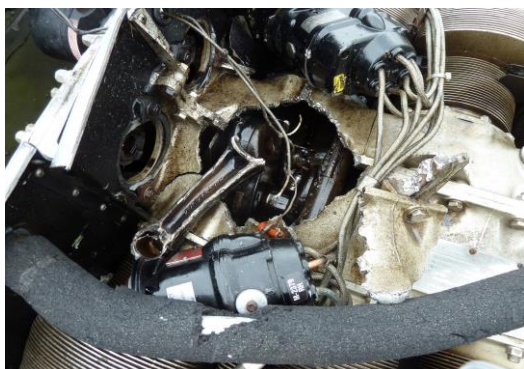
The aircraft was not damaged in the serious incident, except for the engine.

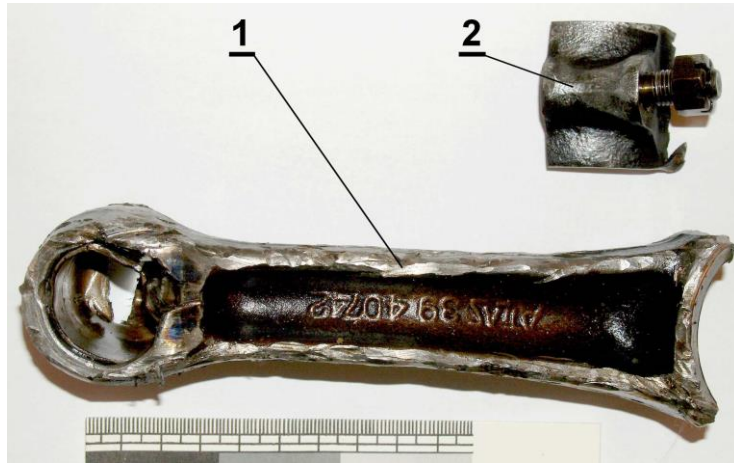
Photo No.1 Submitted parts of damaged connecting rod

The engine was dismantled and partially disintegrated. During this operation the broken part of **connecting rod** (shank) and a fragment of the connecting rod head were found.

The shank of the damaged connecting rod (position 1 on photo No. 1) and the fragment of the connecting rod head with a part of broken connecting rod screw (position 2 on photo No.1) were subject to expert examination at the Institute of Criminology and Forensic Science of the Police Corps with the aim to detect the cause of damage to the connecting rod and of rupture.

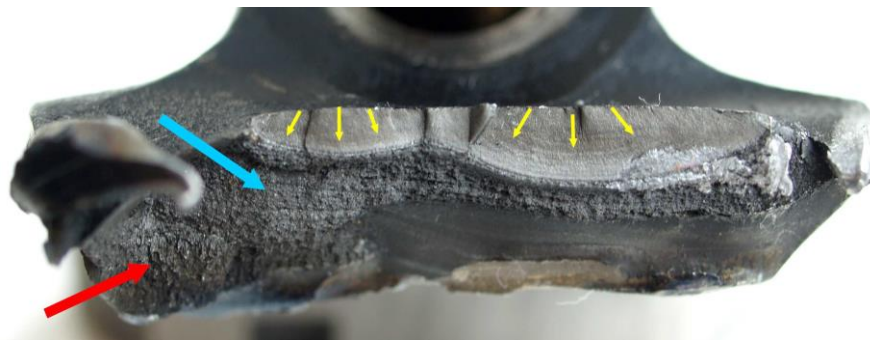
Photo No. 2 Visible fatigue rupture on the fragment of connecting rod head

The presence of fatigue failure, starting from at two points on the external surface and extending inwards to the connecting rod pivot (see the direction shown by yellow arrows on photo No. 2) was detected on the rupture surface of the fragment of the connecting rod head. The leading smooth part of the rupture surface by its character corresponded to high-cycle fatigue. In this phase the rupture progressed very slowly. In the other area, undulated, but with visible progress and relaxation belts (area marked by blue arrow on photo No 2), the rupture progressed much faster. The area without progress and relaxation belts (area marked by red arrow on photo No. 2) represented the area of so-called final rupture of material. The mirror rupture surface of this fatigue rupture was also observed on the connecting rod shank (photo No. 3) and other identified parts of the rupture showed marks of secondary deterioration.

- Formation of fatigue rupture of the connecting rod followed by engine thrust cut-off.
- Crown nut of connecting rod screw was not secured by safety pin against potential detachment during engine operation, which caused the initiation and development of fatigue mechanism of damaging the material on the external side of the connecting rod head.

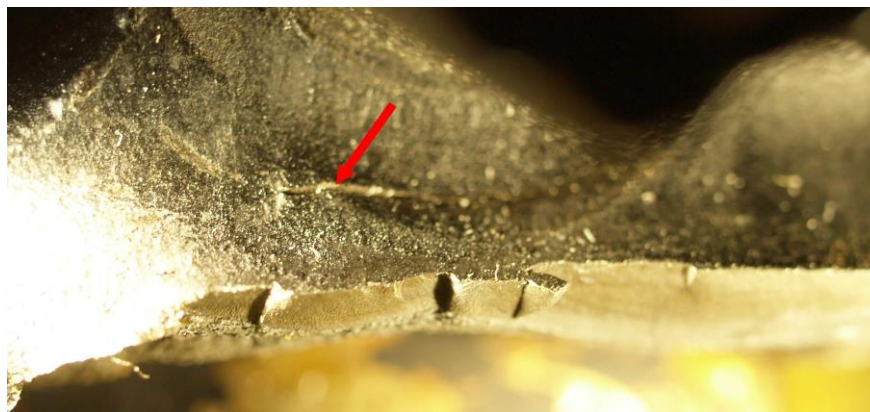
Photo No. 4 Further parallel partial rupture of material

Another parallel partial rupture was detected on the connecting rod head in the vicinity of the identified fatigue rupture (photo No. 4). Such strain on the connecting rod head may occur e.g. when the connecting rod pivot of crankshaft in the connecting rod head (fig. 1) comes off due to the connecting rod screws become loose or due to the wear of bearing caps. Such strain is caused by inertial dynamic forces which at high revolutions often prevail over forces from the working space of cylinder. The highest axial stress at this point is formed at the top dead-center position of piston and to a lesser extent in the suction phase.

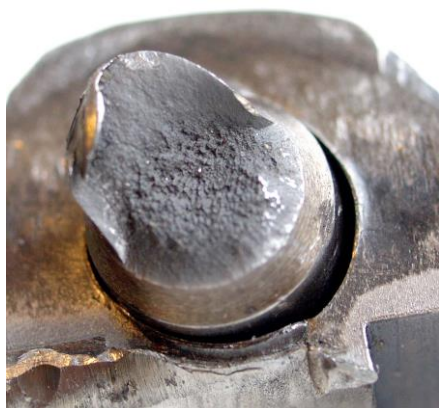
Photo No. 5 Rupture of connecting rod screw

No traces of fatigue mechanism of damaging the material (photo No. 5) were detected on the rupture surface of connecting rod screw. The crown nut of connecting rod screw was not secured by safety pin against potential detachment during engine operation (photo No. 6).

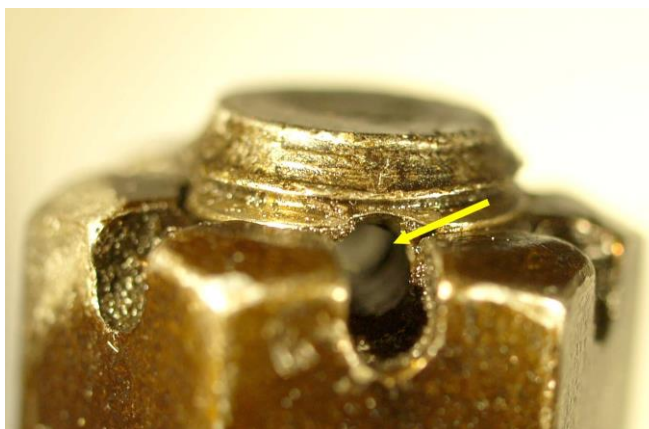
Photo No.6 Missing safety pin on crown nut

On the basis of submitted documentation the commission did not detect performance of such works on the engine after general overhaul where the missing safety pin could have been manipulated.
