FINAL REPORT

on investigation of serious incident of

glider type **L-13SE Vivat**

Registration No **OM-7101**

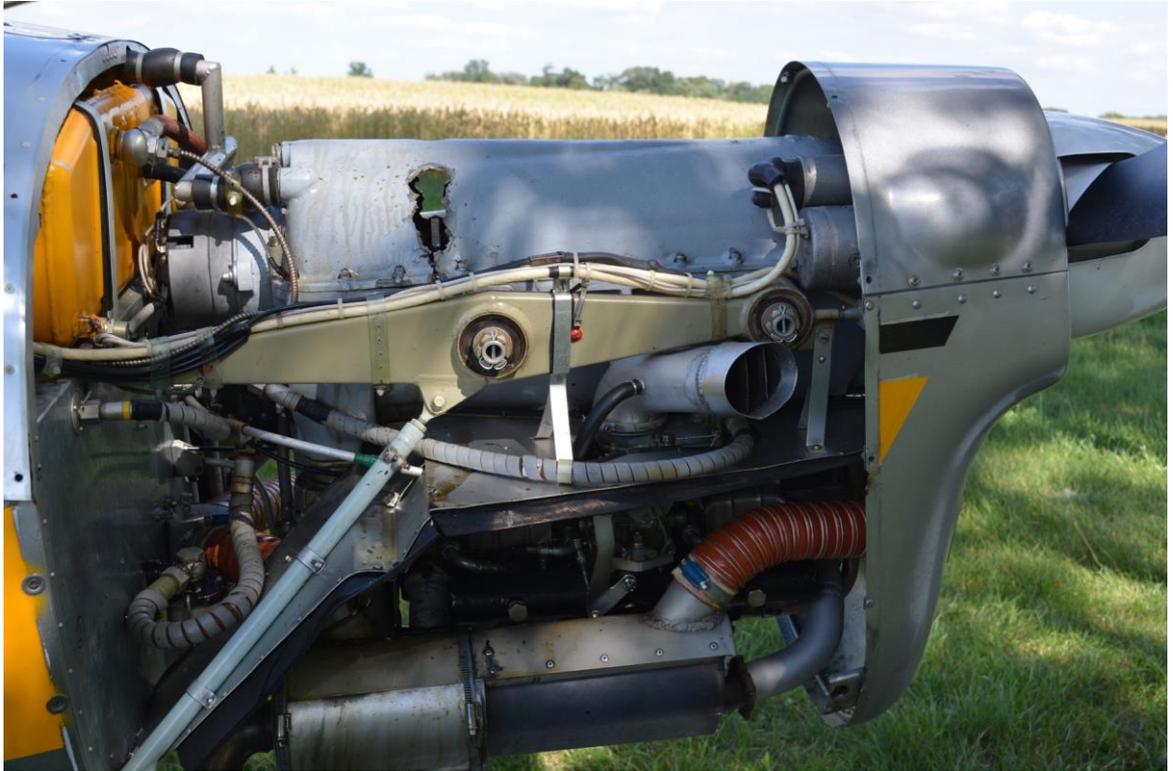
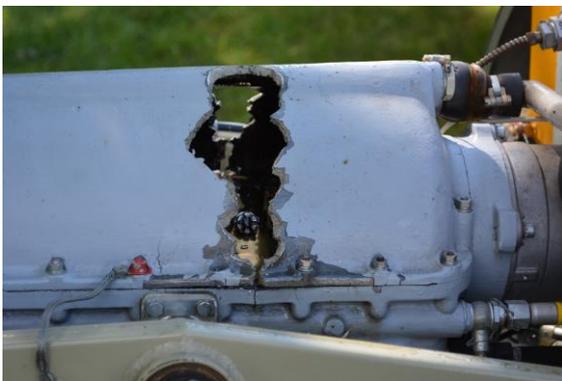
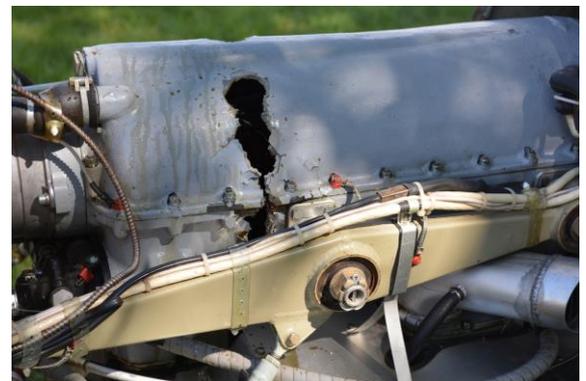
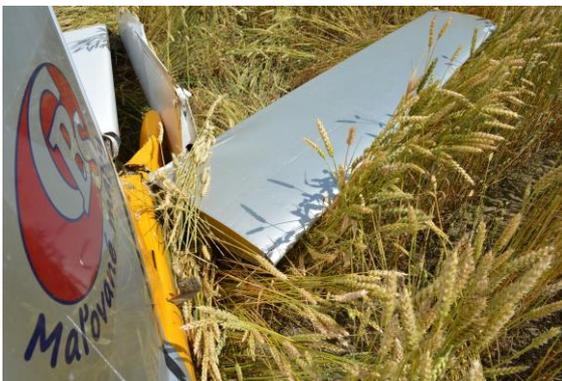
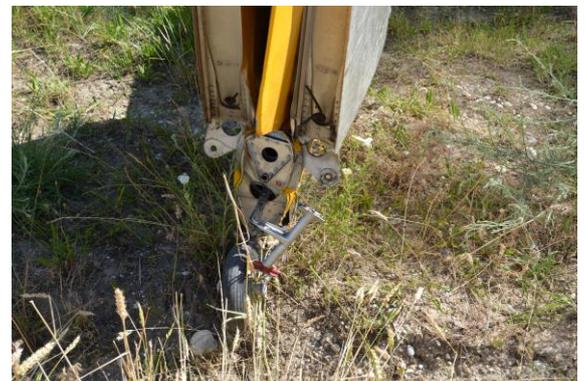
Damage to aircraft:

- Pierced engine block
- Broken connecting rod
- Separated auxiliary wheel on the left wingtip
- Destroyed horizontal stabilizer and elevator.

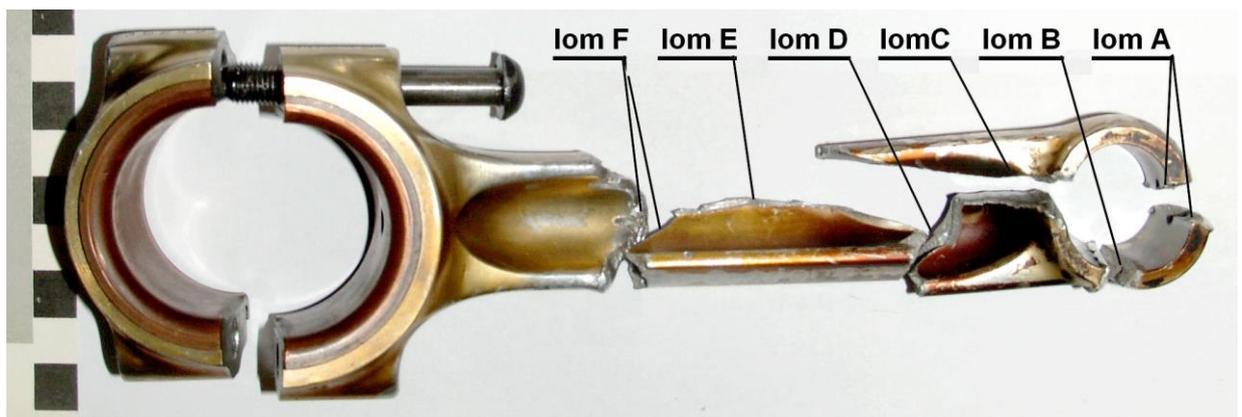
The damaged **connecting rod of the engine**, broken into several parts, was sent to the Institute of Criminology and Expertises of the Police Corps for analysis in order to detect the mechanism of damage to the connecting rod. For better transparency of investigation into causes of the damage to the connecting rod the individual ruptures were marked with alphabetic characters (photo No.1).

Photo No.1 Submitted parts of damaged connecting rod and ruptures marked with alphabetic characters

Rupture B situated on the side of the top connecting-rod eye (photo No.1) did not show any signs of fatigue or other material damage by stages and was caused by secondary material overloading.

Ruptures D, E and F developed later and had no causal relation to the damage to the connecting (photo No.1).

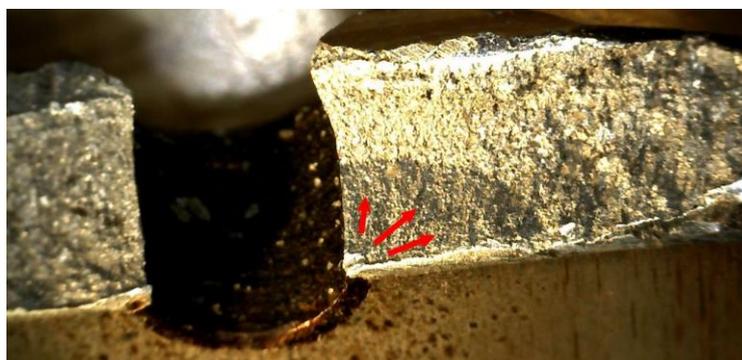
Rupture A situated in the upper section of the top connecting-rod eye and passing through the lubrication hole of the dudgeon pin shows signs of the fatigue mechanism of material damage with initiation area on the inner edge of the lubrication hole (photo No. 2).

Photo No. 2 Fatigue rupture in the upper section

The analysis of submitted parts of the damaged connecting rod showed that the connecting rod had been primarily damaged by fatigue rupture in the upper section of its top eye. The fatigue fracture was initiated on the lower edge of the lubrication hole, which acted at this point as a cut or tension concentrator.

- Failure of engine caused by broken connecting rod of piston No. 4, which then pierced the engine block,
- The rupture of the connecting rod was caused by fatigue rupture in the upper section of the eye on the lower edge of the lubrication hole.

to issue a binding TECHNICAL BULLETIN – to implement the check of connecting rods in the form of NDT RT - Nondestructive Testing Radiography Testing of engines of serial numbers 36xxx (engines from original production Walter), that have already undergone the second general overhaul, not later than 600 hours after the general overhaul.

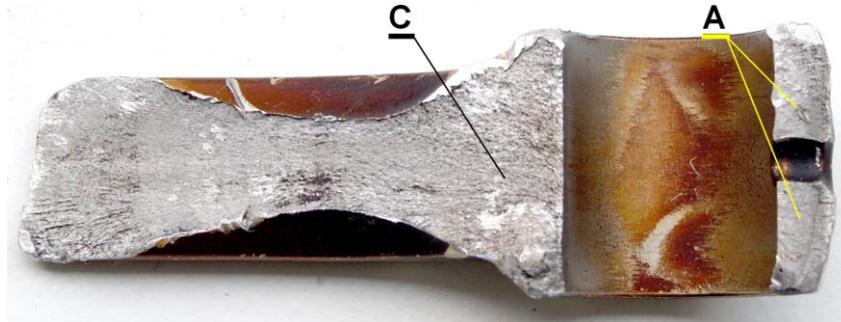
Rupture C showed an unusually straight line of growth and remarkable flatness of the rupture surface (photos No. 1 and 3). The rupture had a fragile or fission character (photo No. 4) without signs of fatigue material damage and was caused by application of dynamic pressure from the dudgeon pin on the internal wall of the eye secondarily, after the formation of rupture A in the upper section of the eye. The straight line of growth of the rupture in this case was related to the high dynamics of destructive load and to the high speed of fracture propagation.

Photo No. 3 Rupture C and its straight line of growth

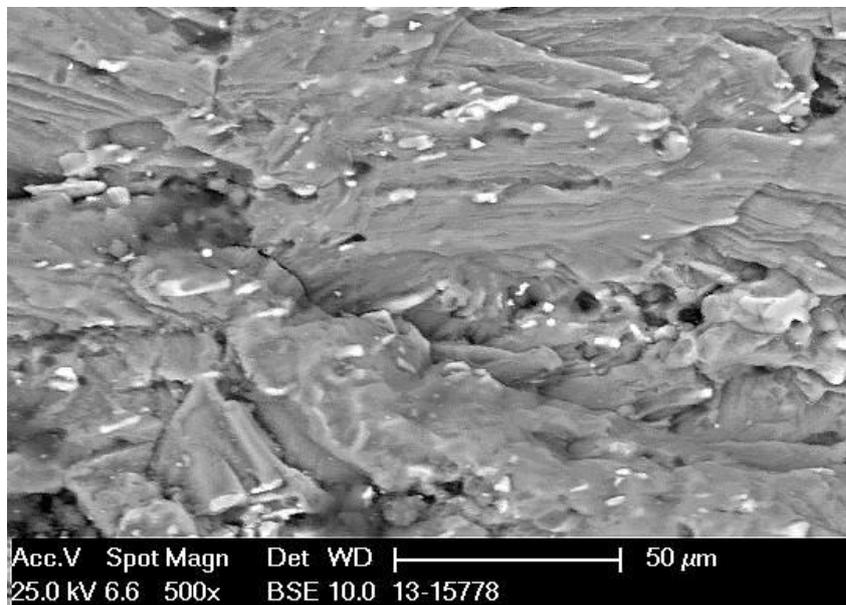
Photo No.4 Fission character of rupture C (SEM – picture from scanning electron microscope)
