FINAL REPORT

on investigation of accident
of paraglider **Avax 26 Gradient**
without registration number

Reg. No.: SKA2014001

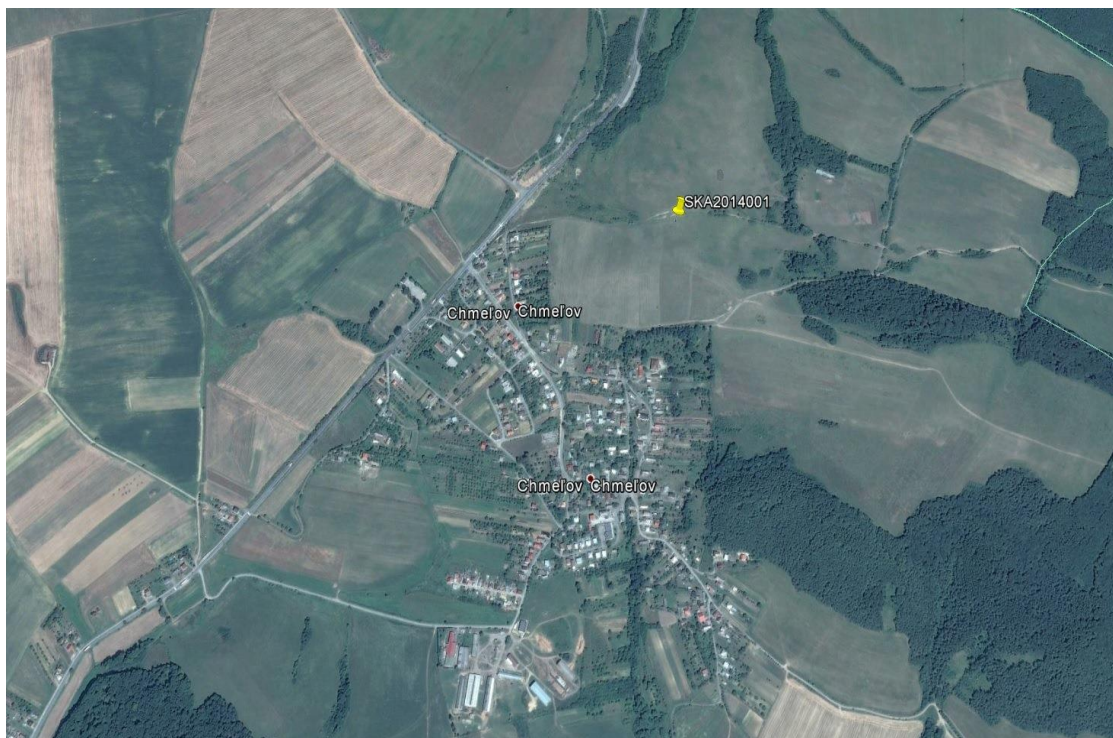
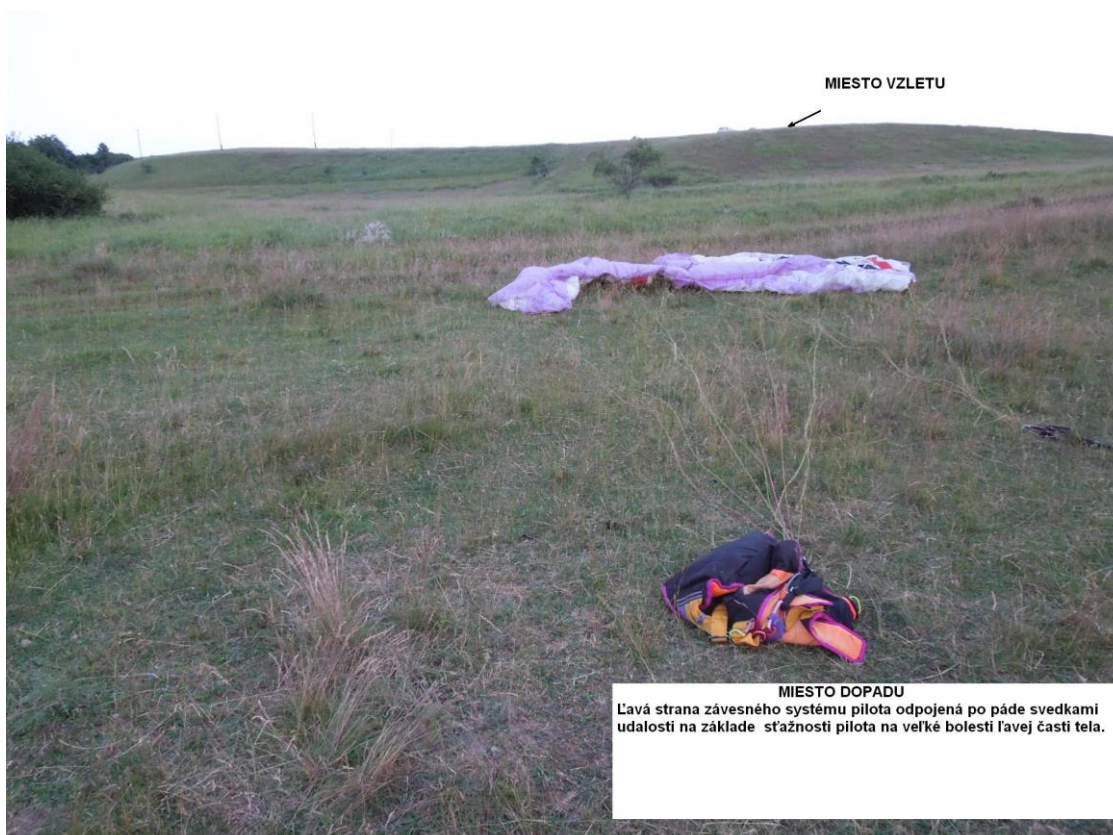
1.12 Wreckage and impact information

The actual state of paraglider and equipment did not show any signs of excessive wear or damage. The pilot had not at his disposal an emergency parachute during the critical flight. The unfavourable flight situation occurred at a low altitude above ground – based on the height data of the take-off site and the point of ground impact, in an altitude lower than 20 m. As the paraglider fell from an altitude of less than 10 m, the use of rescue aids would be impossible even if they had been available. The pilot seat was not equipped by modern passive safety elements able to mitigate the consequences of the fall.
