# FINAL REPORT

on investigation of accident  
of glider type **VSO-10**  
Registration No. **OM-7501**

Reg. No.: **SKA2014002**

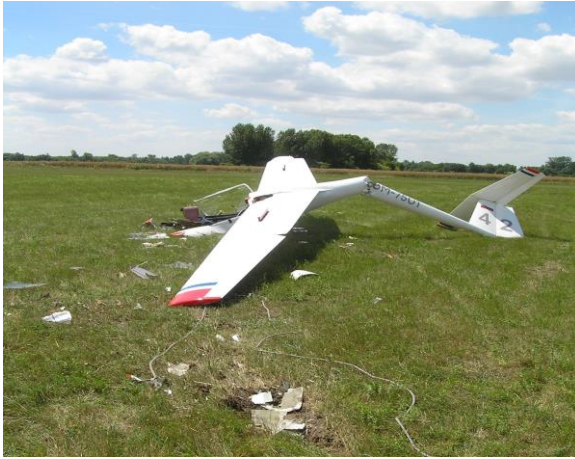
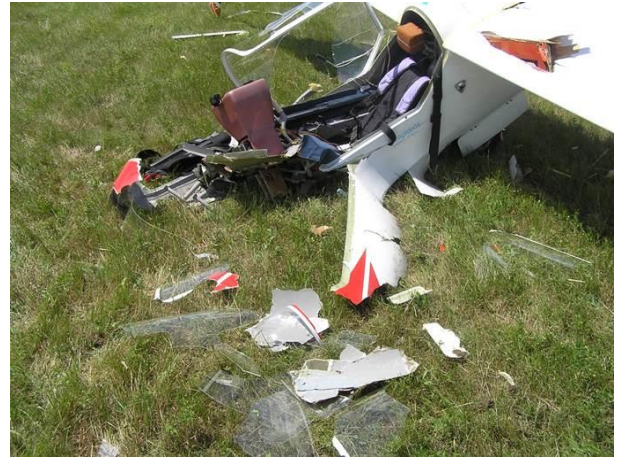
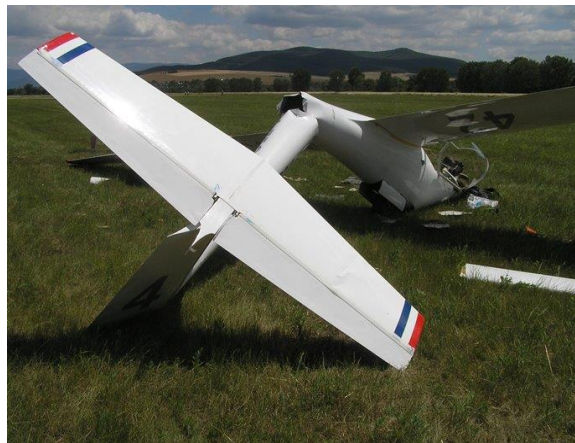
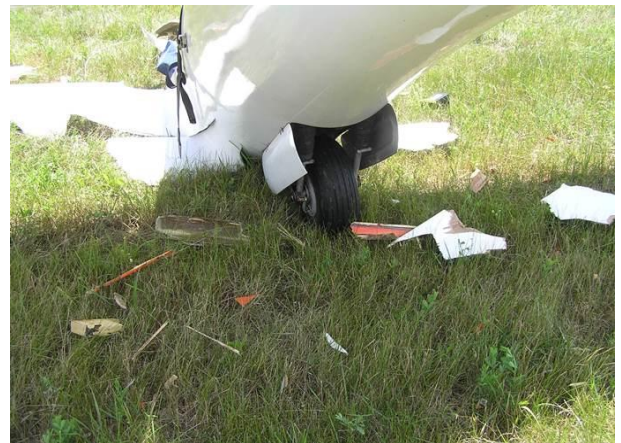
The glider was destroyed in the accident:

- fully destroyed front fuselage front section
- broken aircraft body and
- damaged wings.

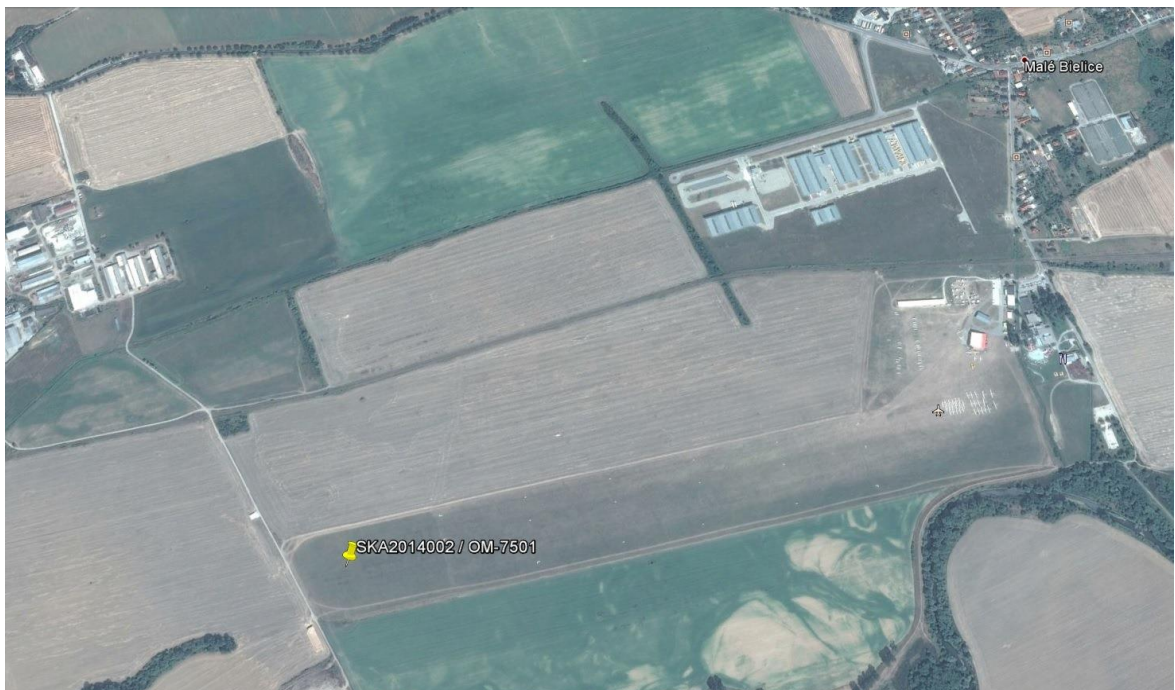
The glider fell to an even ground without major obstacles behind the airport LZPT.
