FINAL REPORT

on investigation of accident
of glider type **Astir CS 77**
Registration No. **D-4802**

Reg. No.: **SKA2014003**

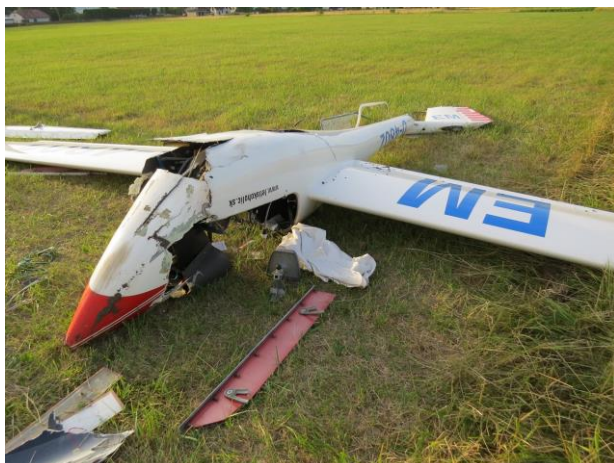
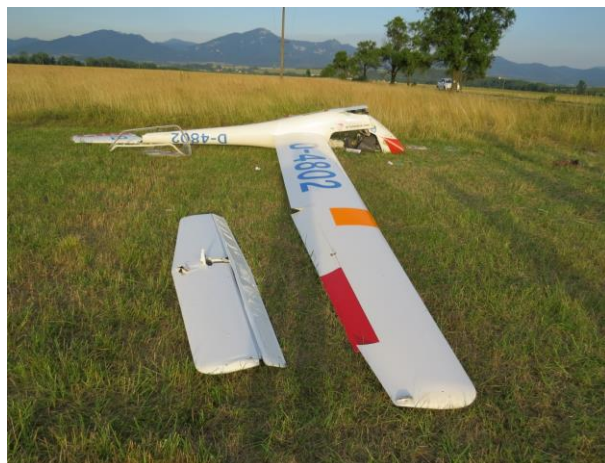
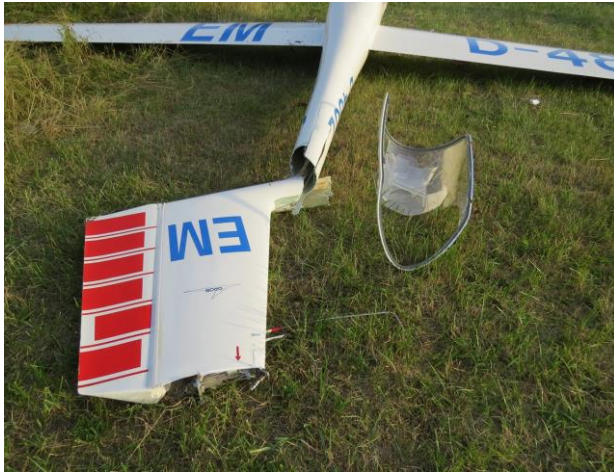
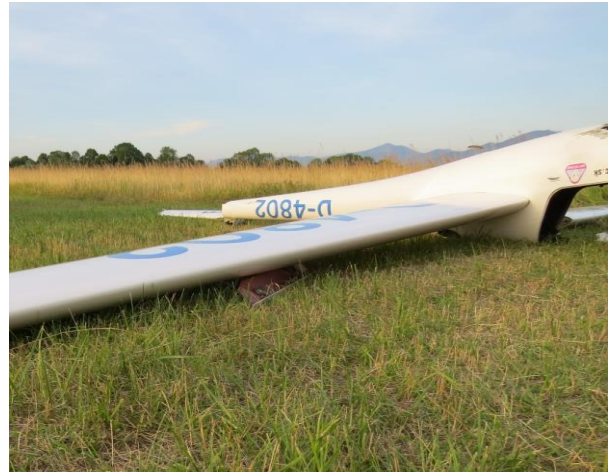
The glider was destroyed in the accident:

- Front fuselage fully destroyed
- Fuselage broken
- Stabilizer and elevator broken off
- Air brakes broken out.

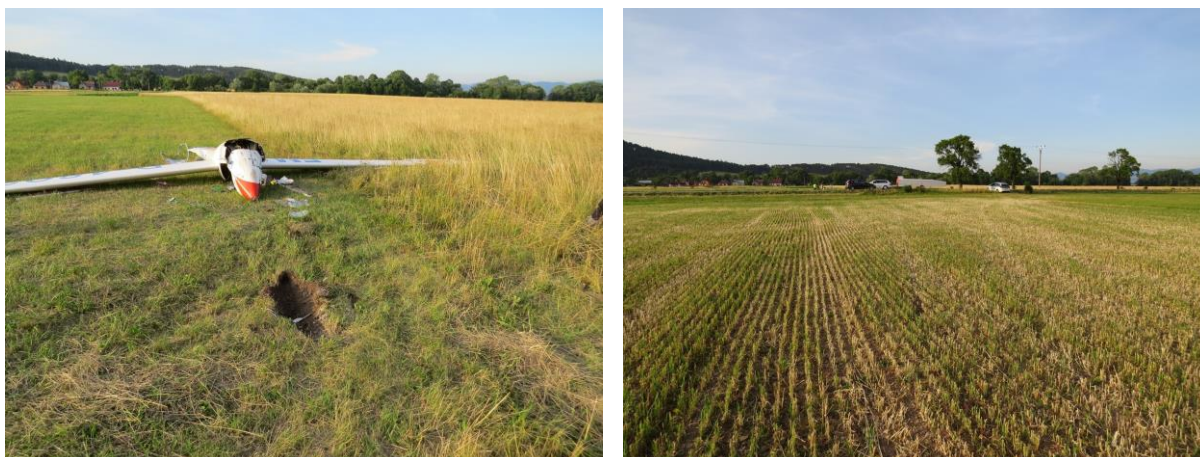
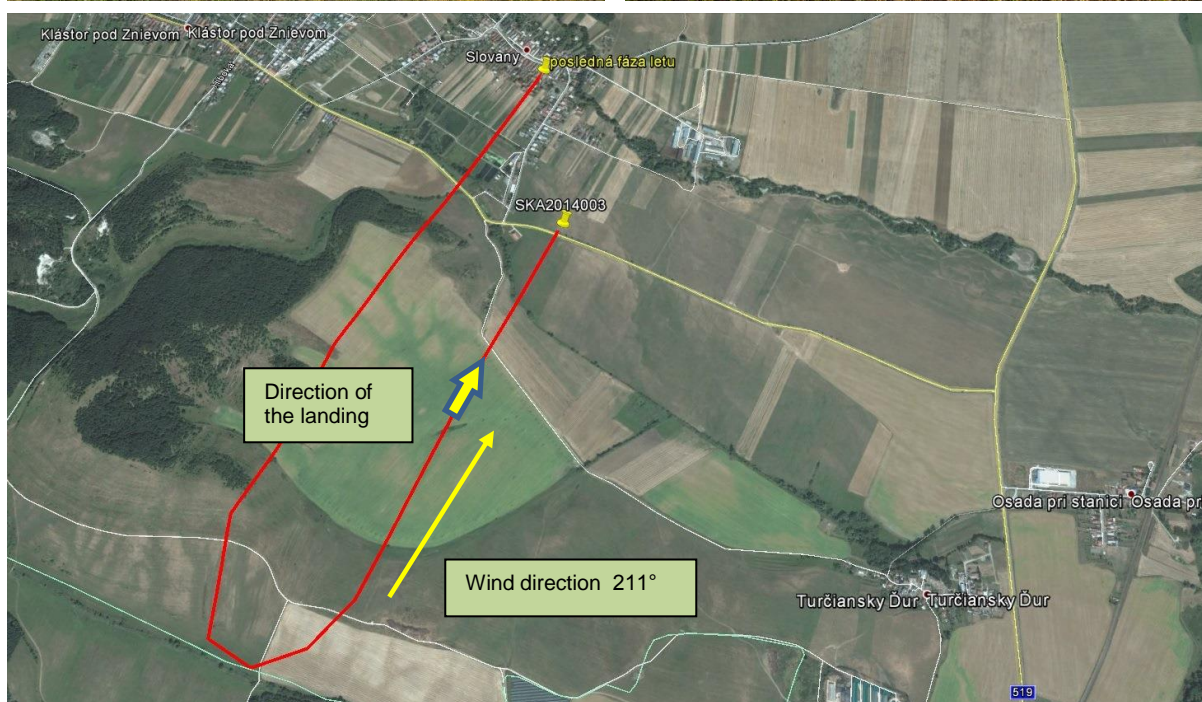
The area surface consists of a meadow with grass growth of 20-30 cm.
