FINAL REPORT

on investigation of serious incident

of aircraft type **AN-12B**

Reg. No.: **SKS2014002**

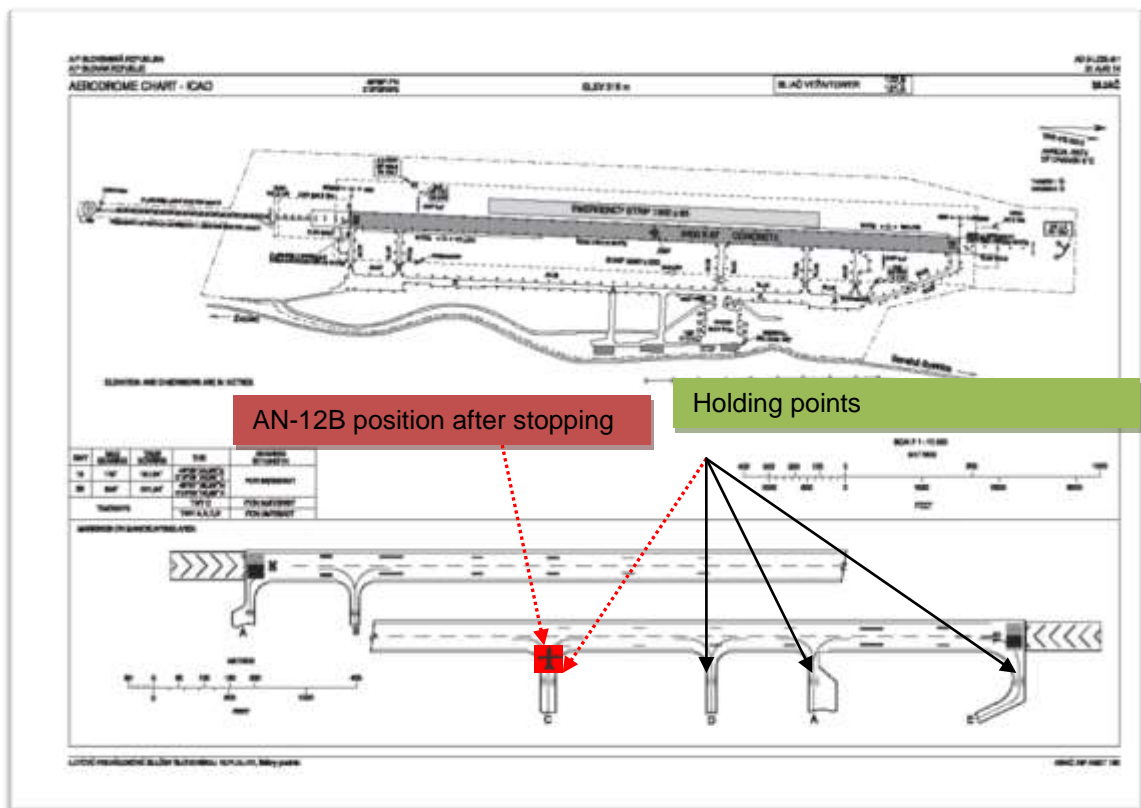
Figure No. 1

The pilot continued taxiing to RWY18 until he the controller gave him a peremptory order to immediately stop (“Mike India Golf niner one six four stop! Immediately stop!”). At that time the aircraft MIG9164 already crossed the line marking the holding point before lining up RWY (Figure No. 1). The controller of TWR correctly reacted to the situation by issuing the go-around order for SABRE 04 “Sabre zero four, go around”.

- To strictly use the standard phraseology in accordance with L4444
- To limit or eliminate non-standard manoeuvres of military operation in the area of responsibility of ATC at simultaneous control of a civil aircraft.
