FINAL REPORT

on investigation of accident

of glider type **ASW 24**

Registration No. **OH-794**

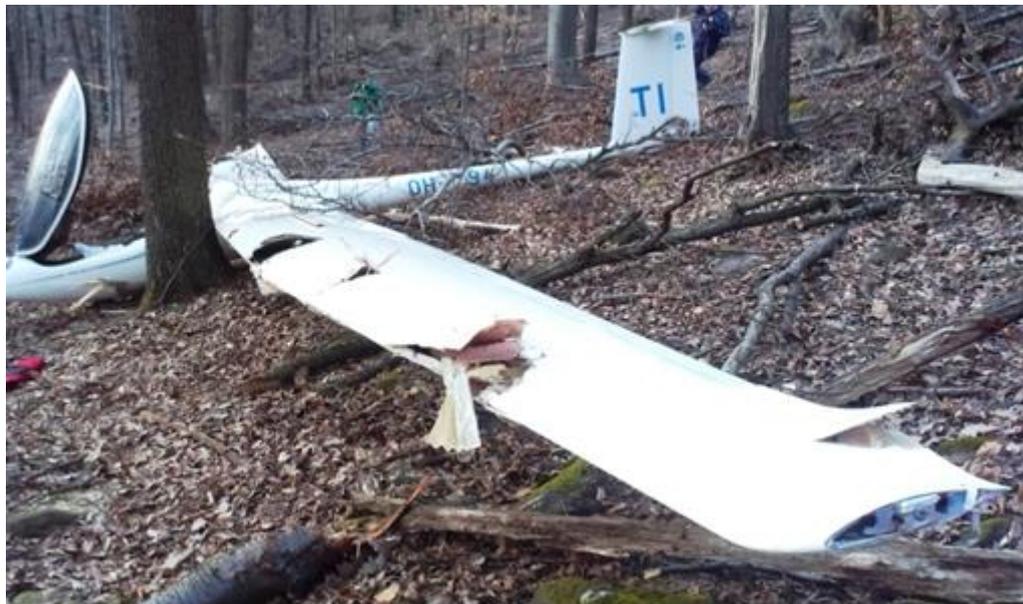
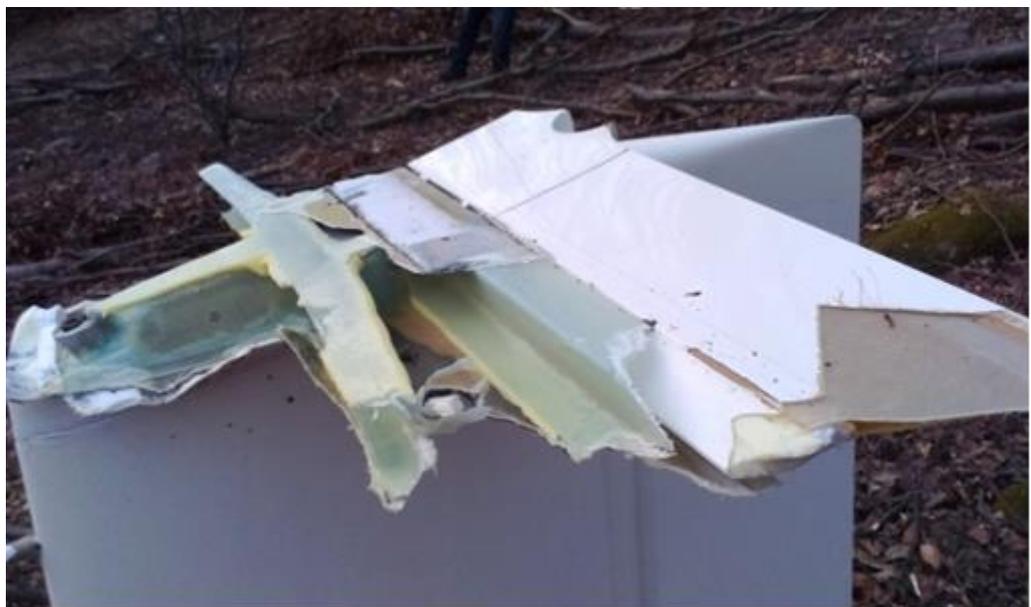
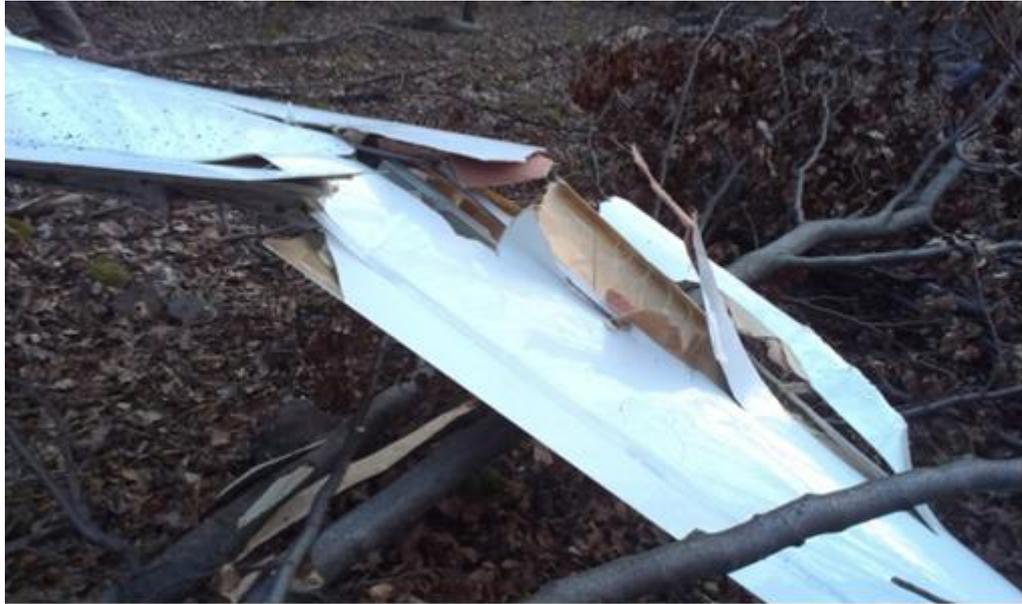
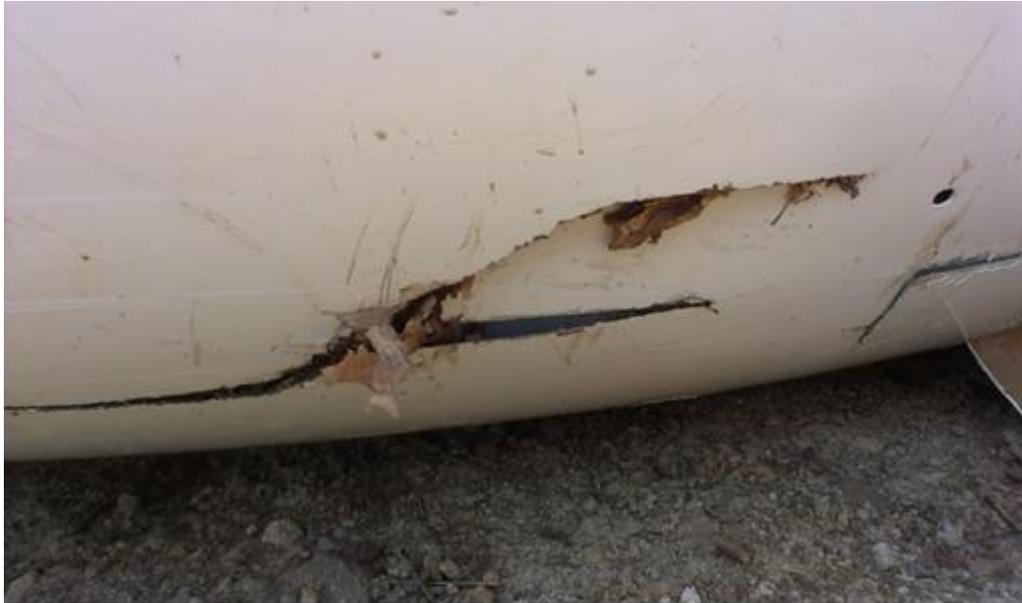
The glider was destroyed in the accident:

- Broken right wing
- Seriously damaged left wing
- Broken horizontal rudder
- Damaged lower part of body

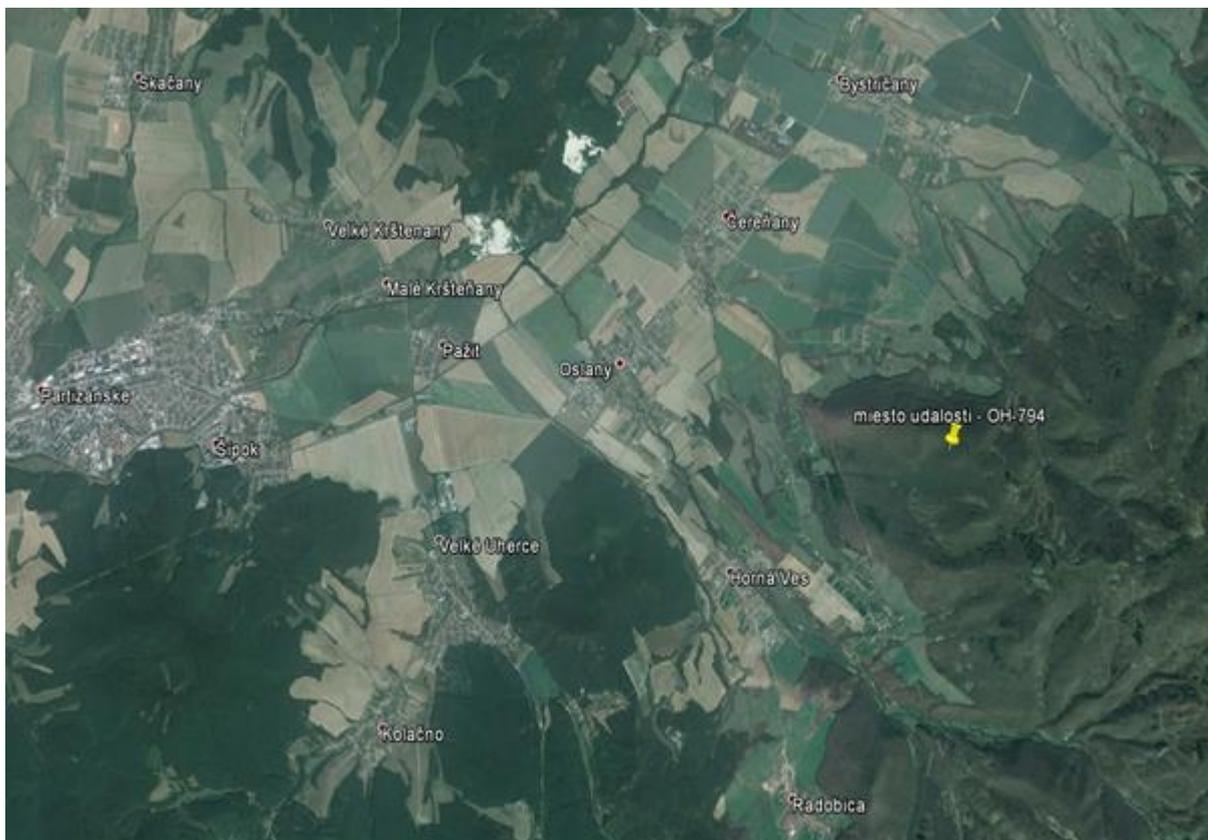
The glider fell into hilly terrain with trees tall approximately 20-30 m.
