AVIATION AND MARITIME INVESTIGATION AUTHORITY
Námestie slobody 6, P.O.BOX 100
810 05 Bratislava 15

FINAL REPORT

on investigation of accident
flying sport vehicle **Speed Glider**
without identification number

Reg. No. SKA2015002

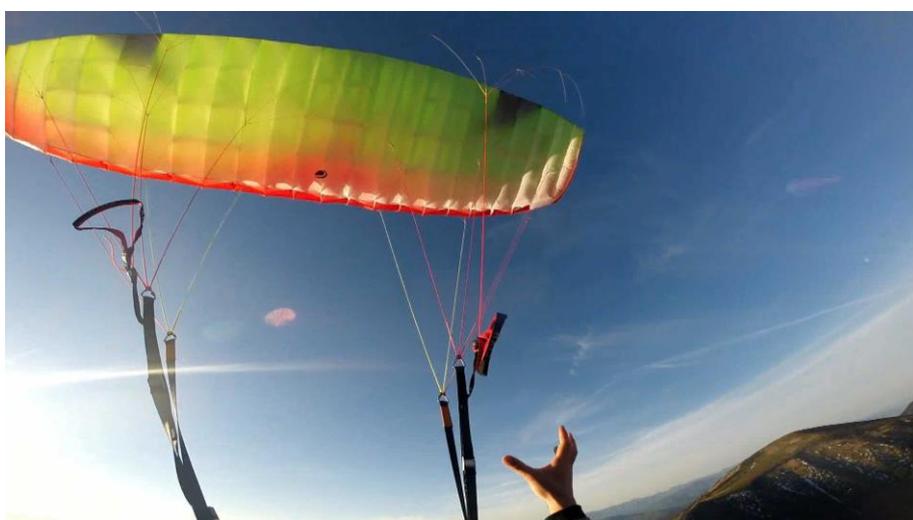
The pilot with FSV started at 04:20 am. After the take-off he let loose the steering lines and settled down in the seat. Then he wanted to again grip the steering lines, but he could not reach them.

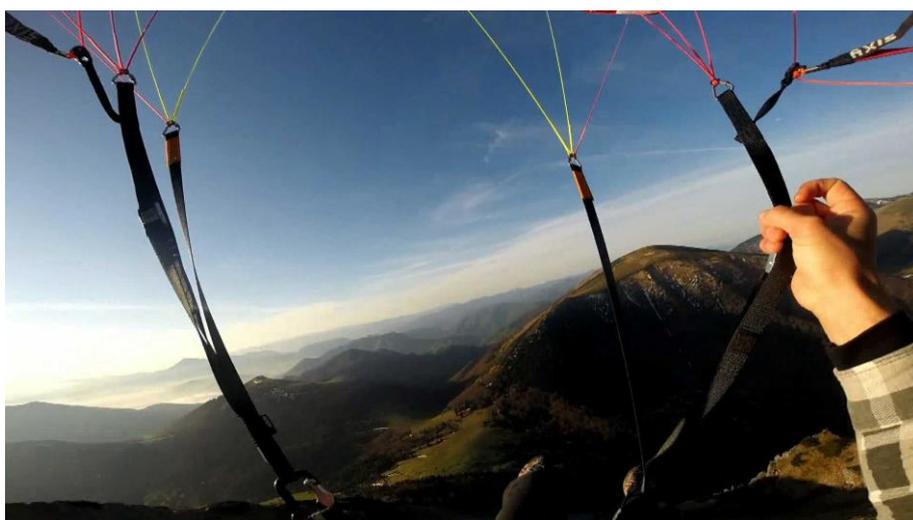
In the effort to reach the steering lines, he pulled on the right-hand back harness, causing the wing to sway. Some 10 seconds later FSV crashed hard into the ground.

The pilot failed to adjust the speed glider seat before the flight, which led him to let the steering lines loose in order to settle down in the seat and failed attempting at griping them again. During this manoeuvring the speed glider started to sway violently and finally crashed into the ground.

Non-adjusted speed glider seat and poor mastering of the flying technique.

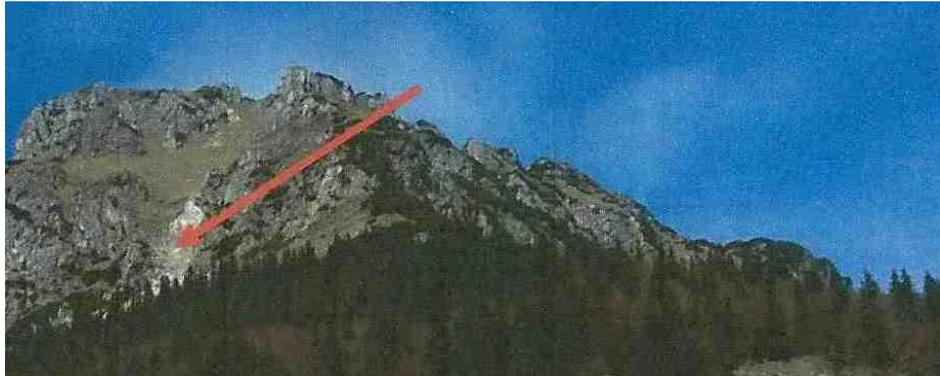
The pilot fell about 300 m away from the place of take-off run, in altitude of 1398 m.
