FINAL REPORT

on investigation of accident
of glider type **Cirrus VTC**
Registration No. **OM-2908**

Reg. No: **SKA2015003**

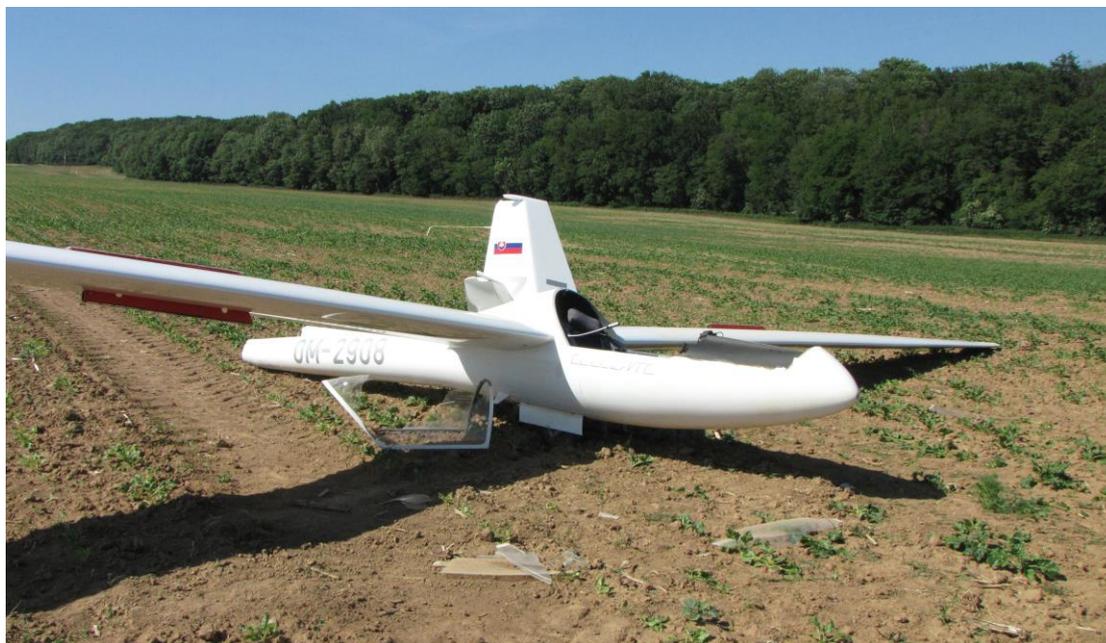
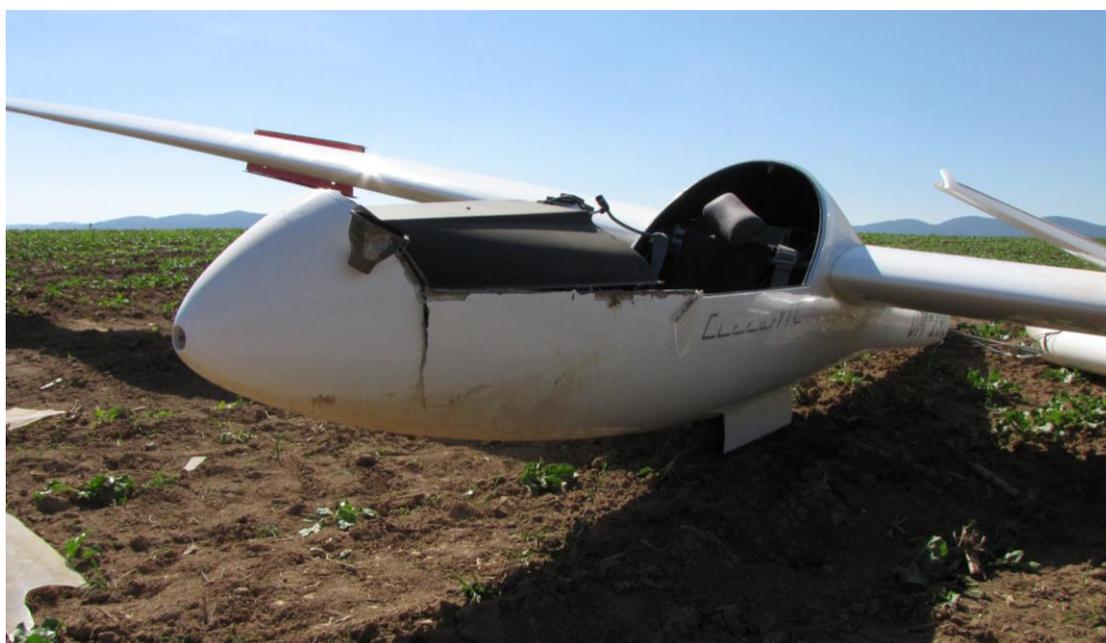
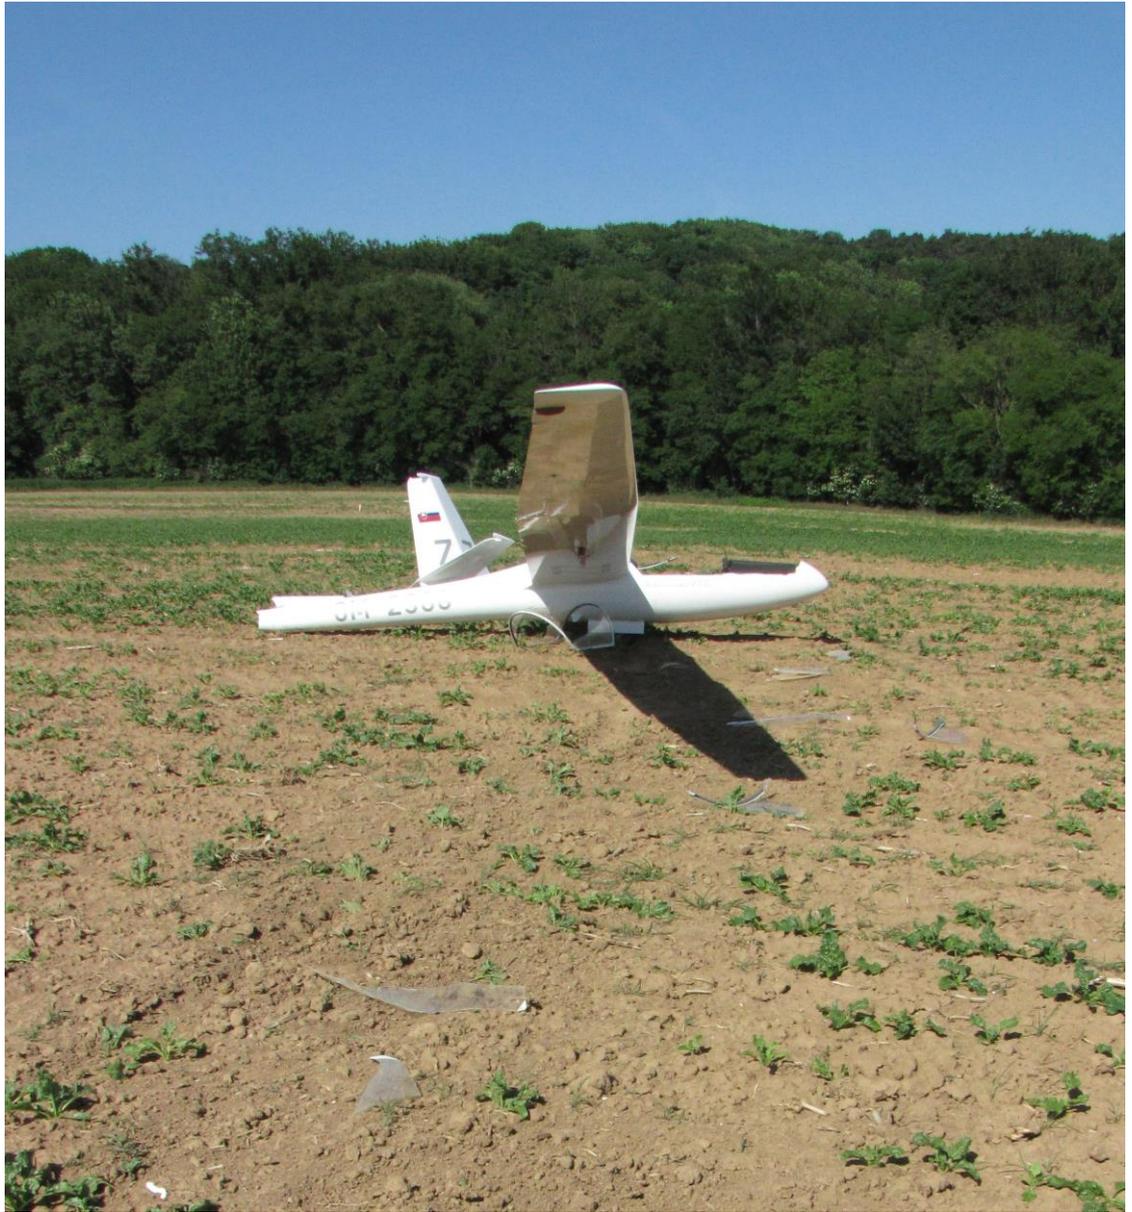
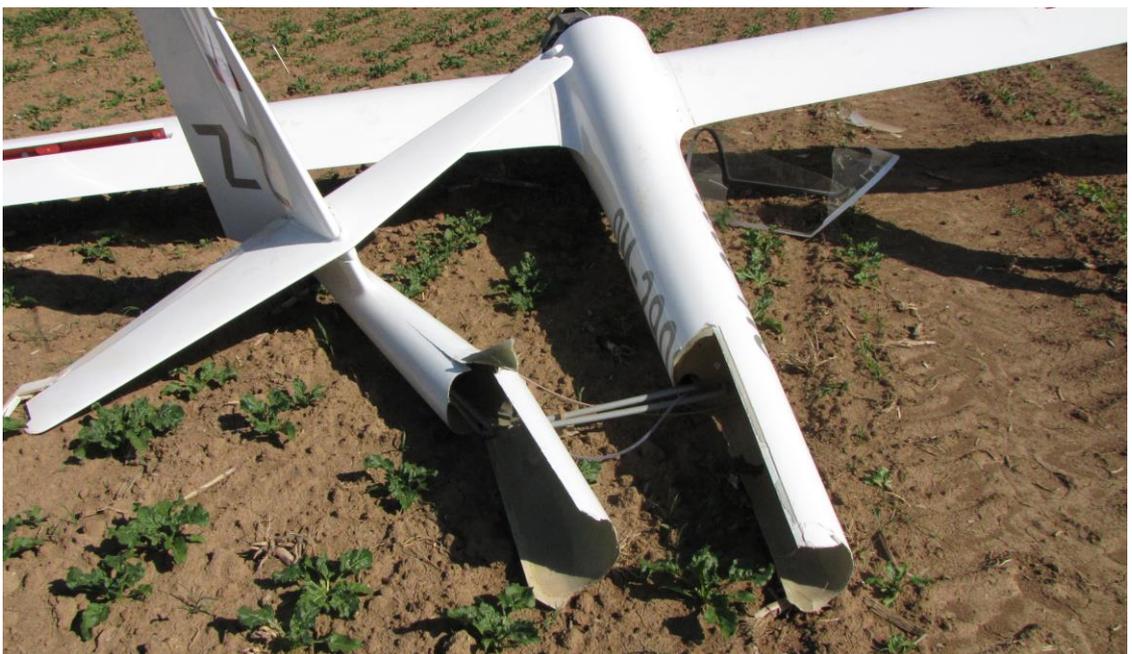
The glider was destroyed in the accident:

- Broken hull,
- Damaged lower part of body and cockpit.

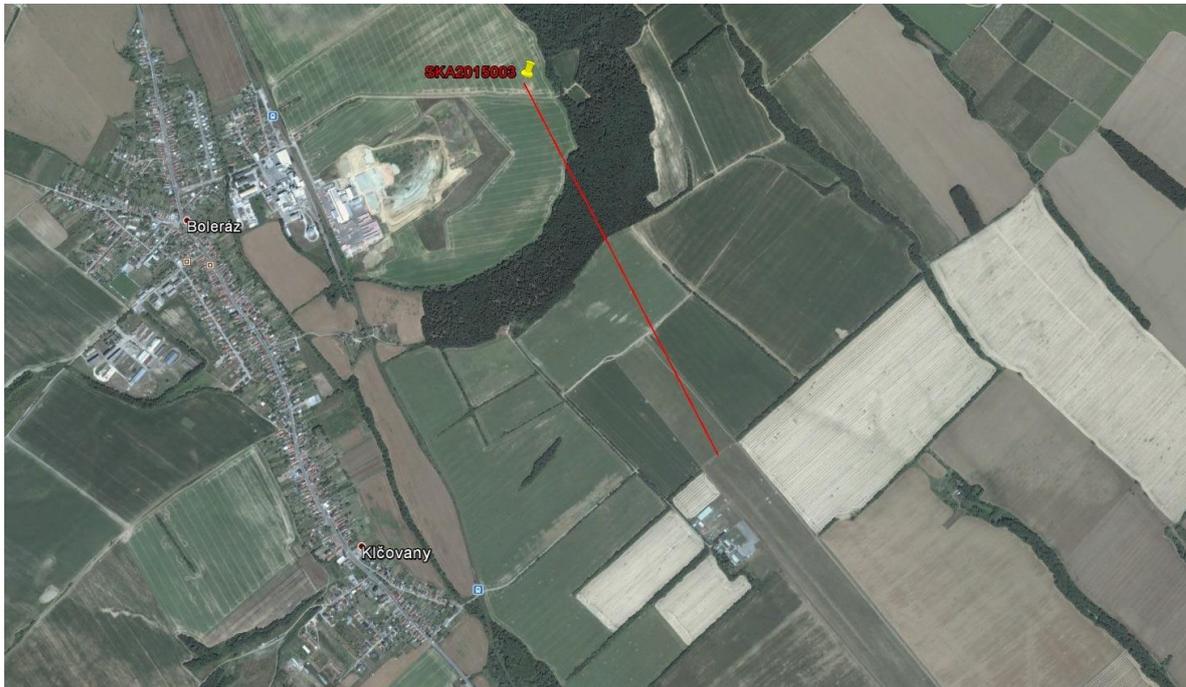
The glider landed in the field 1.84 km north-west of the threshold of RWY14 of the aerodrome LZTR.

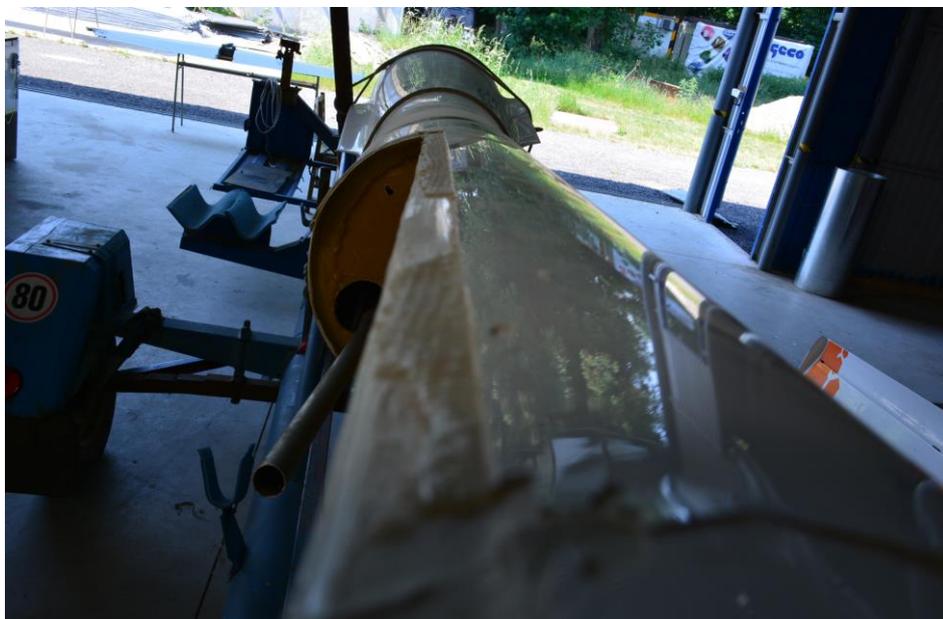
- Inspection of the glider was performed with the aim to verify whether some controls had not been damaged. The result of inspection was negative.
- Following a visual check of the wreckage and inspection of the fracture areas by the commission, the inspectors found shining surfaces sprayed by colour, which could have get to the hull margin during preparation of the mould in the manufacturing process. The commission concluded that during the manufacturing procedure, before gluing of the halves of the hull, the surface of the glued joint had not been perfectly prepared for gluing.

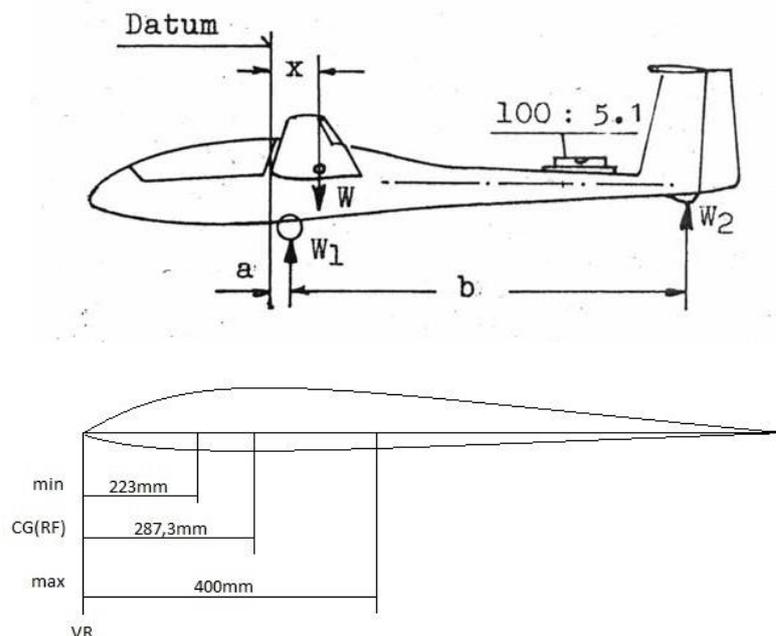
- CG(E) 618.6 mm – position of the empty glider’s centre of gravity according to the report on the certificate of airworthiness dated 7 May 2015.
- W 304.2 kg – empty weight according to the report on the certificate of airworthiness dated 7 May 2015
- a 500 mm – position of the pilot’s centre of gravity according to the flight manual in front of the datum - negative moment
- Wp 128 kg – weight of the pilot
- W(RF) W+Wp - (304.2 kg+128 kg = 432.2 kg)

- Maximum front: M.F.C.G. = 223 mm behind the datum
- Maximum rear: M.R.C.G. = 400 mm behind the datum

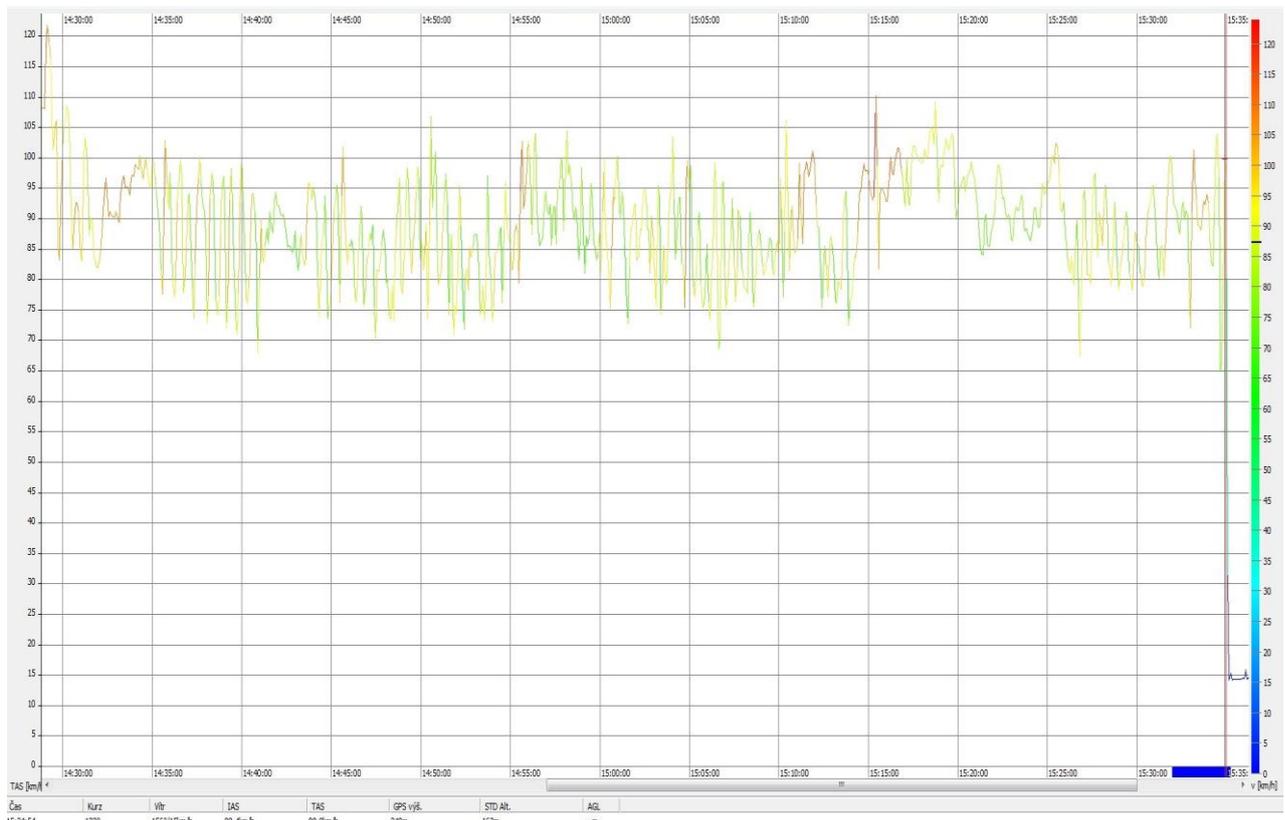
According to the onboard flight recorder during the critical flight the pilot flew with the glider at low speeds near to the stall speed. Moreover, the controls were low-efficient and did not allow him to perform the planned manoeuvres. At the attempted left turn the glider changed from the left-hand turn to the left wing stall with a sign of left spin.

Stall speed of 75 km/h at area load in the critical flight
Optimal flight speed of 85-90 km/h at area load in the critical flight

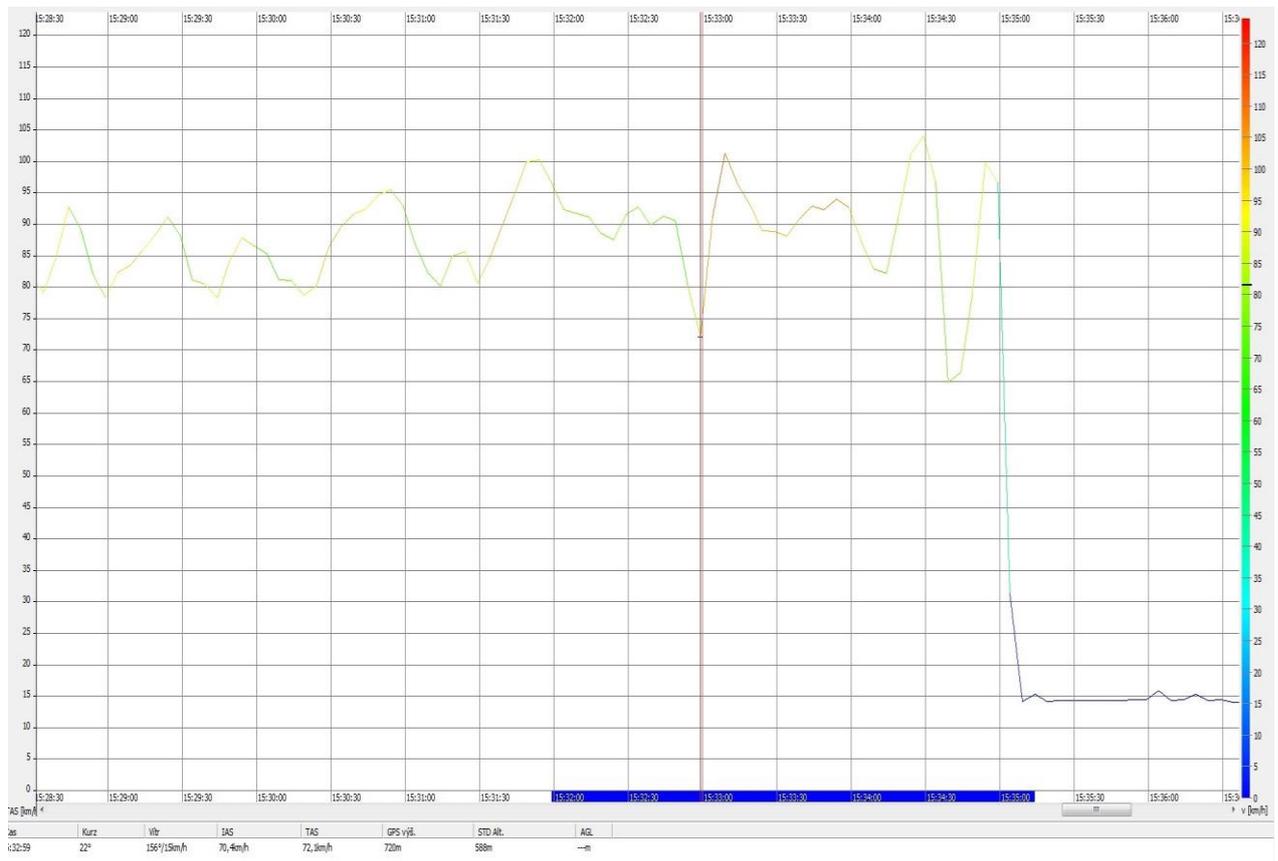
At the last flick into a left spin the glider was flying in such a low altitude that all the pilot could do was fully extend the air brakes and land in the field in front of him. After the contact with the ground at speed of about 100 km/h the glider did not continue by straight landing run, but he turned left in slipping, which caused destruction of the front section and breaking of the rear part of the hull.
