FINAL REPORT

on investigation of accident
of helicopter type **AGUSTA A 109K2**
Registration No **OM-ATB**

Reg. No: **SKA2015004**

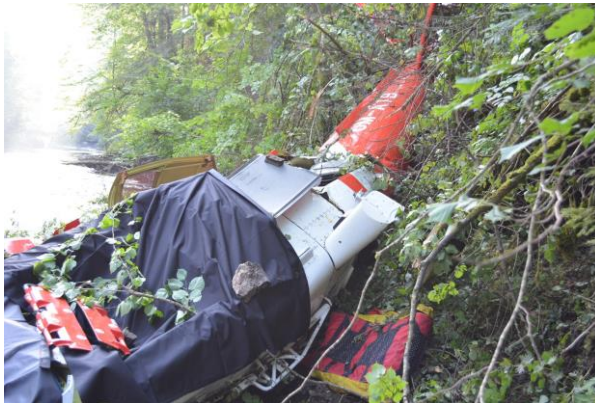
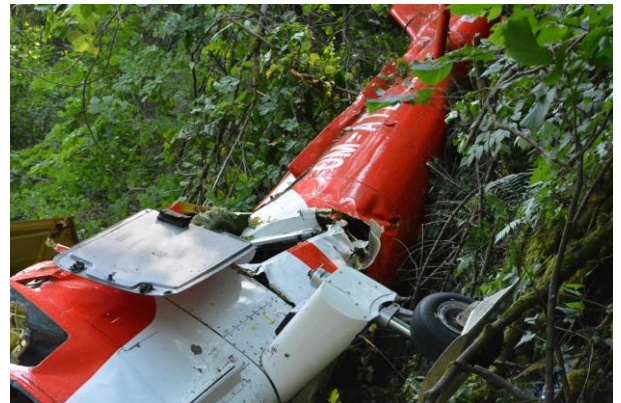
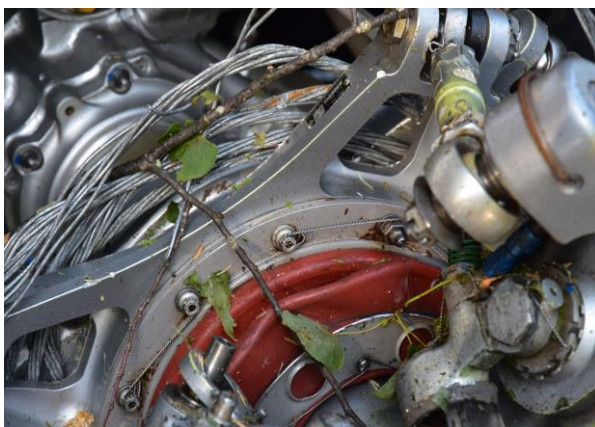
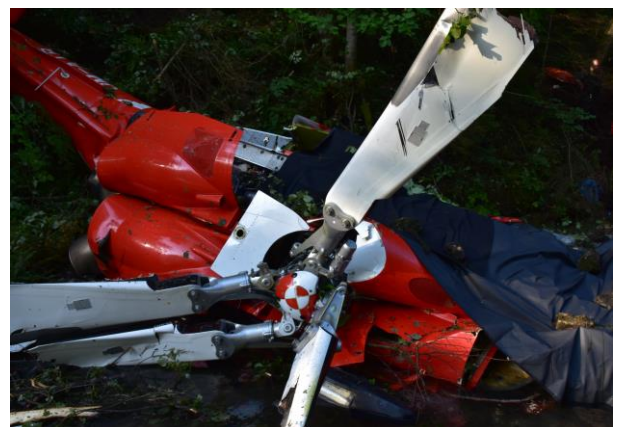
The helicopter was destroyed in the accident:

- fully destroyed rotor, broken helicopter body, massive damage to the cabin.

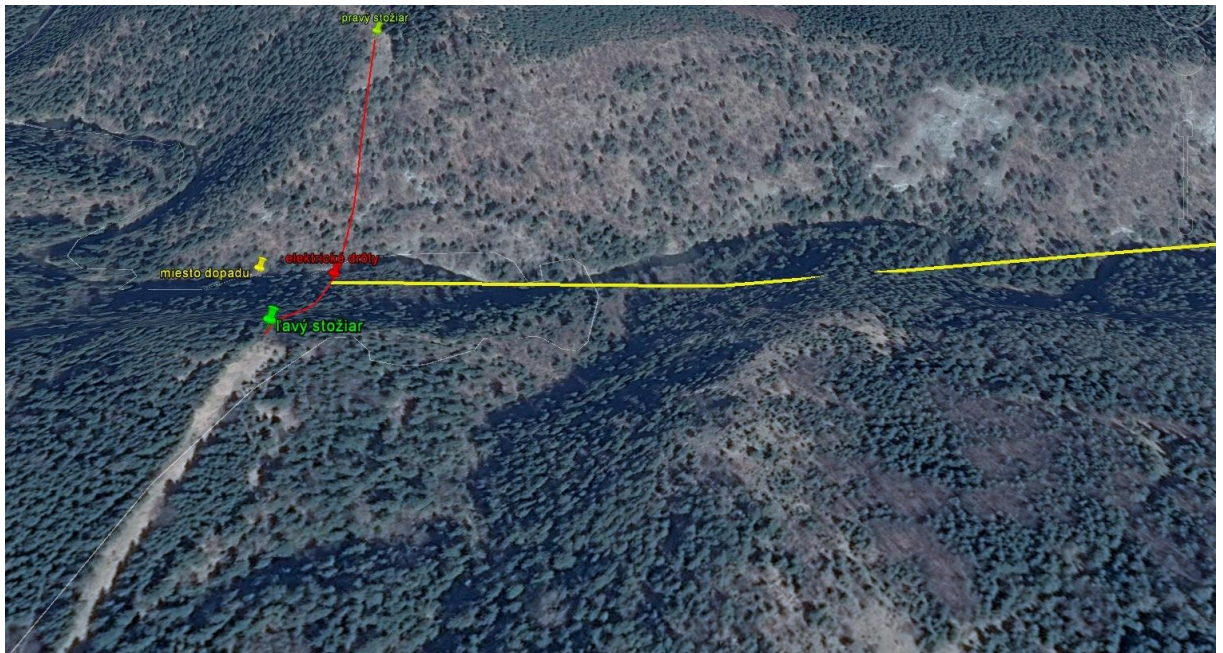
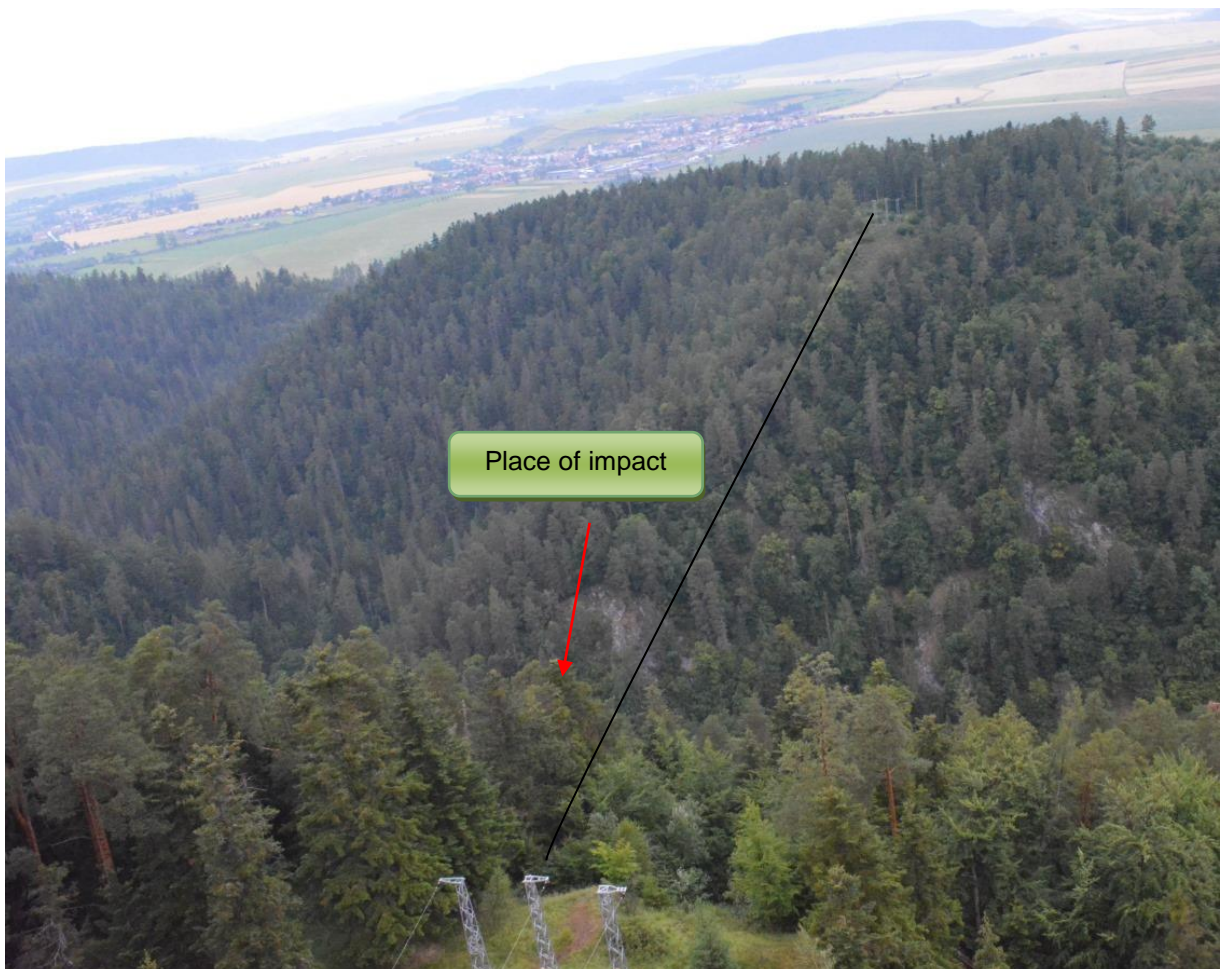
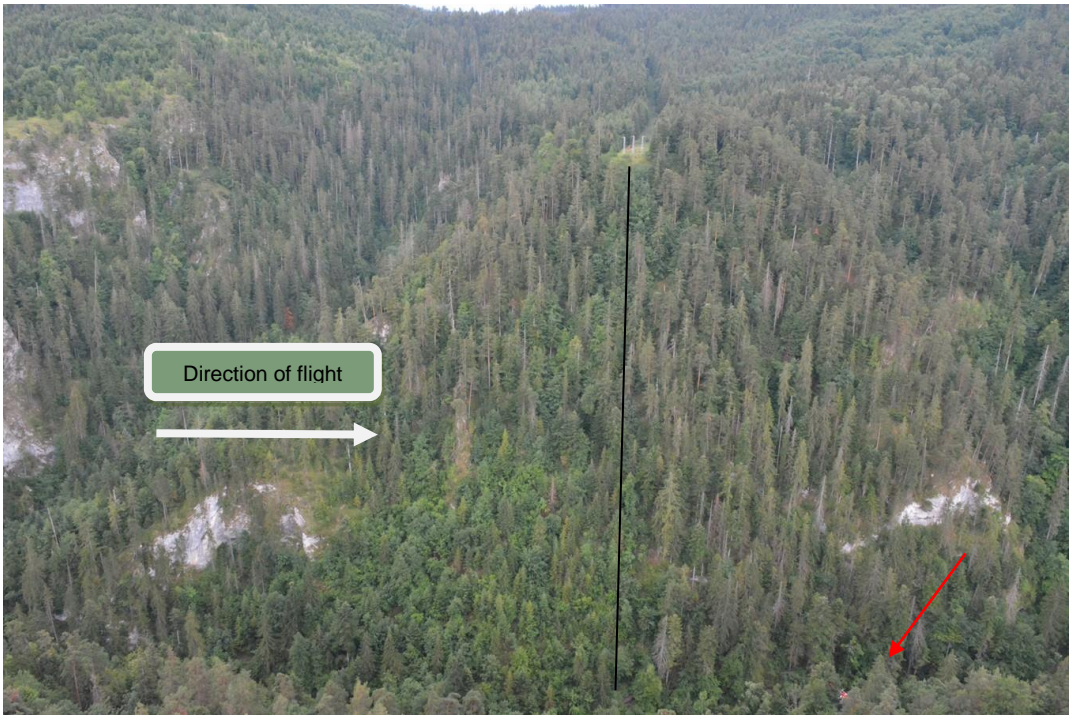
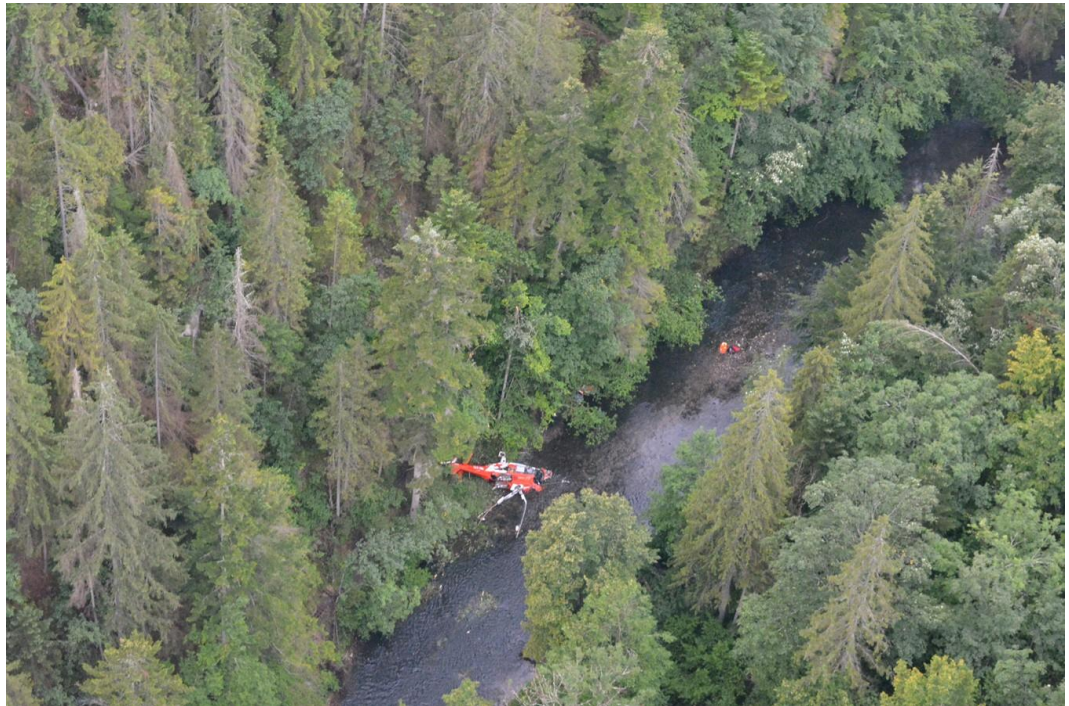
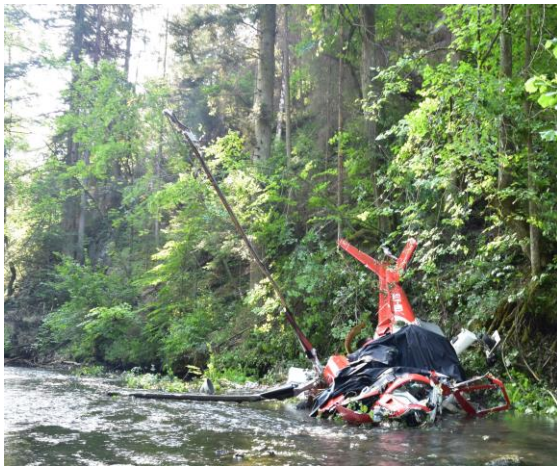
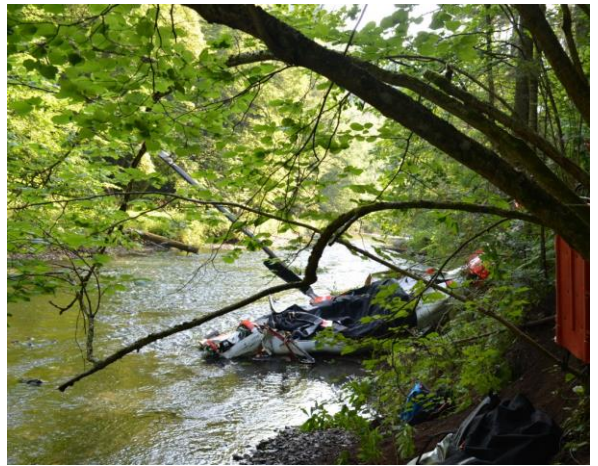
N 48°57'10.10" E 20°25'12.70"

The helicopter crashed into a narrow gorge, on the bank of a river, in hardly accessible area with thick forest stand. A portion of wrecks was dispersed in its proximity, in the river. Segments of rotor blades were found on a hardly accessible hillside of the gorge.

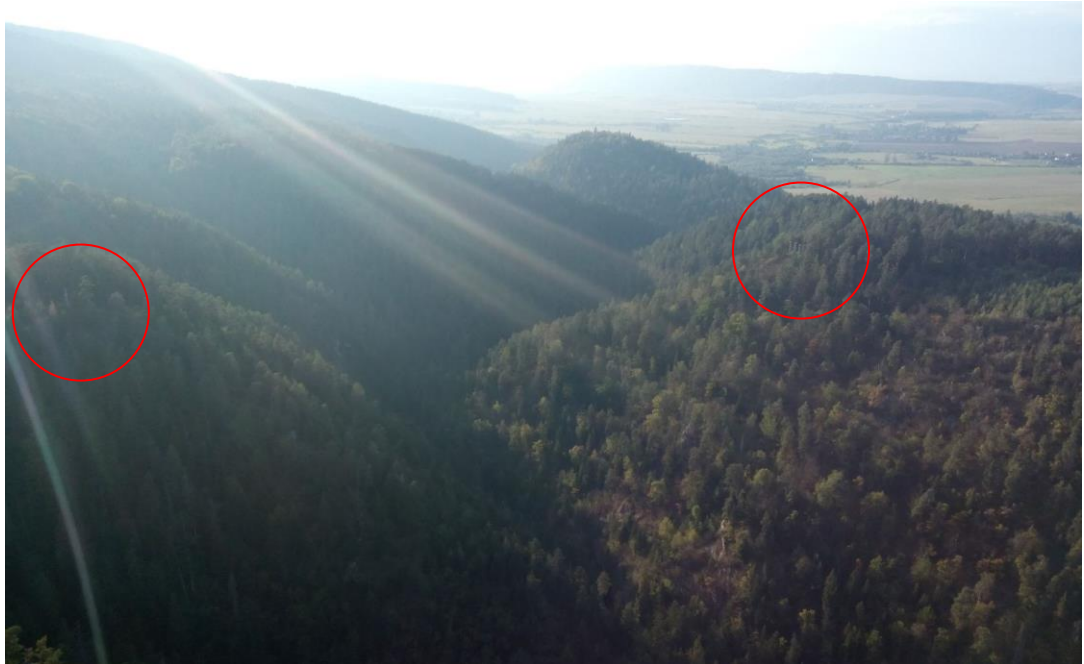
The arrival at the place of accident was performed on a straight course to the Sun, like on the day of accident. Although the pilot was exactly informed about the location of existing power line pylons and conductors he had to interrupt the arrival at the close proximity of the place of accident, because he was unable to identify the obstacle. Subsequently, he conducted air suspension and with help of the operator identified the pylons without problems; however, the position of conductors toward the ground and the Sun could not be identified.

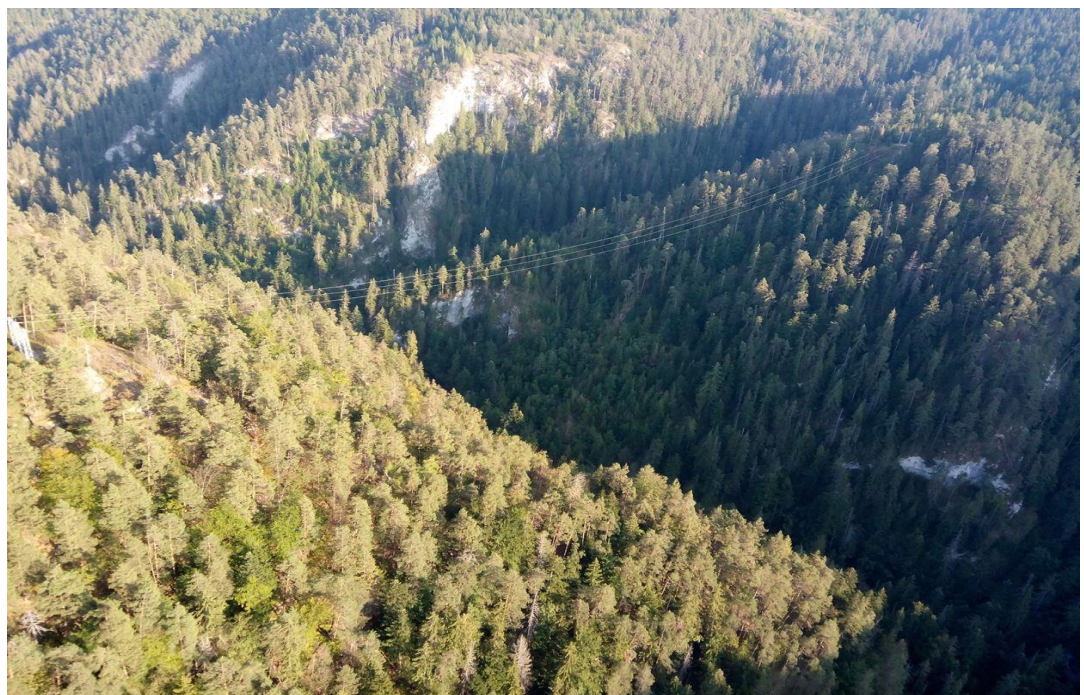
The pilot also conducted approach/arrival from the opposite direction, i.e. from east to west, like on the day of accident, but this time with the sun shining from behind his back. He identified the power line pylons and conductor without problems.

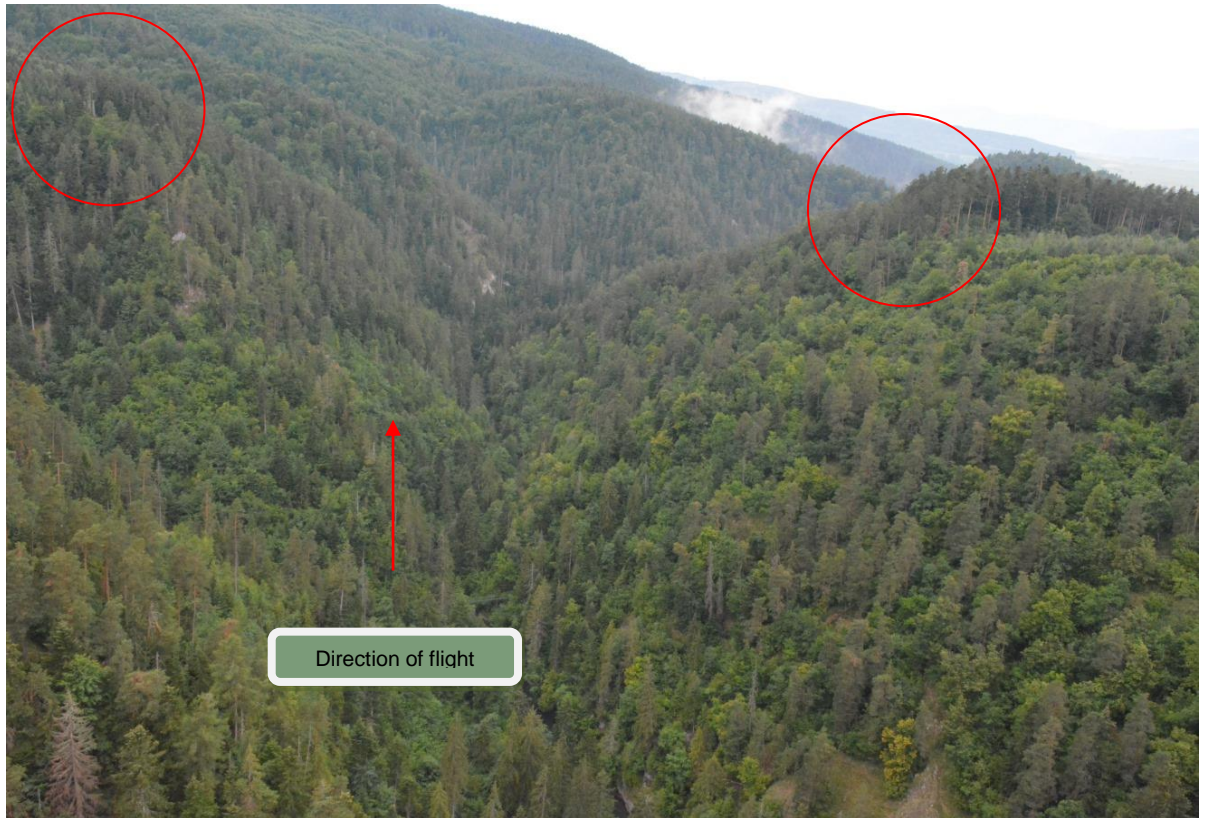
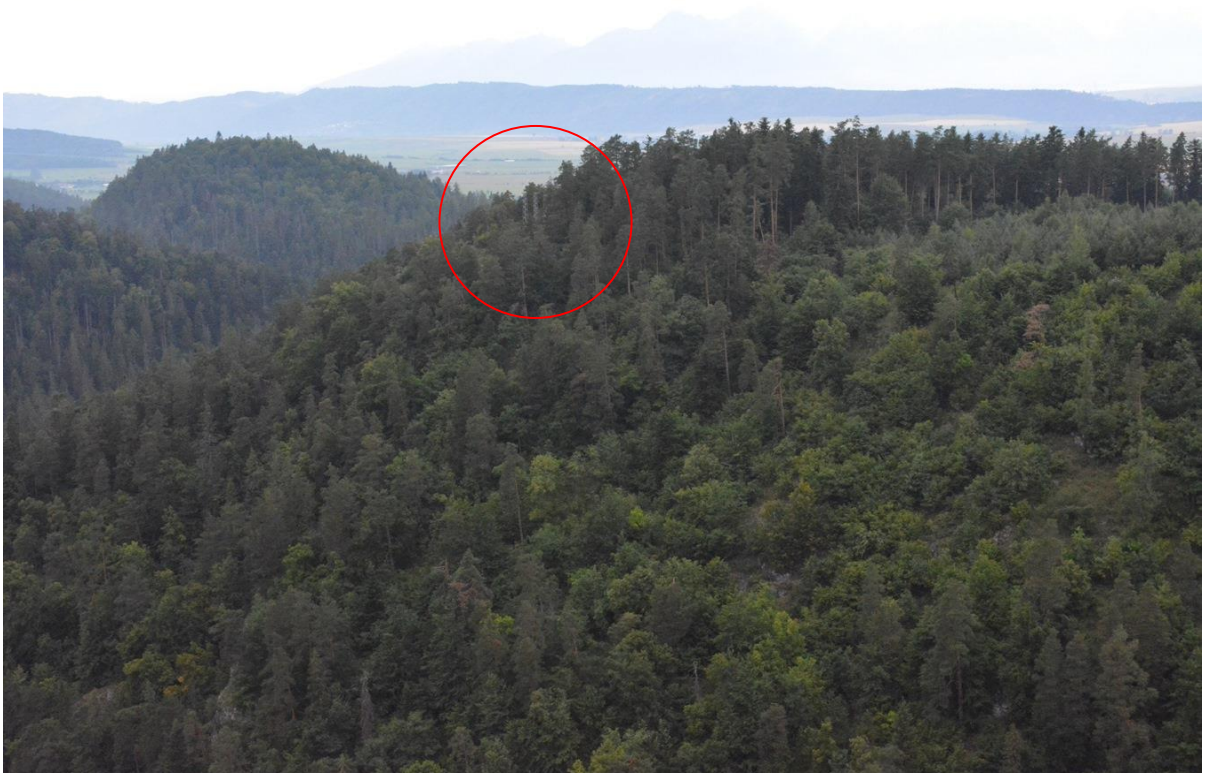
The process of destruction and the character of damage to preserved fragments indicate the primary contact of electric power lines with peripheral arches of main rotor blades. On this basis it can be concluded that in the final approach phase the flight was conducted at the level of the power lines from the view of rotor blades and with the helicopter slightly banking to the right, which is proved by the fact that the first conductor remained intact and that rotor blades collided with the following conductors.

It can also be assumed that one of potential causes of the contact with power lines was the pilot's limited view in certain directions during the flight due to the structure of cabin and dashboard. If the pilot does not notice an obstacle before some point of time, in the following phase of flight this obstacle is practically unidentifiable.
