FINAL REPORT

on investigation of accident

of aircraft types **L-410UVP, L-410MA**

Registration numbers: **OM-ODQ, OM-SAB**

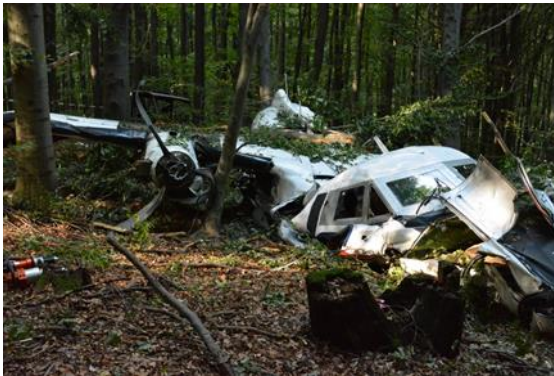
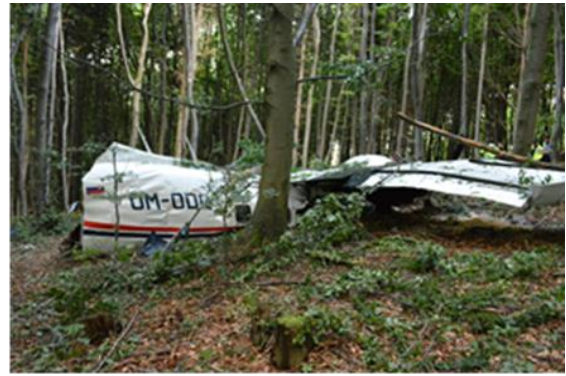
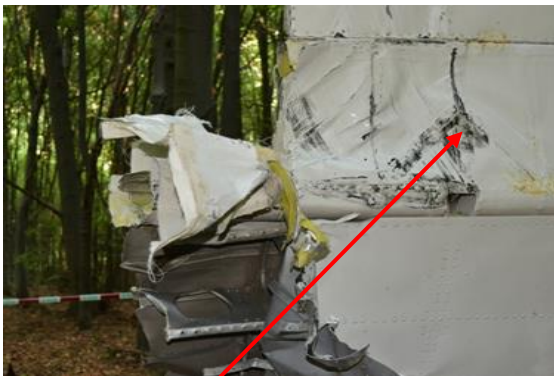
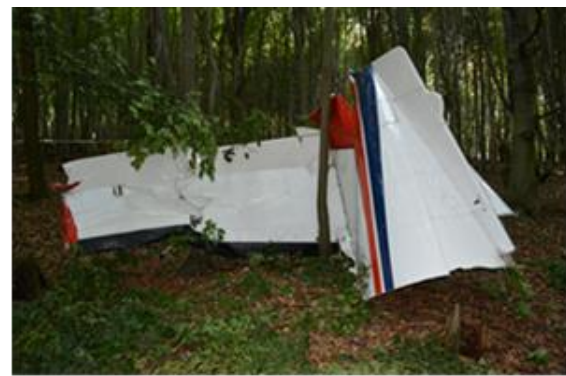
*Traces left by aircraft OM-SAB
on the separated tail of OM-ODQ*

*Separated tail of OM-ODQ
near the 24th partition*

In the contact the right wing of aircraft OM-SAB first damaged the roller door of aircraft OM-ODQ in the upper section. In the following movement its rear part, in the direction from the door to the tail, got so severely damaged that the tail of the aircraft, together with horizontal and vertical surfaces, came off in the area of the 24th partition.

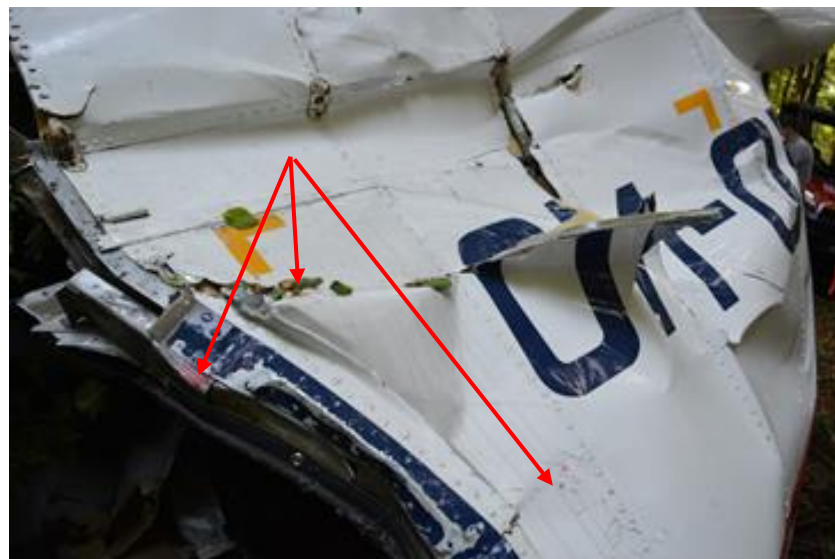
In the contact the right wing of aircraft OM-SAB first damaged the roller door of aircraft OM-ODQ. In the following movement its rear part, in the direction from the door to the tail, got so severely damaged that the tail of the aircraft, together with horizontal and vertical surfaces, came off and the aircraft OM-ODQ became unmanoeuvrable.

Traces of red colour on OM-ODQ from the wingtip arc of OM-SAB

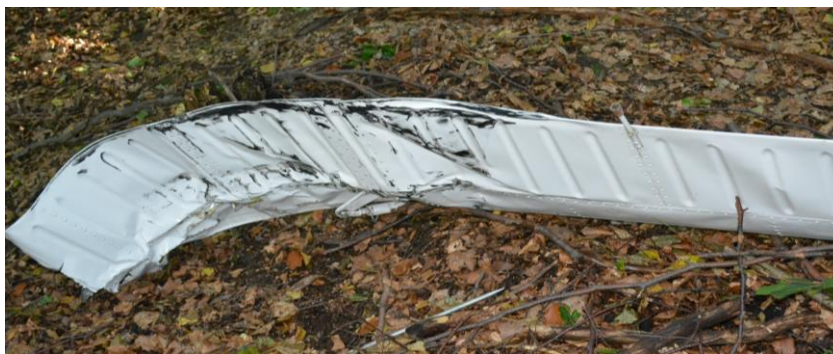
Balance aileron of the right wing of OM-SAB with traces from black tail leading edge of OM-ODQ

The separated tail section of aircraft OM-ODQ then came into contact with the balance aileron of aircraft OM-SAB, which broke off. In the next movement the separated tail damaged the right side of horizontal tail surfaces of aircraft OM-SAB.

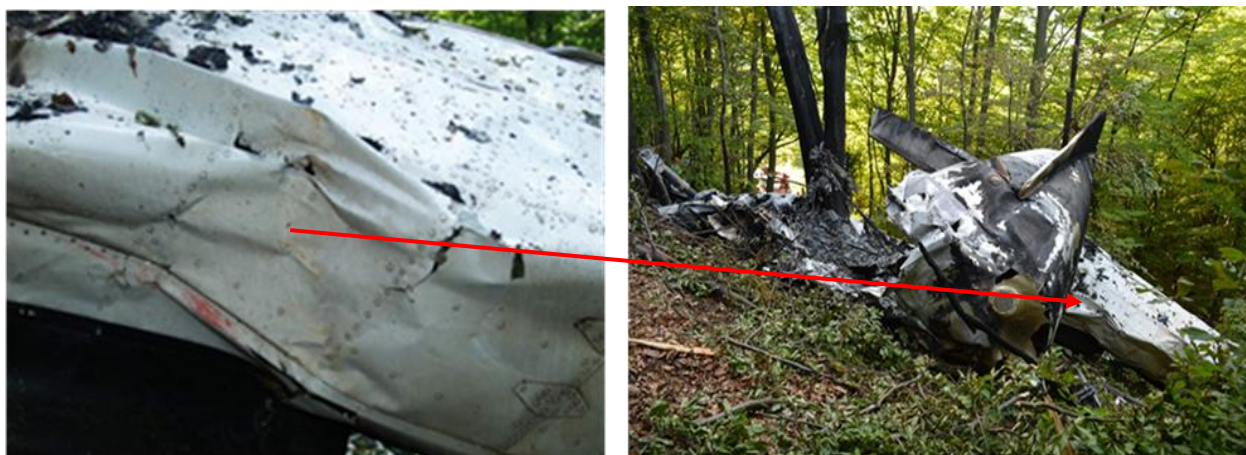
Damaged part of the right horizontal tail surface of OM-SAB from separated tail of OM-ODQ

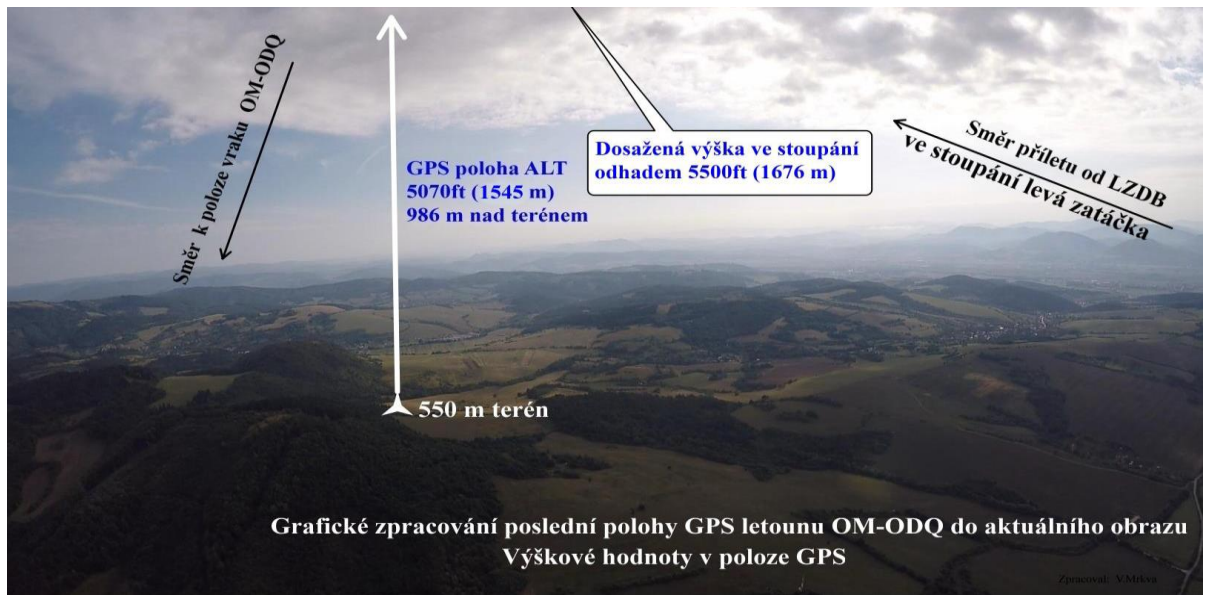
Graphic representation of directions and trajectory related to the GPS fix in an overall picture of the occurrence

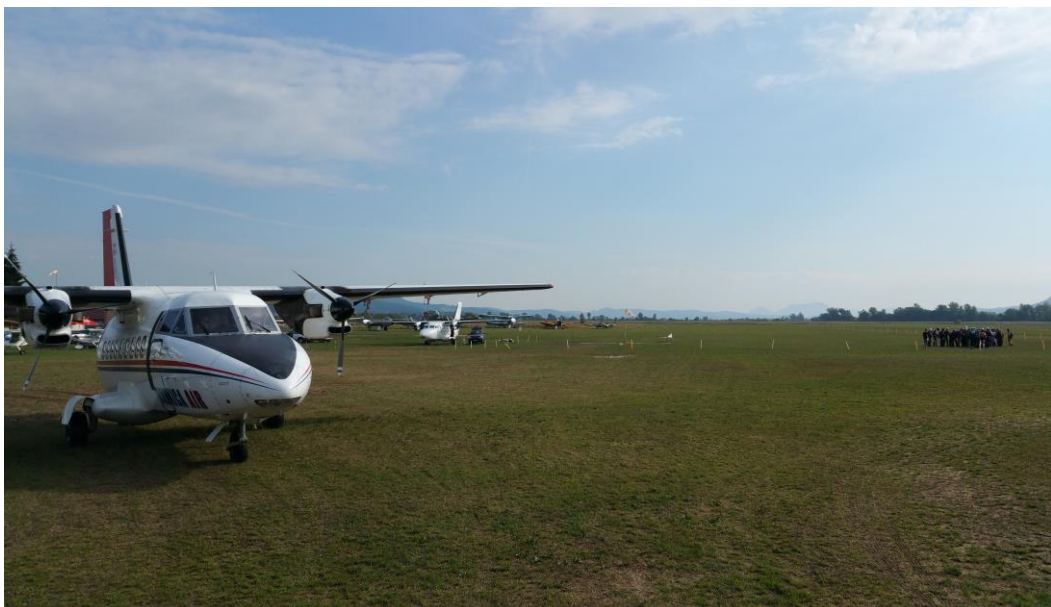
Figure 1: Before the take-off, shot at 09:04:56

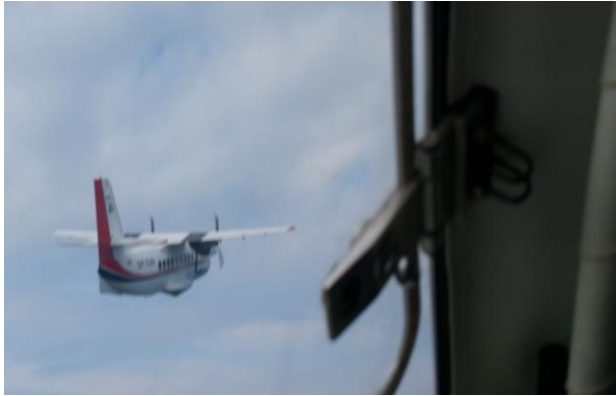
Figure 2: Close formation approach, shot at 09:20:31

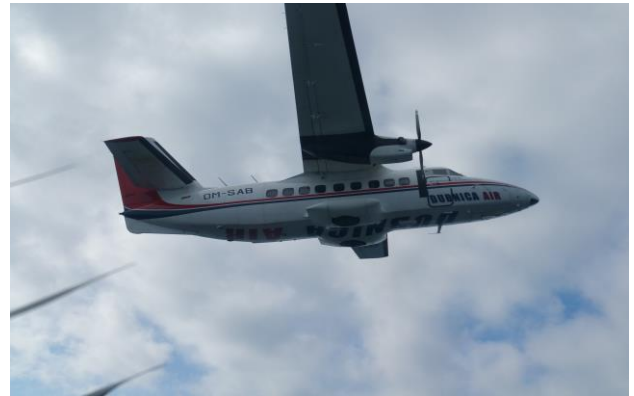
Figure 3: Flight in close formation before collision, shot at 09:20:40

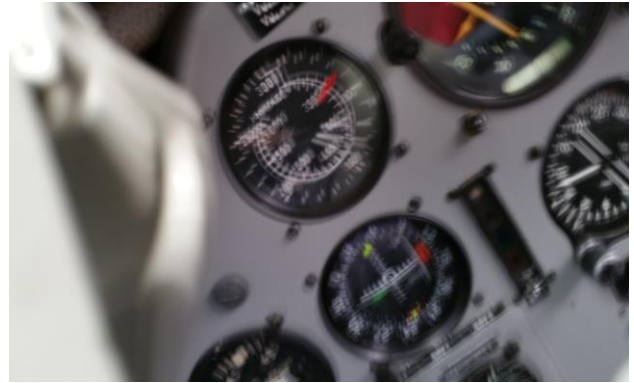
Figures 4-5: Fuzzy pictures, probably after a sudden violent manoeuvre, shot at 09:20:41 and 09:20:43, respectively.
