FINAL REPORT

on investigation of accident

of helicopter type **Mi-2**

Registration No. **UR-CAEO**

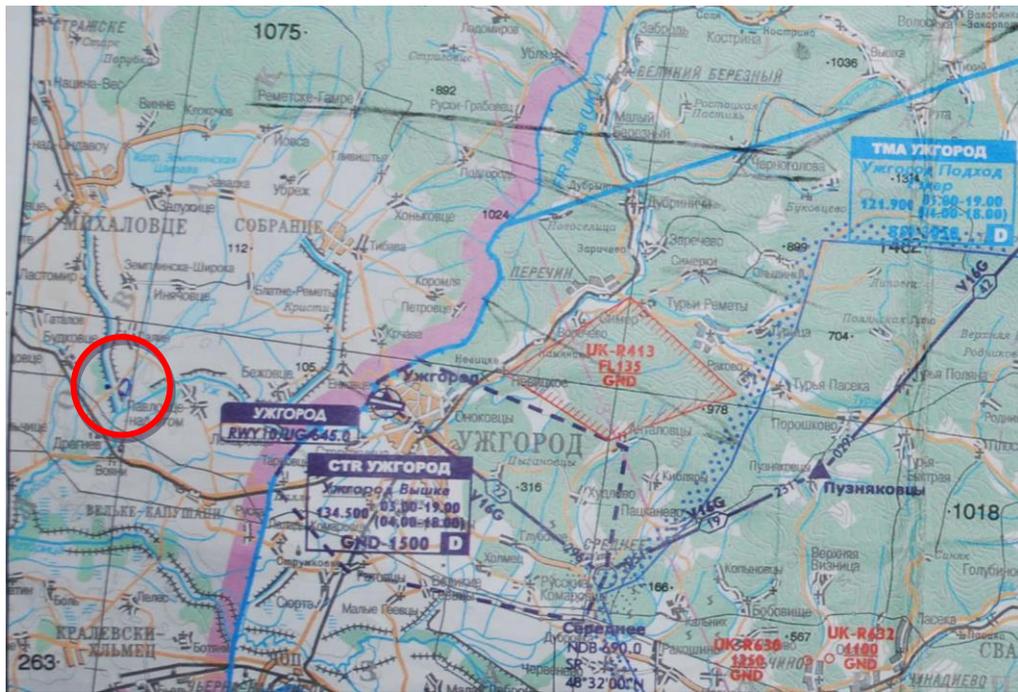
The control panel ARK-9 showed the frequency of 317 MHz, which proved that the pilot probably tried to use NDB of the airport Poprad-Tatry in combination with adjustment of ZK on the wide pointer/rail of the course system indicator (*Fig.6*) for the approach to the planned landing site, which was marked in his aeronautical chart 1: 500 000 by a blue circle (*Fig.1*) and which corresponded to the place of accident.

Fig.1 Marked planned landing site

The marked circle in the aerial navigation chart indicates that the helicopter did not crash on that particular place incidentally; this place was chosen as the planned landing site and the accident occurred during the search for a suitable landing site – the pilot was searching for the chosen area at night and in a thick fog and during the blind descent with zero visibility he hit the ground at a forward speed, probably higher than 95 km/h. The subsequent forward movement of the helicopter caused destruction of the airframe.

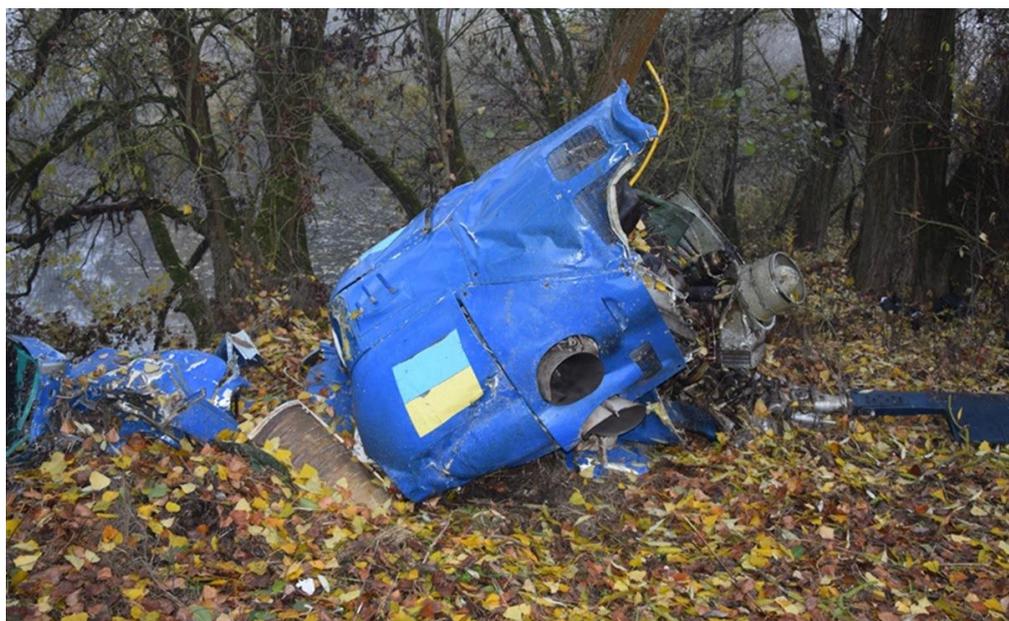
The helicopter was destroyed in the accident.

Fig.2 Front upper part of the airframe with engines

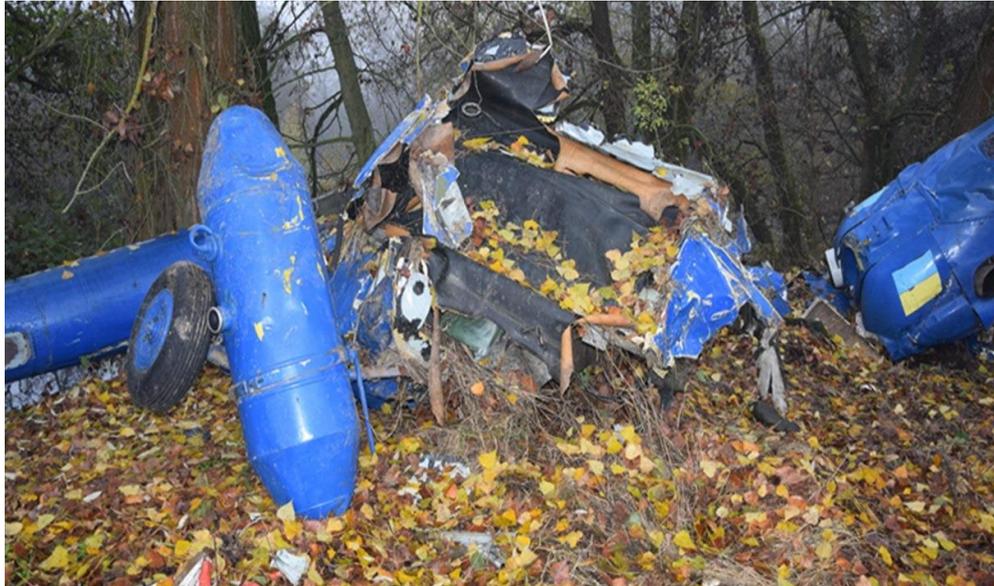
Fig.3 Rear part of the airframe with the right wheel of main landing gear and secondary fuel tank

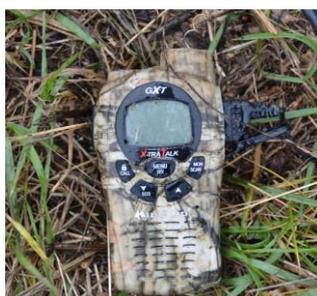
The pilot did not establish communication with LPS SR, š.p. and probably used the manual radio station MIDLAND X-Tra Talk GXT1050 for communication with an unknown person on the ground (Fig.7).

Fig.7 Radio station MIDLAND

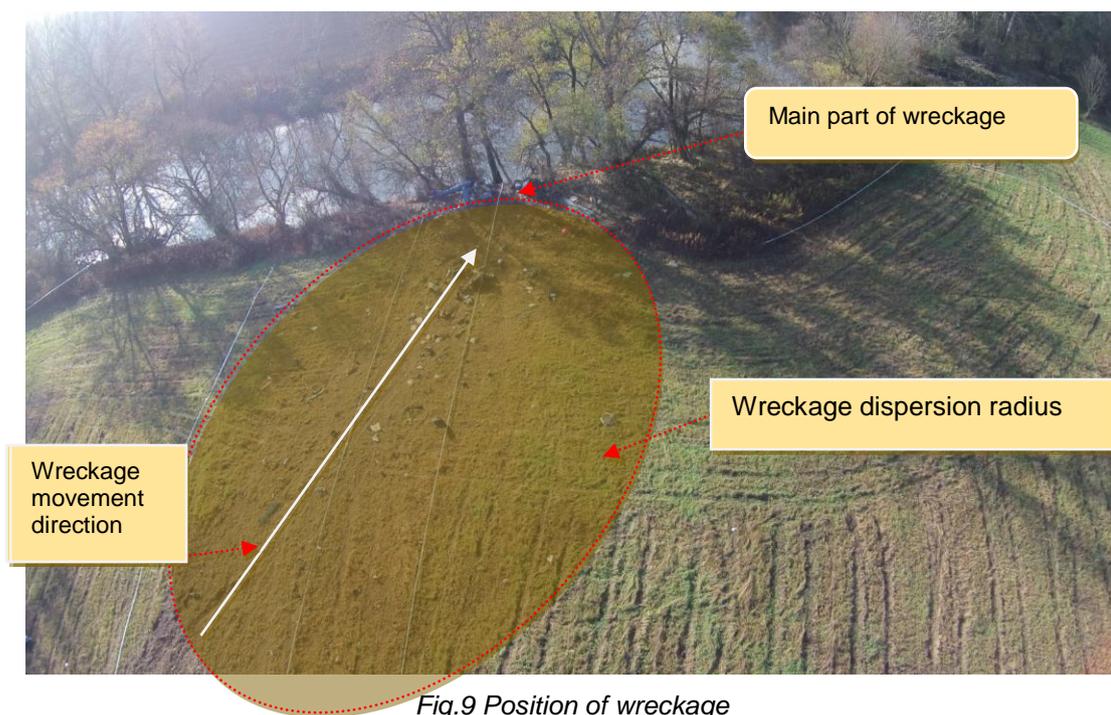
When descending for landing at a forward speed, the left wheel of main landing gear came into contact with the ground, which caused sharp braking on a soft surface and inclination of the helicopter to the left, where it touched the ground with blades of its lift engine. It caused the turnover of the helicopter and its gradual destruction in a 80-90 m long section. In the last phase of movement of wreckage the cockpit was fully devastated and the whole crew was dispersed around the main parts of the broken fuselage of the helicopter. Two bodies were found in the blind arm of river Uh behind the wreckage in the flight direction.

Fig.9 Position of wreckage

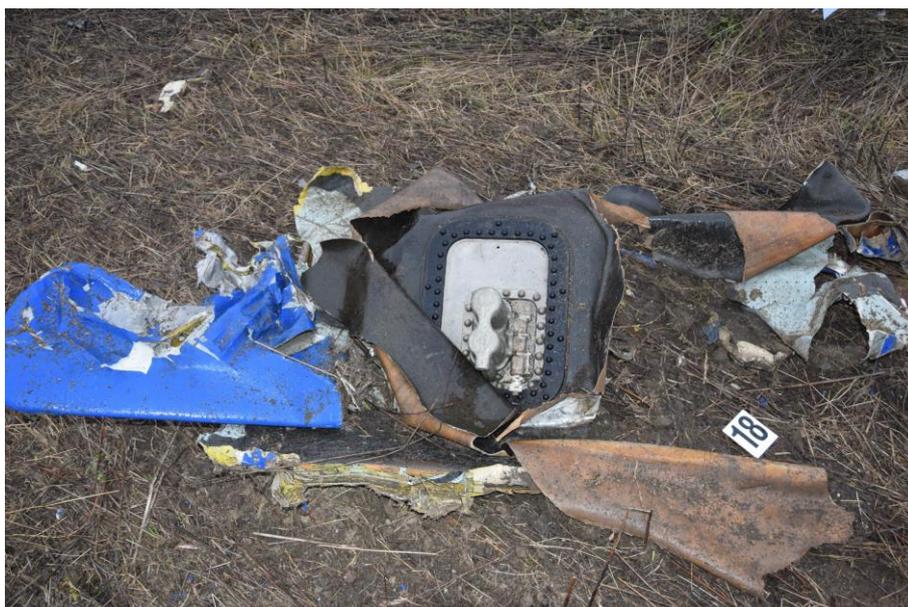
- As the main fuel tank was destroyed by the hard contact of the fuselage with the ground and subsequent forward movement of the helicopter (*Fig. 10*) and as the secondary fuel tanks were perforated too, fuel sampling and testing could not be performed. The intensive smell of dispersed fuel on the place of accident indicated that the tanks had contained fuel before the accident.

Fig. 10 Destructioned main fuel tank

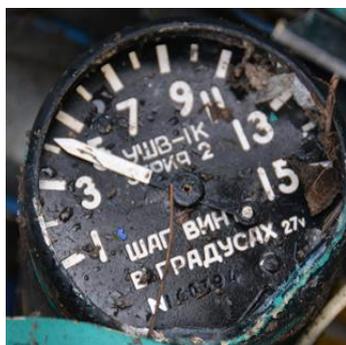
The traces of running lift rotor and the readings of devices monitoring the engine function (Fig. 11 - 13) indicate that the engines were running before the accident.

Fig.11 Lift rotor blade pitch

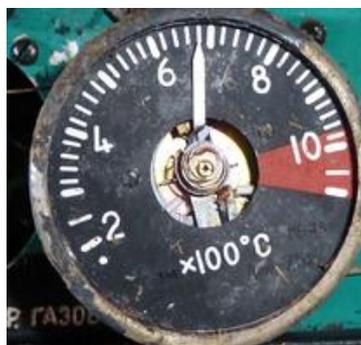
Fig.12 Temperature of exhaust gases (left-hand engine)

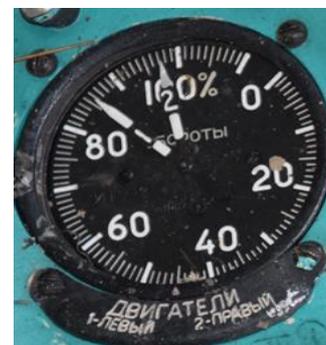
Fig.13 Engine speeds

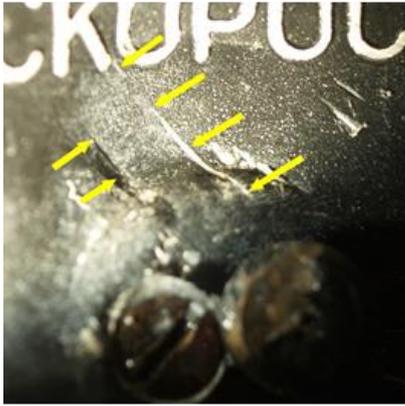
- The pointer of damaged speed indicator remained immobile after the accident. In its final position it pointed to the value of 67 km/h on the scale of the device. The rear counterbalancing part of the pointer was broken. In the process of breaking, its edges created two parallel indents in the device screen, pointing to letter "K" in the sign "СКОРОСТЬ" (see the indents marked by arrows in (Fig. 14 and Fig. 15).

- The indents originated when a foreign object (another part of the helicopter, vegetation, ground, body of a crew member etc.) pressed the rear part of the pointer against the device screen. It means that the indents are not simply the result of the forward inertial swing of the pointer at the moment of impact, but they originated with some, even though minimum delay after the impact, during which the pointer could have been changed its position.

Fig.14 Detailed view of indents from edges of the broken part of the pointer

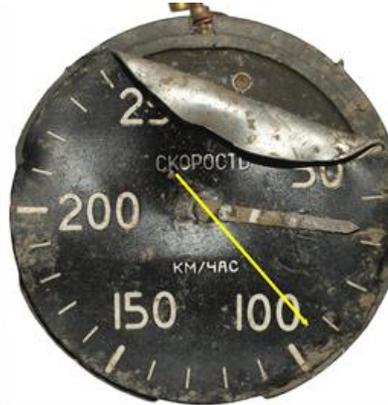
- From the direction of these indents it was obvious that at the time of their origin the pointer indicated speed of about 94 - 95 km/h (see the direction of the arrow in Fig. 14 a 15).

Fig.15 Direction of the pointer at the moment of origin of the indents
