FINAL REPORT

on investigation of
parachute accident

Reg. No. SKP2015001

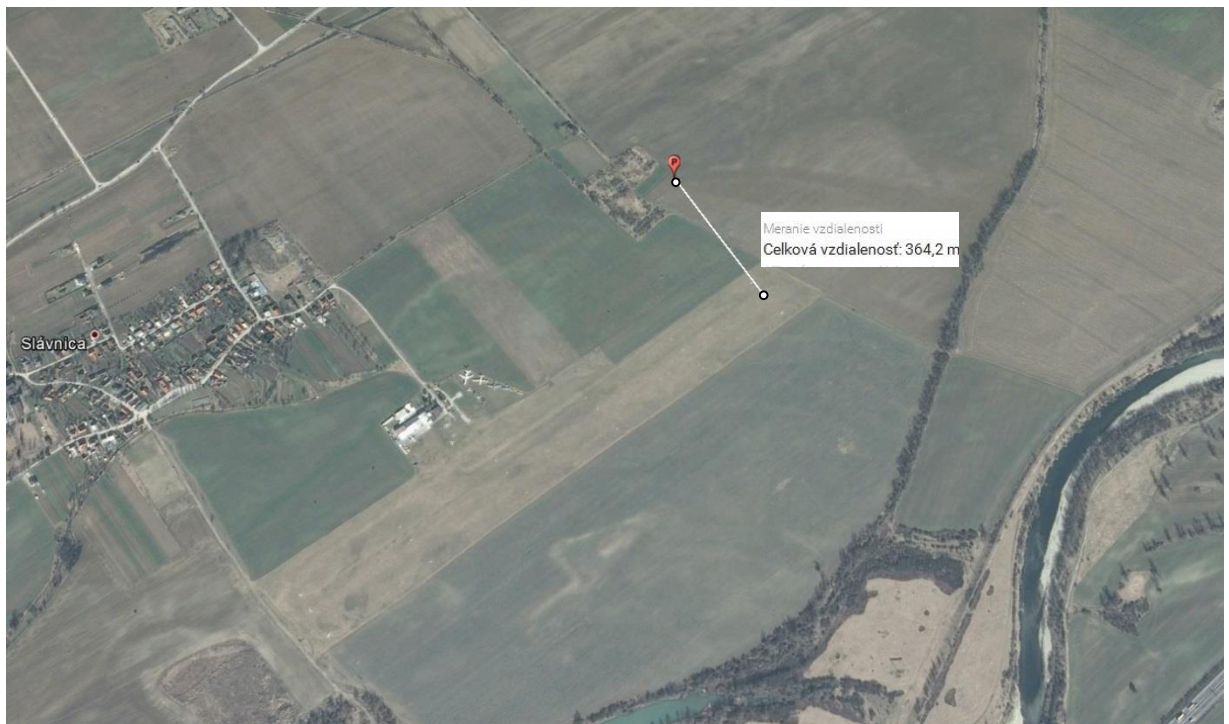
The place of accident is situated 364 m NNW away of the centre of the threshold of RWY23. At the time of accident the field, impact point, was hard after the corn harvest. Geographical coordinates of the field: N 49°00'10,87'', E 18°11'43,25''.
