FINAL REPORT

on investigation of serious incident
Flying sport vehicle – Prototype AeroMobil 3.0.1
Identification number OM-M929

Reg. No.: SKS2015001

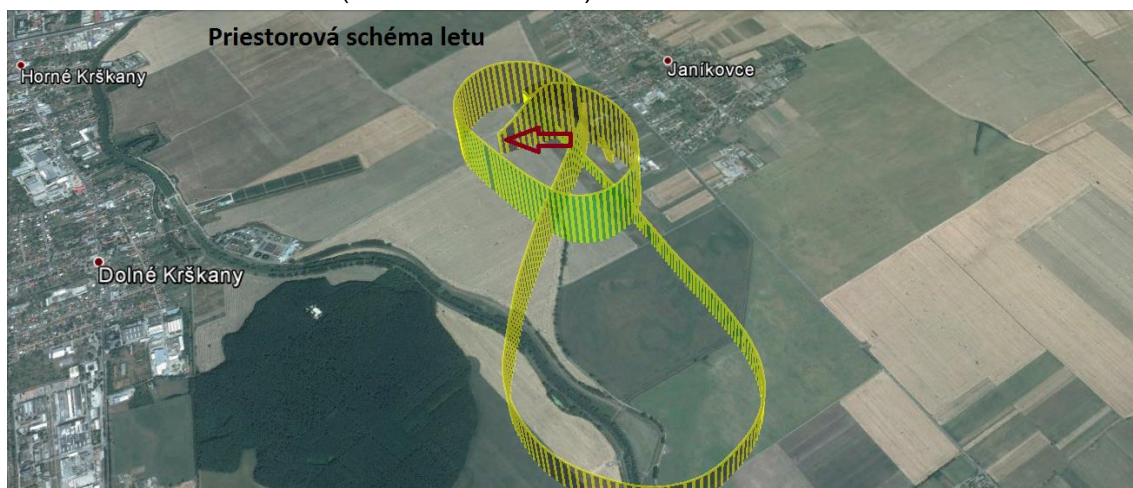
Fig. Spatial flight scheme

Before the critical flight the pilot taxied with AeroMobil to RWY15 and at 19:01:05 he conducted the ground run and takeoff with climb to an altitude of about 90 m. After the lift-off the pilot retracted the flaps from position 15° to position 0° and left the air incidence angle in take-off configuration, because the measurement required it. After the take-off he did a short climbing right turn of 220° to an altitude of about 200 m. Then he did a short direct climbing movement and climbing left turn of 180° to an altitude of about 250 m, followed by a short direct movement and climbing left turn of 180° to an altitude of about 327 m. This configuration was maintained until the start of left wing stall, with left flight path turn of 90° from the start of the take-off (v 284 s - 19:05:48).

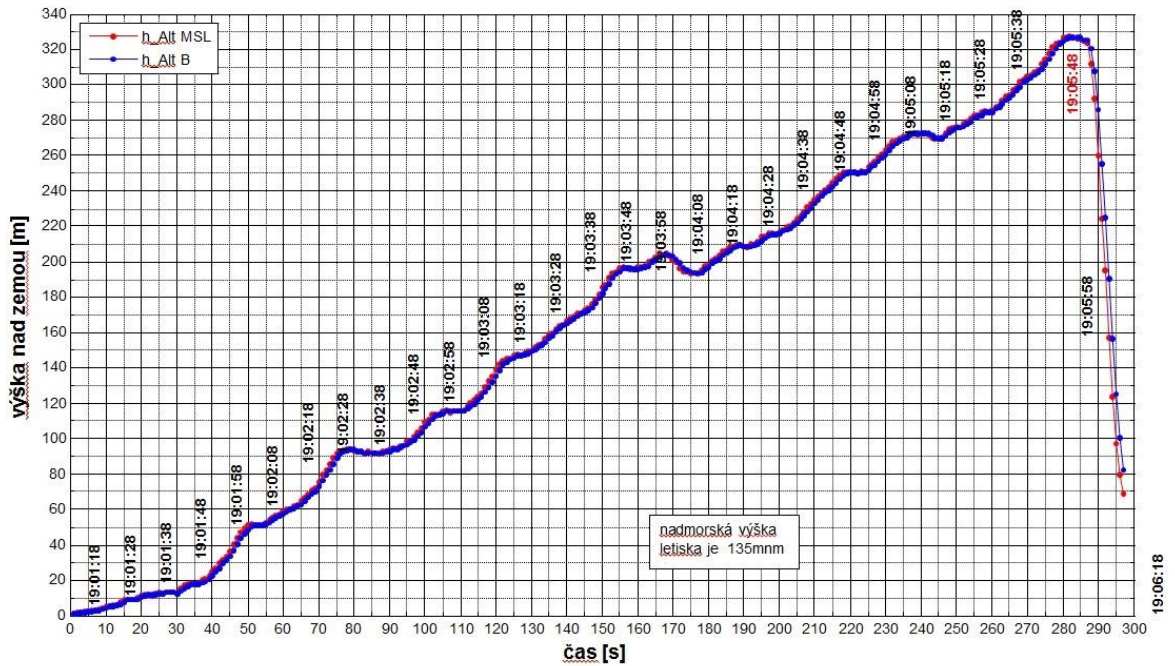
Fig. Dependence of altitude of AeroMobil above ground level on time during flight

During the stall the pilot switched the engine to run at idle thrust and activated the rescue parachute system (286 s). In an altitude of about 70 m he felt the full opening of the canopy, which caused a dramatic decrease of the vertical stall speed. AeroMobil fell to the ground (v 302 s - 19:06:18) about 80 m away of the west boundary of airport LZNI.

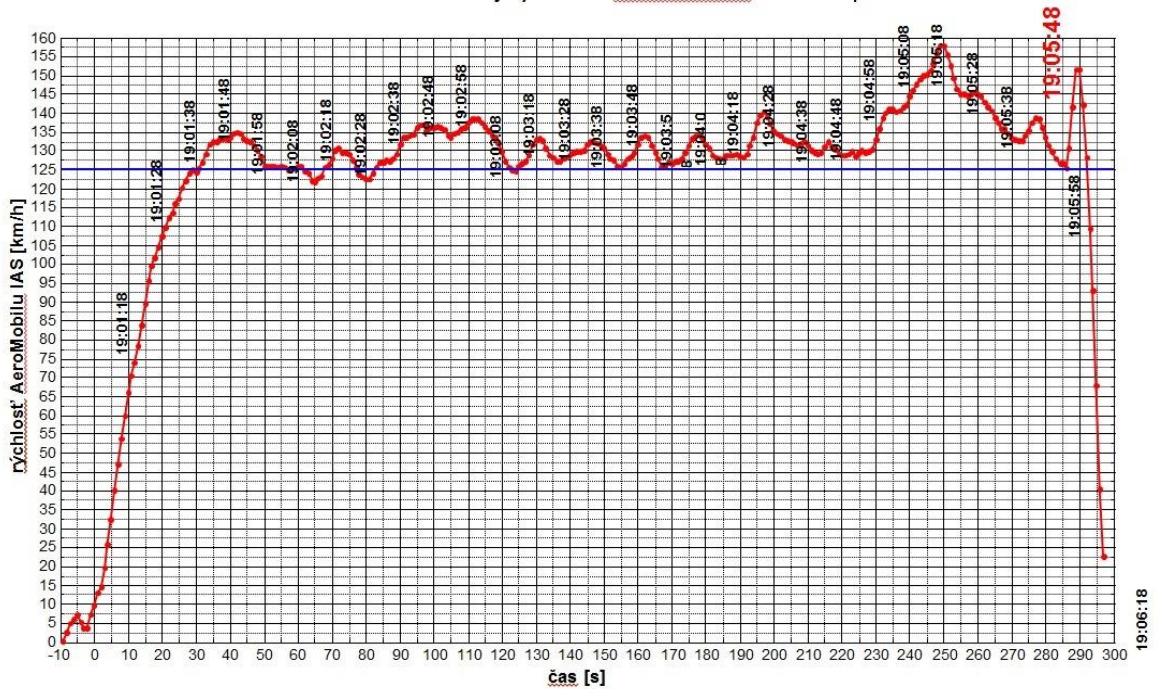
Fig. Dependence of indicated speed of AeroMobil on time during flight

During the test flight the speed indicator showed more than the actual flight speed, due to the tapping of static pressure from the cockpit of AeroMobil.

Similar dependence was observed on the speed indicator for all test ground rolls and flights. The speed indicator always showed a higher speed than the actual speed, which probably influenced the flight of AeroMobil at low/stall speeds.

- To conduct test flights under weather conditions CAVOK,
- To change the method of static pressure reading in order to increase the precision of the speed indicator during flight;

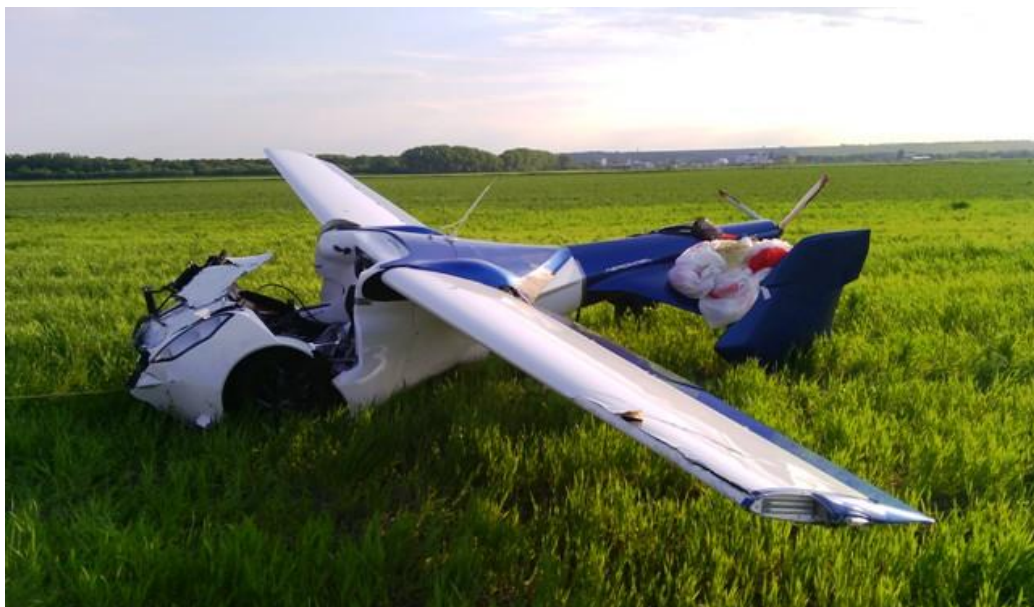
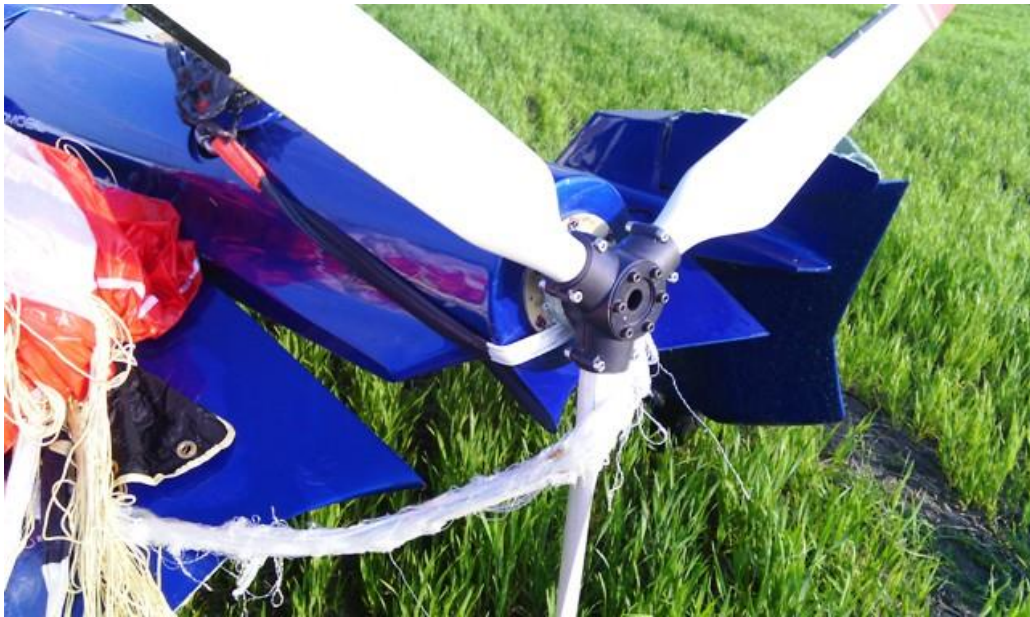
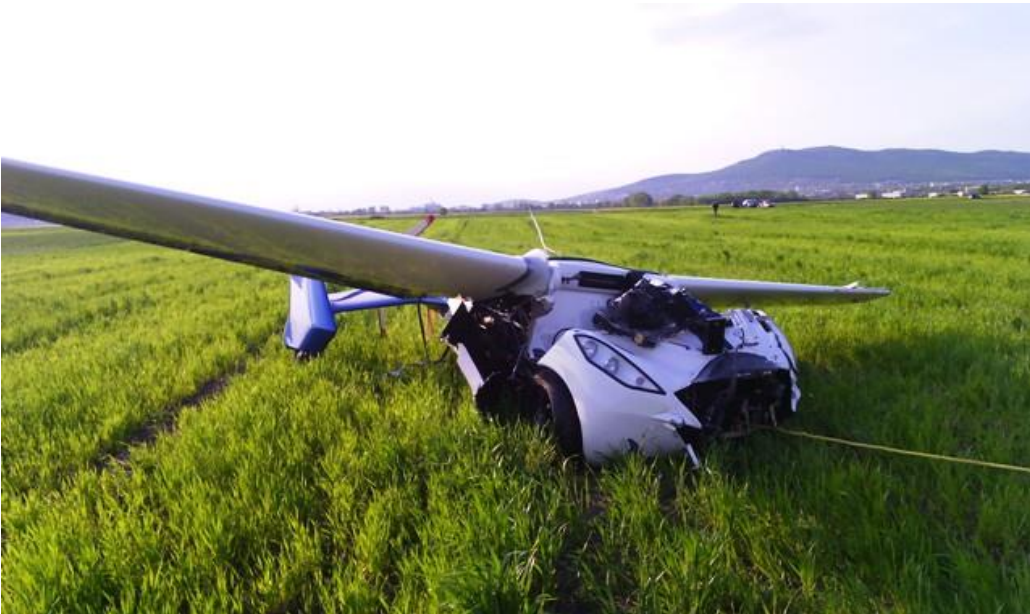
During the stall of AeroMobil the pilot successfully activated the rescue parachute system. During its operation the pack assembly and the parachute chords became entangled in the rotating parts of AeroMobil.

The inspection of AeroMobil detected the following scope of damage:

- Damage to front fuselage
- Damage to left wingtip
- Damage to elevator hinge (detachment of the hinge from the elevator); after fixing the joystick it was possible to drive the elevator by application of little force.
- Damage to right horizontal rudder caused by the rescue system chords (the upper part of horizontal rudder was cut through),
- Damage to the hinged part of fuselage and cockpit canopy
- Damage to deformatio part of fuselage consisting of side tunnels
- Damage to front landing gear axle
- Damage to canopy (rupture) and rupture of several parachute chords.

Consequently, the canopy and the parachute chords came into contact with rotating parts of AeroMobil (wrong direction of the rescue parachute).

It caused the rupture of several parachute chords, damage to the parachute canopy and higher descent speed of AeroMobil suspended on the parachute (based on data from the board variometer more than 10 m/s). In altitude of about 70 m the pilot felt the full opening of the canopy, which caused a dramatic decrease of the vertical stall speed.

- To change the pitch of the rescue parachute system to prevent the canopy and chords from getting caught into the rotating parts of the engine after ejection of the parachute;
