MINISTRY OF TRANSPORT, CONSTRUCTION
AND REGIONAL DEVELOPMENT
OF THE SLOVAK REPUBLIC

FINAL REPORT

on investigation of serious incident

Reg. No.SKS2015002

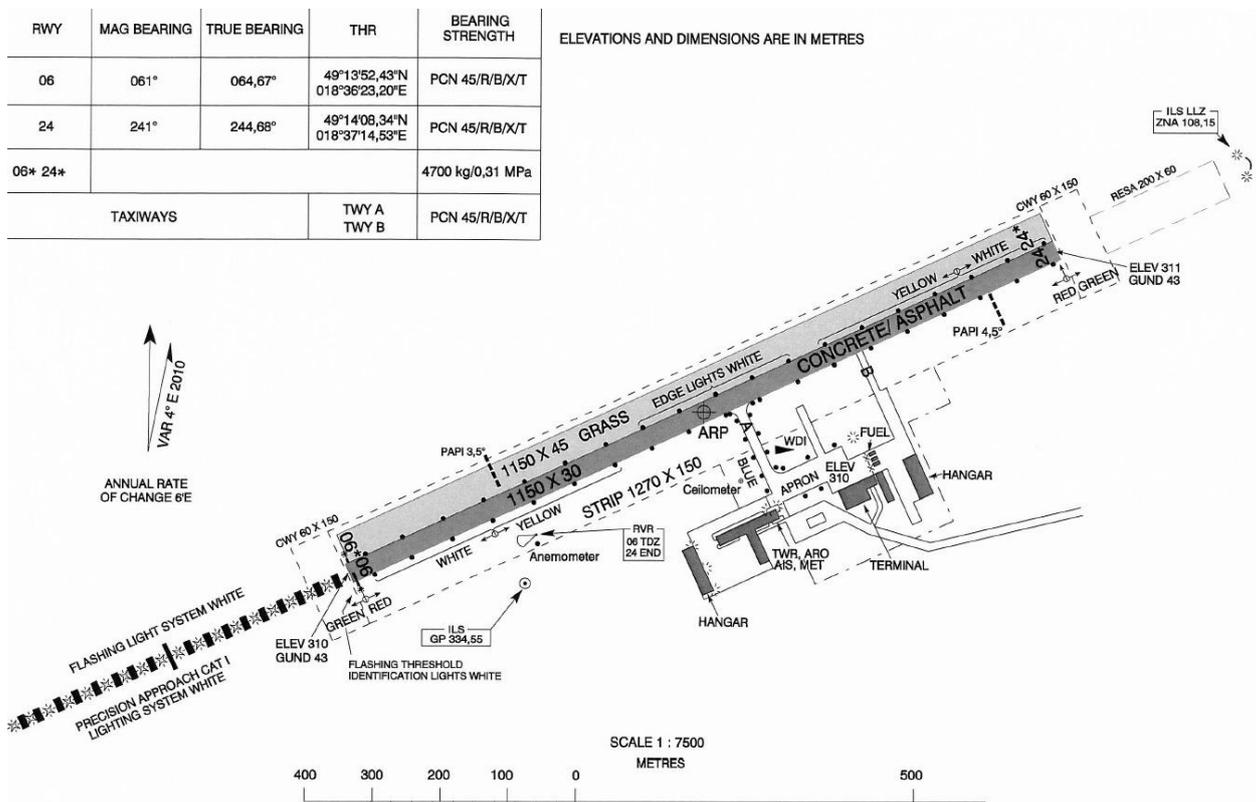
LZZI is an international airport. The asphalt RWY 06/24 with LDA of 1,150 m and width of 30 m is used for the aircraft operation. At the time of incident the airport LZZI was closed and RWY was occupied.
